## MARINE INVESTIGATION REPORT

M03M0077

### FIRE AND SINKING

SMALL FISHING VESSEL *SILENT PROVIDER*

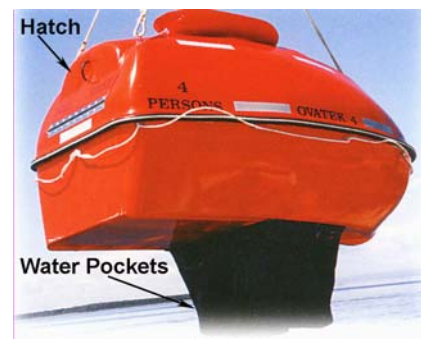
Photo 2. Ovatek 4

The Ovatek 4 water pockets fill with seawater when the liferaft is launched. These bags are intended to stabilize the craft during boarding and when in a seaway (in open seas). When stowed, the bags sit under the liferaft in a shallow cavity within the stowage cradle. Although protected from sunlight, salt water can seep into the cavity and saturate the textile. The stowage cradle has drain holes, but salt crystals

left from the evaporating water remain imbedded in the fabric. In contrast, the Ovatek 7 does not have water pockets. It has an internal ballast arrangement whereby seawater enters openings in the hollow fibreglass keel.

The nylon water pockets had been severely damaged with multiple tears in the material. Although the crew of the *Silent Provider* reported that some damage to these bags occurred during efforts to stabilize and right the liferaft when trying to board, some additional damage may have been incurred during the salvage and recovery of the liferaft. It was not possible to quantify the extent of the damage incurred solely during the boarding attempts.

- Prototype assessment is ongoing to replace the textile water pocket arrangement on the Ovatek 4 with an integrated fibreglass system similar to that of the Ovatek 7.

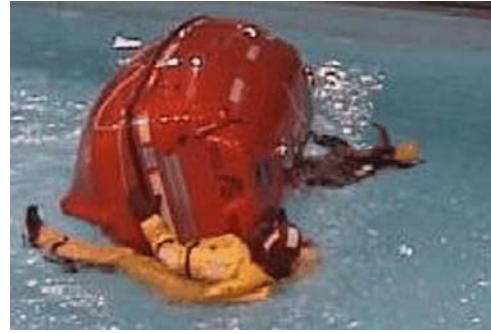
During pool tests, it was discovered that, once swamped, the Ovatek 7 assumed a near 90-degree list. Even if the hatches were closed, the liferaft could not be righted by two people in the water. The manufacturer explained that, under these conditions, the liferaft must be entered, the hatches closed, and the liferaft de-watered using the hand pump to discharge water through the air vent. Once de-watered, it will return to the upright position. However, information and guidance about what to do when the liferaft is swamped are not contained in the training video or in the user's manual for either Ovatek model.

**Photo 4.** Swamped Ovatek 7 on its side during TSB pool tests

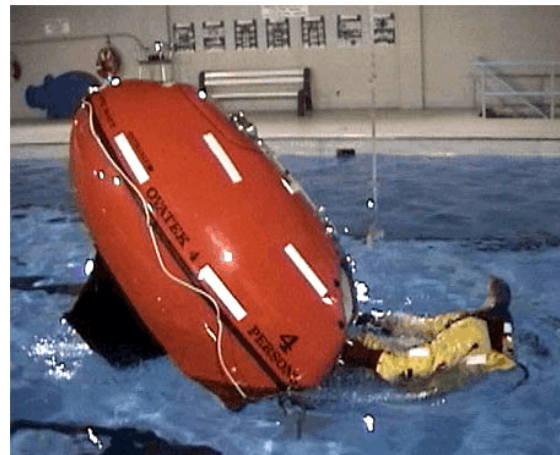
The boarding tests conducted by the TSB revealed no discernable difference in trim while boarding either with or without water pockets fitted to the Ovatek 4. The water pockets will only exert a significant restoring moment if lifted out of the water. The fact that the water pockets on the Ovatek 4 are located near midships and close to the longitudinal pivot point decreases their ability to reduce the trim of the liferaft while boarding (see Photo 5). When the first boarder is heavy, trimming

**Photo 5.** Ovatek 4: trim while boarding during TSB pool tests

Since an Ovatek has sufficient inherent buoyancy to remain afloat when completely flooded, any water that is shipped inside during boarding cannot sink the liferaft. However, the events of this occurrence and the results of the TSB pool tests demonstrated that the liferaft's instability under these conditions prompted personnel to abandon their attempts to board the liferaft and instead remain outside in the water. As the Ovatek 4 could not be boarded safely, it exposed the crew to undue risk.

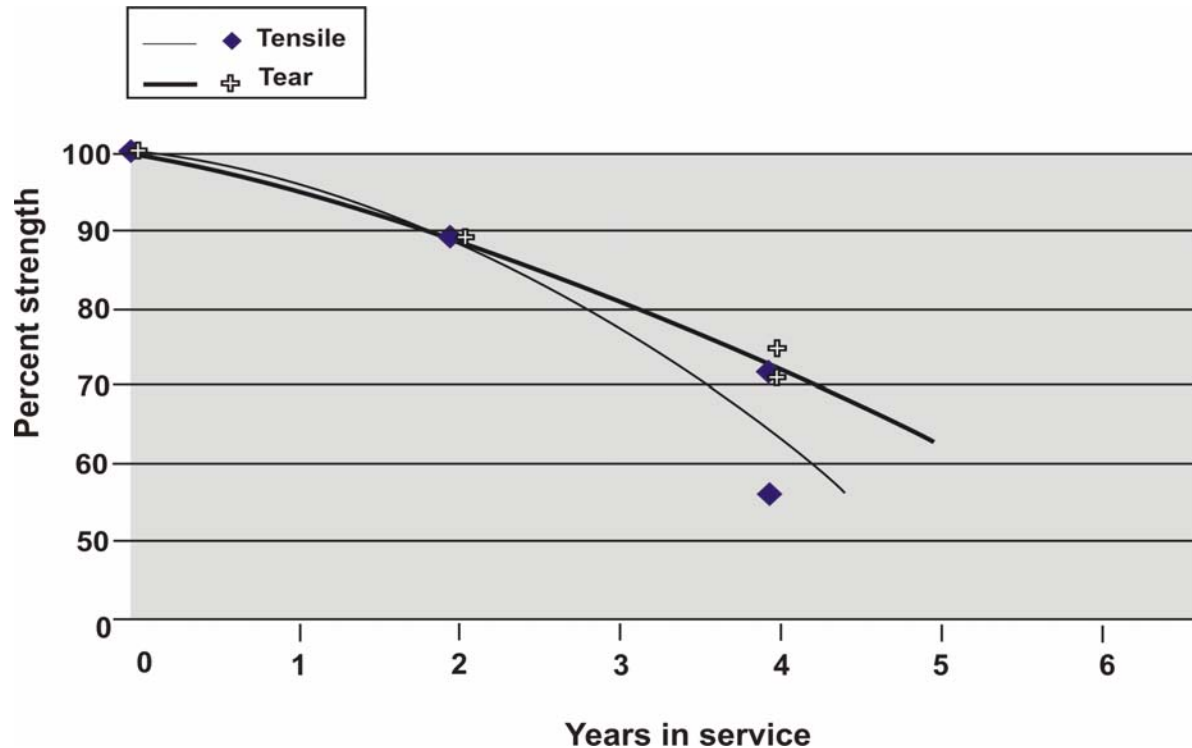
Examination of fabric samples taken from Ovateks that had been in service showed no indication of pre-existing mechanical damage or wear, degradation due to sunlight exposure, or chemical attack.<sup>29</sup> However, all used specimens showed degradation in strength over time (refer to Figure 1). By virtue of their external stowage position, the water pockets are vulnerable to the effects of environmental weathering and to the risk of mechanical damage during deployment

or use. With no minimum strength standard for construction, and no replacement policy or inspection guidelines to ensure their continued integrity, the probability of damage will significantly increase over time.

**Figure 1.** Graph showing nylon strength degradation (weft direction) over time
