MARINE INVESTIGATION REPORT
M03N0050

FIRE ON VEHICLE DECK

ROLL-ON/ROLL-OFF PASSENGER FERRY
JOSEPH AND CLARA SMALLWOOD
8 NAUTICAL MILES SOUTH OF PORT AUX BASQUES,
NEWFOUNDLAND AND LABRADOR
12 MAY 2003

Report Number M03N0050

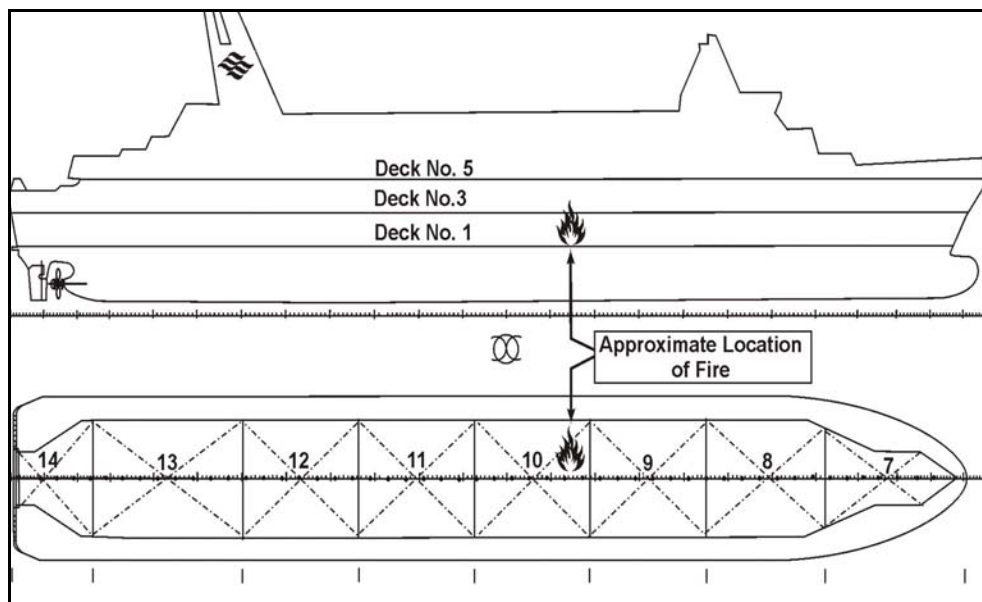
Figure 1. Deck 1 – Deluge zones and location of fire

1. The fire originated in or around a tractor-trailer parked on vehicle deck 1; the cause of the fire was undetermined.

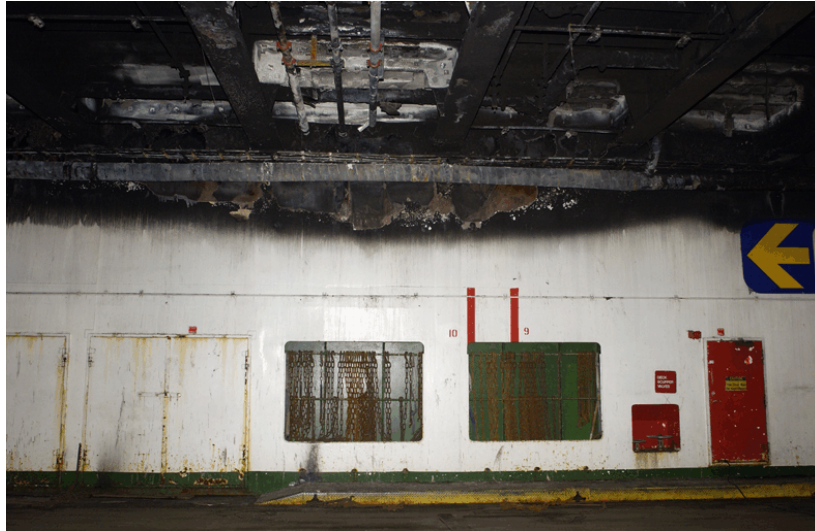
When discovered, the fire was burning in one of the tractor-trailers on vehicle deck 1; however, the precise origin and cause of the fire has not been determined. The resulting damage to the vessel included, but was not limited to, the following:

- Some 40 m² of deck plating above the origin of the fire was buckled.
- Some 40 m² of thermal insulation was damaged.
- Various electrical fixtures (for example, lighting fixtures, heat detectors, annunciators, associated wiring) were damaged.
- Various internal and external areas were smoke damaged.

Photo 2. Damage to deckhead

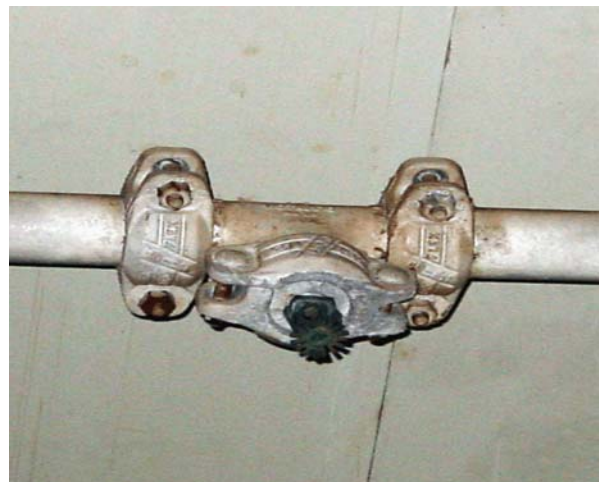
Photo 3. Deluge spray head

The primary function of the deluge system is to contain and control the fire and to provide cooling, thus allowing the crew an opportunity to better fight the fire. In this occurrence, the deluge system on board the *Joseph and Clara Smallwood* effectively limited the fire to the underside of the three burning vehicles.

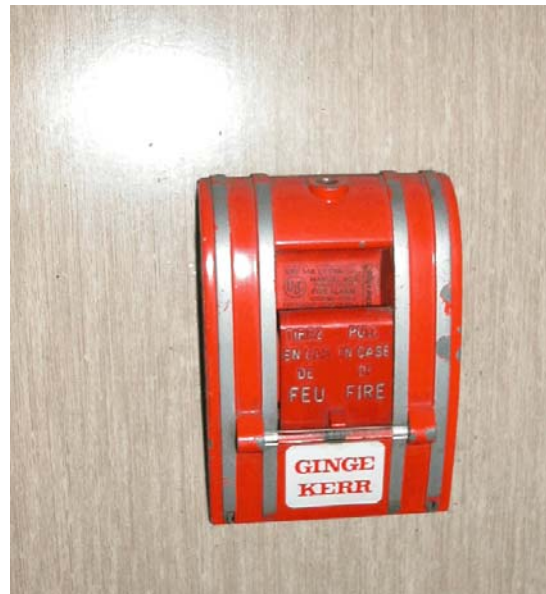
The manual pull stations on the *Joseph and Clara Smallwood* require the user to pull a lever down in order to send a pre-alarm signal to the bridge. No feedback is provided to the user about whether an alarm signal has been successfully transmitted until a bridge officer elects to sound the alarm, or the alarm is automatically activated after the preset time.

Crew members lacked understanding as to exactly what should occur when a manual pull station is activated. Some knew that the alarm would initially sound only on the bridge; some thought an audible

Photo 4. Typical manual pull station

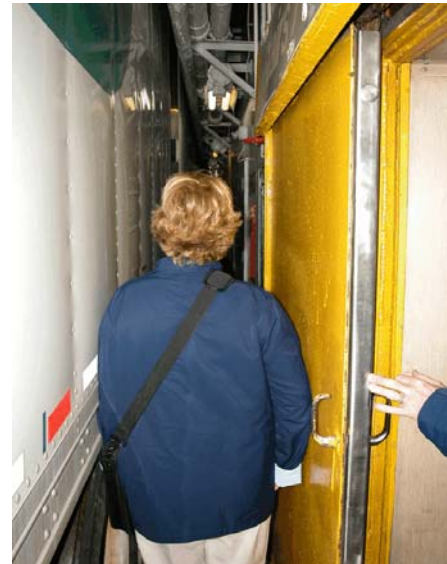
Photo 5. Typical spacing between vehicles and deck perimeter

During the occurrence, dense black smoke resulted in poor visibility, and the close spacing between the vehicles made it extremely difficult to access the fire. The fire team was also hampered by the physical limitations of a fully pressurized two-inch fire hose with which they were required to crawl around and under the trailers to gain access to the fire. These conditions increased both the amount of time required to access the fire and the physical effort expended by the firefighters. As a result, the ship's crew was unable to extinguish the fire, even though it had been effectively contained by the deluge system. Eventually, the stern door was opened and the deck was cleared of vehicles. This provided better access to the fire, which was then extinguished with the assistance of shore-based firefighters using their smaller (1 ½-inch-diameter) fire hoses.

The difficulty of fighting a fire in restricted spaces is currently recognized by TC in that, under certain conditions, vessels may be permitted to use reduced diameter fire hoses in machinery spaces.²⁶ The application of this principle to the restricted spaces of the *Joseph and Clara Smallwood's* loaded vehicle decks would similarly provide firefighting crew with improved access to these areas.

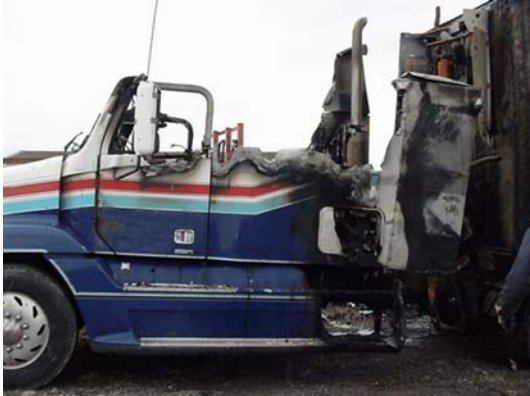
- One tractor truck was completely destroyed. Its attached trailer was heavily damaged and the cargo of orange juice destroyed.
- The contents of a moving and storage company trailer sustained heavy damage.
- A drop trailer with building supplies sustained heavy damage.
- Several other tractor-trailer rigs suffered varying degrees of smoke and water damage.
- A private motor vehicle sustained heat damage to the rear bumper, left tail-light and rear tires.

Tractor fire damage

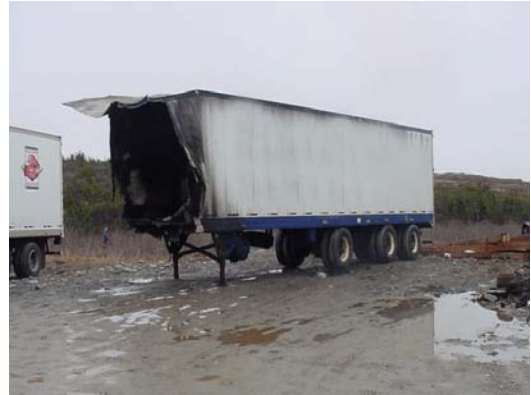
Trailer fire damage

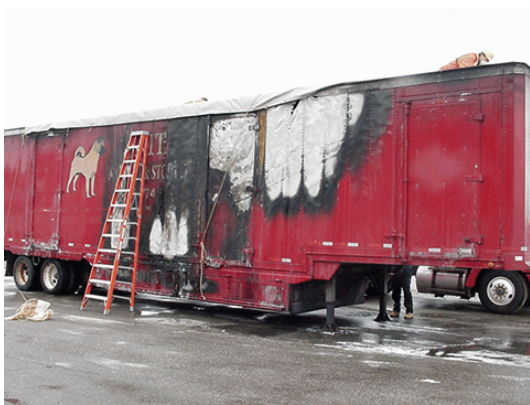
Moving and storage trailer fire damage

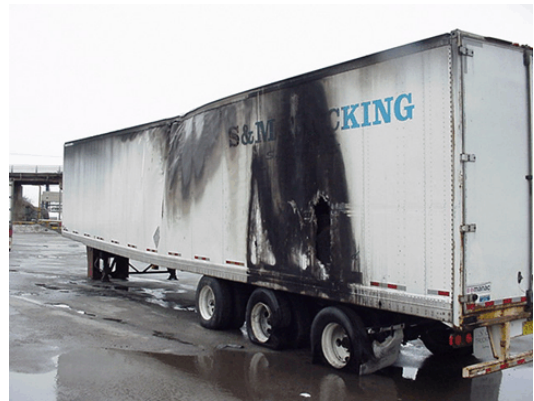
Drop trailer fire damage

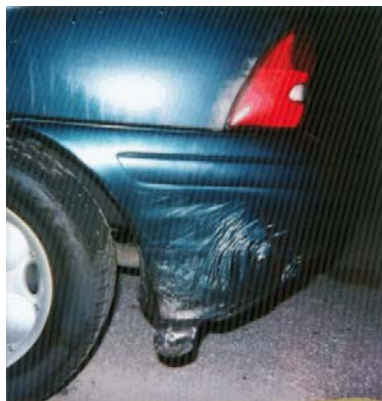
Private motor vehicle heat damage
