**MARINE INVESTIGATION REPORT
M04C0044**

**BY TUG AND BARGE *KAREN ANDRIE* AND A-397
OFF BAR POINT PIER LIGHT D33,
IN THE LOWER DETROIT RIVER, ONTARIO
11 SEPTEMBER 2004**

Report Number M04C0044

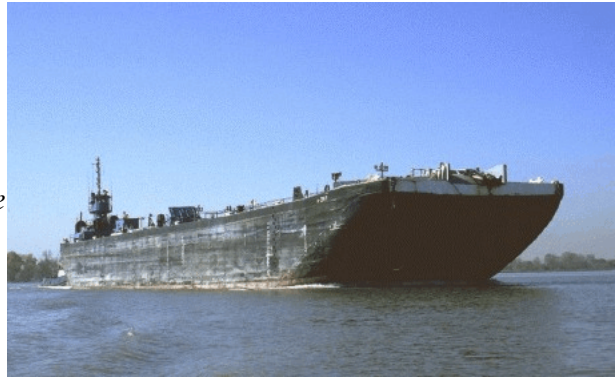
The barge A-397 was built as a tank barge with nine cargo tanks, certificated to carry high-flashpoint petroleum products such as asphalt. It has a raked bow designed for ease of movement in sea conditions (see Photo 2) and a notch at the stern for the bow of the *Karen Andrie* when it is pushing the barge. It also has two small pump rooms approximately 5 m by 3 m and 2.5 m high on the port and starboard sides of centre near the stern. The barge is equipped with navigation lights that meet regulatory requirements.
