**MARINE INVESTIGATION REPORT
M05W0080**

CAPSIZING

**INFLATABLE RIVER RAFT
ELAHO RIVER
SQUAMISH, BRITISH COLUMBIA
14 MAY 2005**

Report Number M05W0080

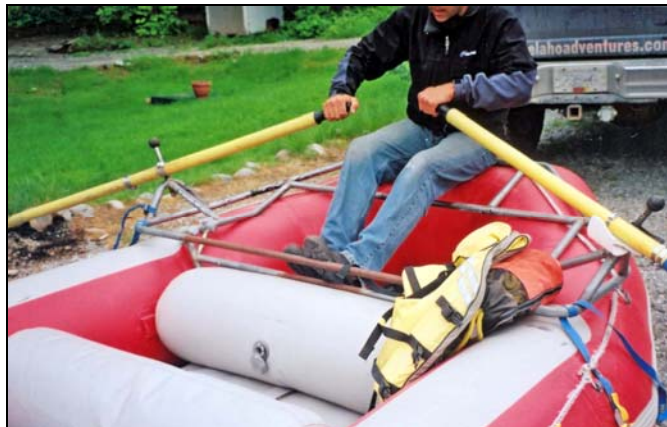
The raft floor has its own air chamber with ports to dispense water from the craft known as “self-bailers.” A rectangular steel steering frame is fitted over the top of the buoyancy tube at the stern. A guide sits at the stern looking forward and steers the raft by means of left- and right-side oars that rest in metal brackets held in place by clips attached to vertical “thole pins.”¹

Photo 1. Stern view showing the steering frame with oars clipped to thole pins. Indicates the position of the trip leader and the transverse buoyancy chambers.

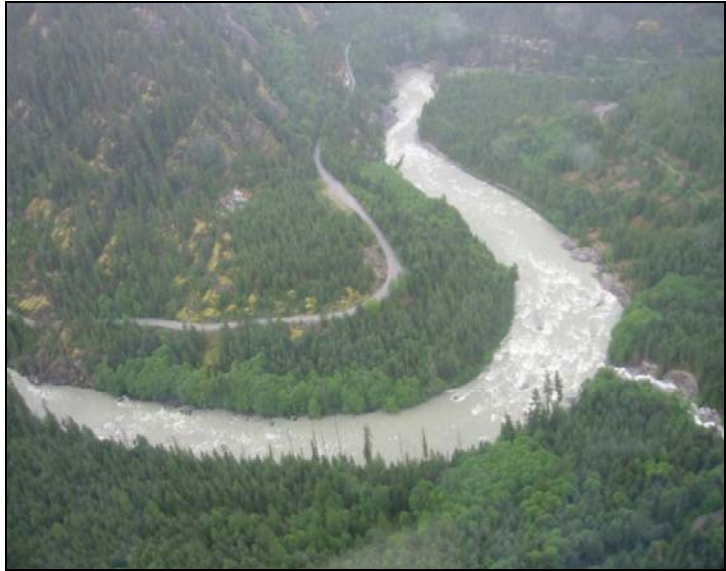
The Elaho River is a medium-volume, glacier-fed river in the Coast Mountains of British Columbia approximately 60 km northwest of Squamish, British Columbia. River turbulence can change daily depending on rainfall² and the rate of glacial runoff, which is dependent upon sunlight and temperature. As the river level changes, so do the relative positions of submerged obstructions such as boulders, stumps, and logs.

Photo 2. Elaho River, with the “Devil’s elbow” shown at the top

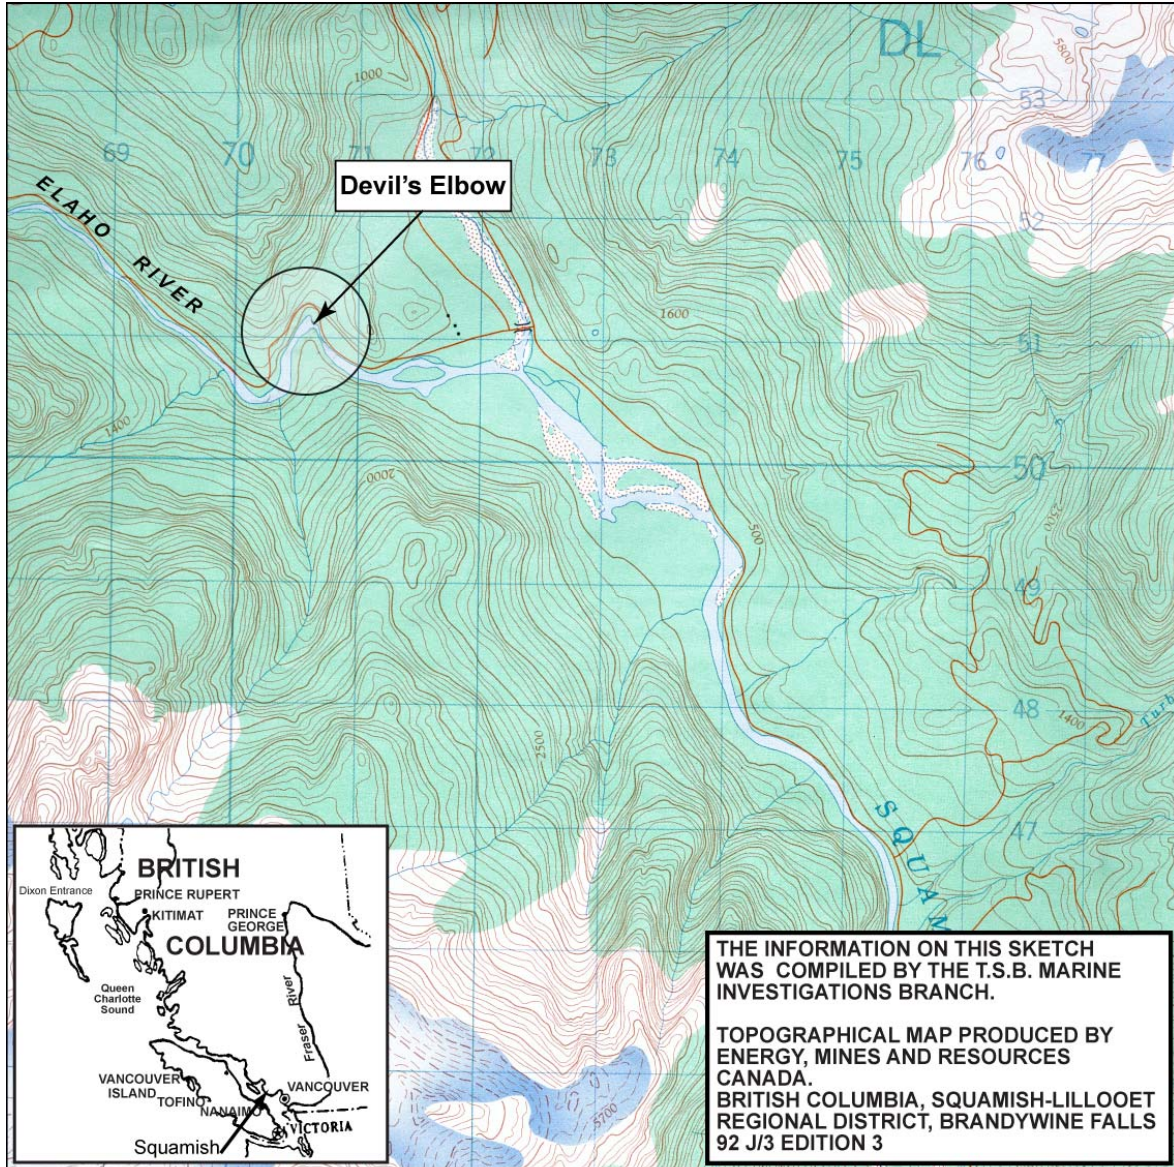
Appendix A – The Elaho River

After about 1 km, the convoy reached a river section known as “Devil’s elbow” (see Appendix A). There, the three craft encountered numerous waves, rocks, eddies and rapids. Both the safety kayak and the first raft traversed the area without mishap, but the right oar of the second raft struck a rock on the riverbed, jarring the oar loose from its lock so that it was briefly unusable for steering.
