**MARINE INVESTIGATION REPORT
M09M0073**

TAKING ON WATER AND SINKING

**SMALL FISHING VESSEL *PUBNICO EXPLORER*
11 NM SOUTHWEST OF CAPE ST. MARYS, NOVA SCOTIA
16 DECEMBER 2009**

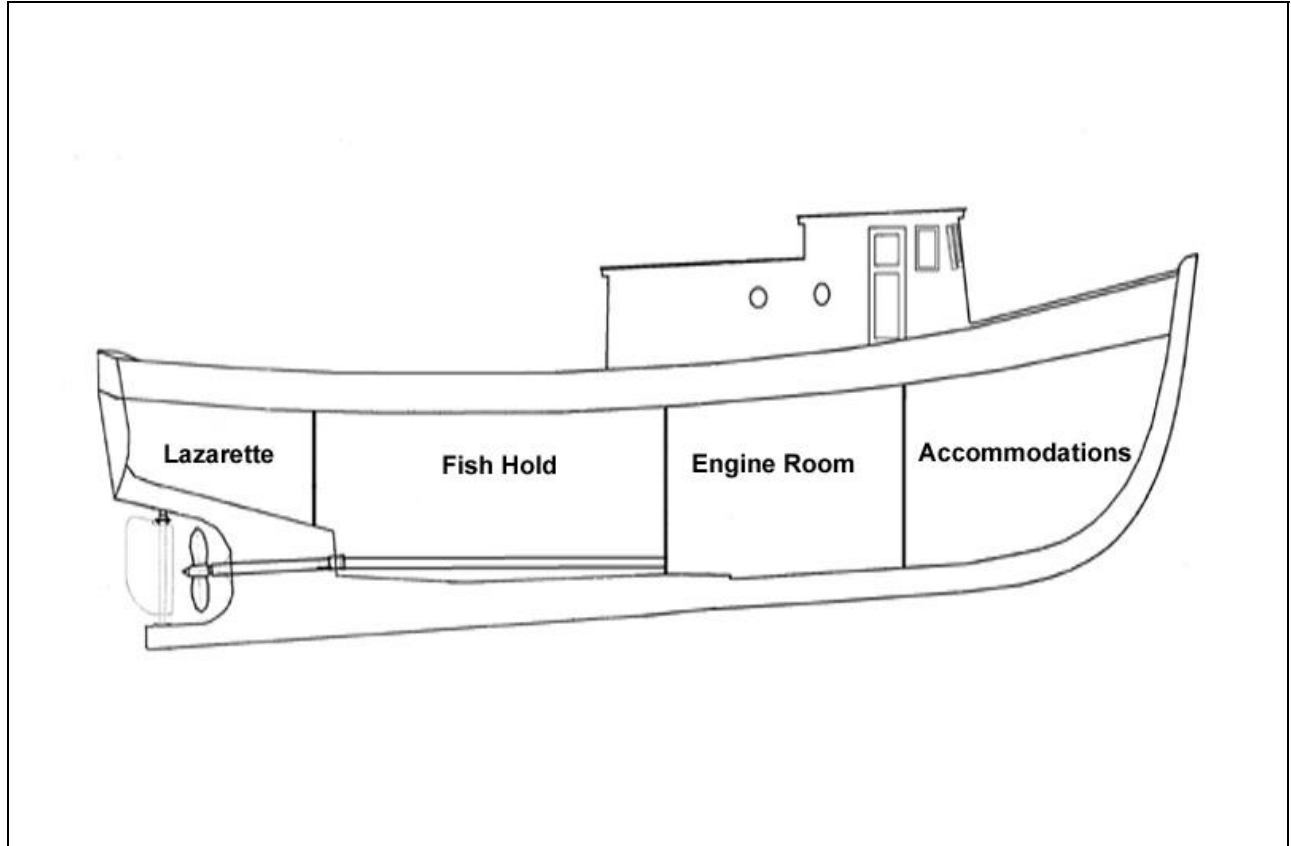
Appendix A – General Arrangement

The *Pubnico Explorer* was a wooden Cape Island design small fishing vessel of closed construction. The wheelhouse and accommodation were forward, with the engine compartment beneath the wheelhouse. The hull below the main deck was subdivided by 3 transverse watertight bulkheads that enclosed, from forward, the crew accommodation space, the engine room, a fish hold and a lazarette in which the hydraulic steering gear was located (Appendix A).
