**MARINE INVESTIGATION REPORT
M10M0014**

CAPSIZING AND SINKING

**SMALL FISHING VESSEL
CRAIG AND JUSTIN
OFF MARGAREE HARBOUR, NOVA SCOTIA
01 MAY 2010**

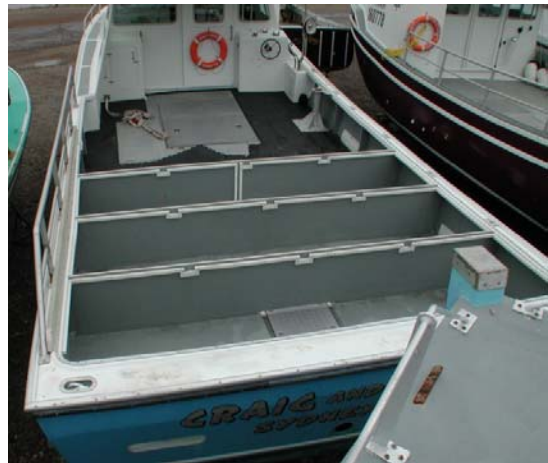
The working deck was fitted with 3 transverse pound boards to create storage areas (see Photo 2). Small holes were cut into the transverse pound boards, which allowed water to flow between the areas. The pound boards were fitted with portable covers, extending to the transom, on which the traps and gear could be stowed.

Photo 2. Working deck with transverse pound boards (Courtesy of Briand Marine Surveys)

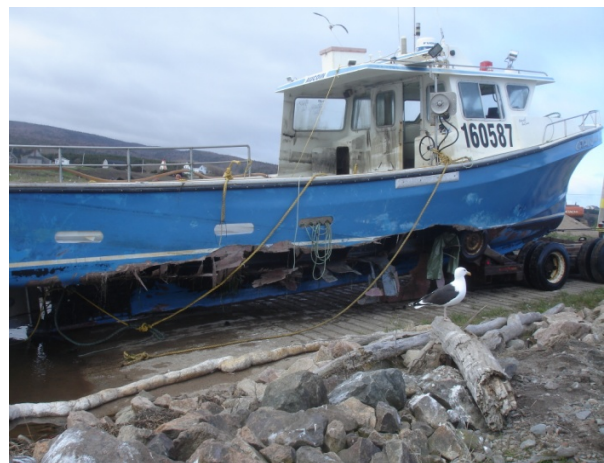
The vessel was subsequently salvaged, but the hull had been extensively damaged on the starboard side and was declared a total loss (see Photo 3).

Photo 3. *Craig and Justin* following salvage

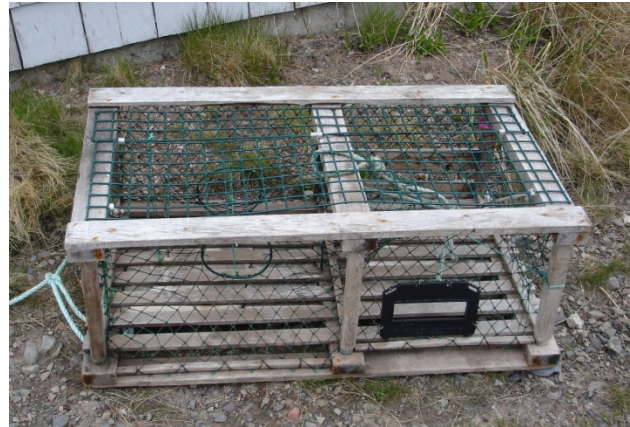
The lobster traps each weighed about 33 kg and the total weight of the traps was approximately 9.08 tonnes. The weight of the ropes for the traps was approximately 0.36 tonnes.

Photo 4. Lobster trap on the *Craig and Justin*

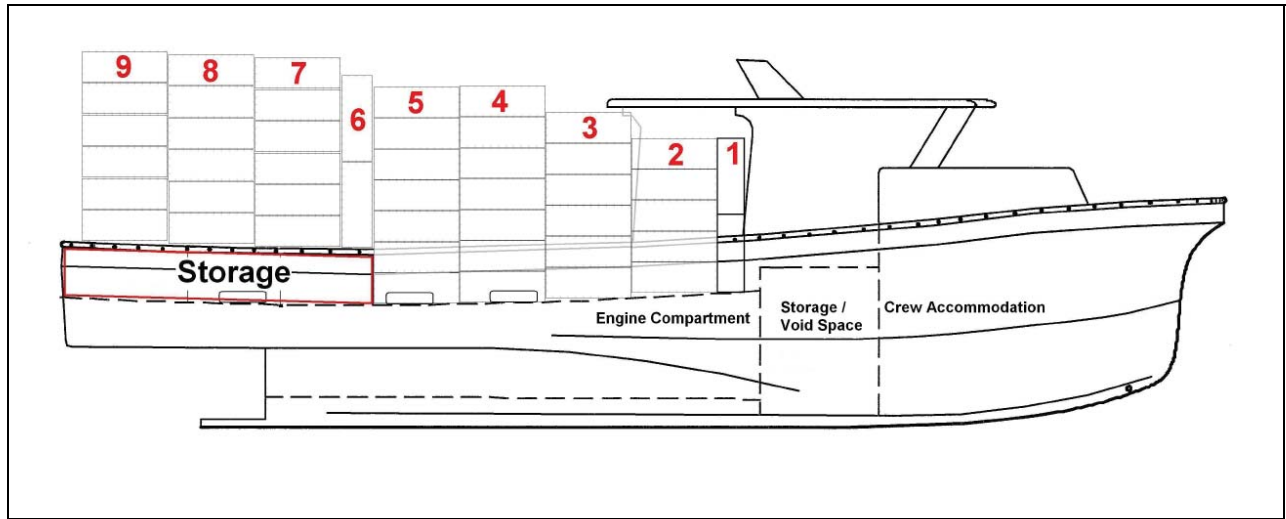
Appendix A – Vessel Profile and Loading of Lobster Traps

When the vessel departed port, the 275 lobster traps were stacked in 9 tiers of varying heights. The foremost 5 tiers were placed directly on deck, and the last 4 tiers were on top of the pound board covers (see Appendix A).

The reserve buoyancy and stability of the *Craig and Justin* during its final voyage was affected by many factors. First, the combined weight of the 275 traps, ropes and fuel on board was such that the vessel was heavily loaded with a list to port, and the freeboard and reserve buoyancy were therefore minimal. Moreover, the storage of the traps on the working deck and high on top of the pound board covers created a trim by the stern and a high centre of gravity, which further reduced the stability of the vessel.

Tier	Column x Row	Traps
1	-	5
2	6 x 5	30
3	6 x 6	36
4	6 x 7	42
5	6 x 7	42
6	6 x 2	12
7	6 x 6	36
8	6 x 6	36
9	6 x 6	36
Total		275

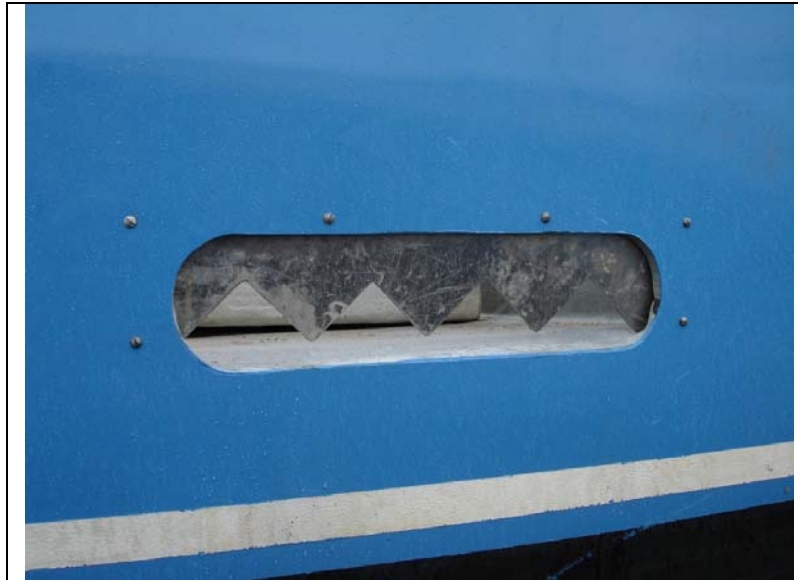
In this occurrence, the 2 forward-most freeing ports of the *Craig and Justin* were modified after its initial delivery without conducting an evaluation of the possible safety implications. While this did not play a significant role in the occurrence, owners may not be fully aware of the safety implications of their modifications unless they are adequately assessed.

Photo 5. Saw tooth style freeing port viewed from outside vessel

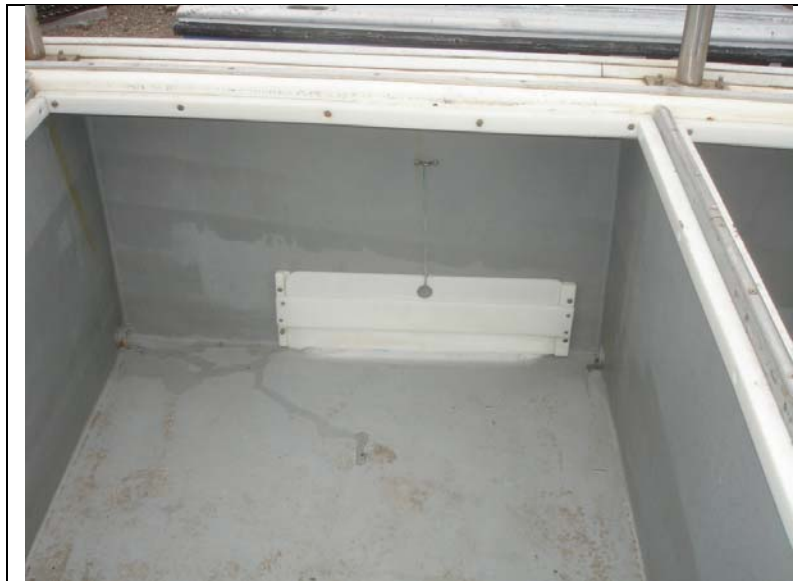
Although the weather and sea conditions were forecasted to be favourable, the small freeboard would have been ineffective at preventing the entry of water on deck via the freeing ports as a result of encounters with natural waves or the motions of the vessel. As such, the 2 forward-most freeing ports, which had not been fully blocked off, would have allowed water to enter the deck well as the vessel manoeuvred along. This water would then have been able to drain aft, through the drain holes in the transverse pound boards, and would have been trapped in the well because the other freeing ports had been effectively blocked by the slider plates.

Photo 6. Slider style freeing port viewed from inside vessel
