## MARINE INVESTIGATION REPORT

M11L0160

## GROUNDING

**BULK CARRIER *ORSULA***  
**BATTURES DE GENTILLY, BÉCANCOUR, QUEBEC**  
**15 DECEMBER 2011**

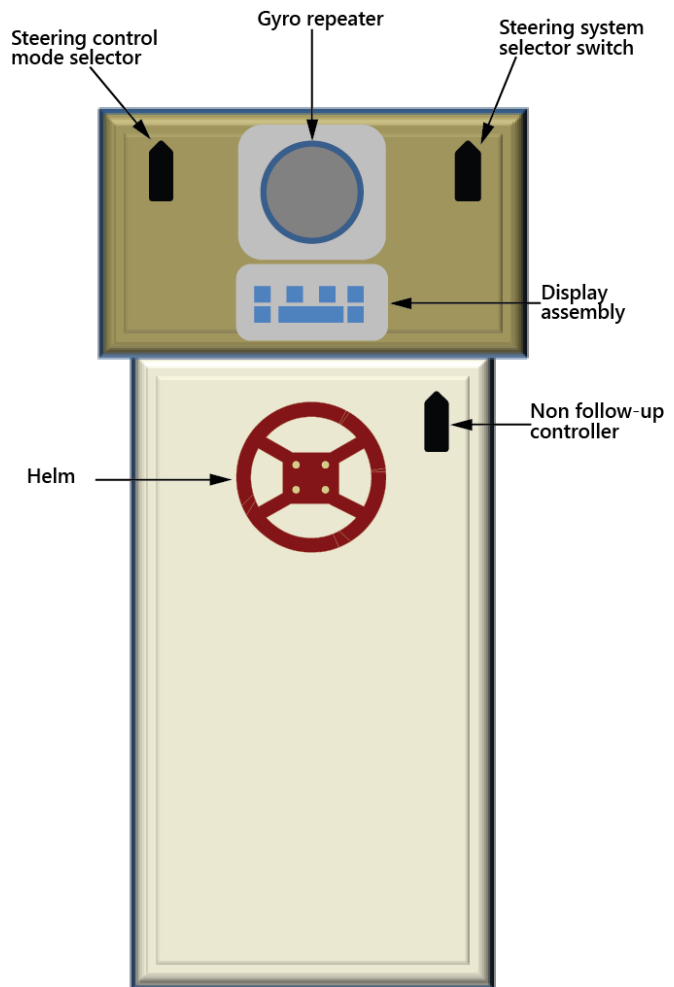
**Figure 2.** Bridge helm unit arrangement

A steering control mode selector switch, located on the upper left-hand side of the steering stand, is used to select 1 of 3 different means of steering the vessel: autopilot, hand or non-follow-up (NFU). When the steering mode selector switch is set to the "hand" position, the helm wheel is activated, permitting the helmsman to operate the steering in FFU mode. In FFU mode, when the operator changes the position of the helm wheel, the rudder begins to move and keeps moving until it reaches the ordered position indicated on the helm. To return the rudder to the neutral (0°) position, the helm wheel must be manually positioned to 0°. The helm order data signal to the steering gear telemotors is provided by 2 potentiometers that are mechanically linked to the helm wheel and electrically linked to each telemotor: 1 potentiometer per telemotor.

Typically, when the NFU mode is selected, the NFU controller becomes operational and the helm wheel is deactivated. However, on the *Orsula*, once the NFU controller is used, it overrides all other steering controllers without the need to set the steering mode selector switch to NFU. The NFU controller is a spring-loaded lever that must be held to one side or the other for a signal to be sent to the steering gear telemotors. Operating the NFU control causes the rudder to rotate left or right for as long as the control is held in the left or right position. On releasing the control, the rudder stops rotating and holds its position until the NFU controller is again operated.

A steering system selector switch is located on the upper right-hand side of the steering helm unit. The steering selector switch selects either the port or starboard steering system. Each of these systems controls the steering gear telemotor.

In this occurrence, the potentiometer connected to the port steering system failed, disrupting the link between the steering stand and the port telemotor in the steering gear compartment, resulting in the loss of control of rudder movement. The potentiometer had failed due to the consequences of contamination; however, the investigation was not able to determine the origin of this contamination.

Furthermore, the owner revised the safety management system for the *Orsula* and other vessels with the same equipment to include the requirement to replace potentiometers every 5 years for preventative maintenance.
