**MARINE INVESTIGATION REPORT
M14P0150**

**GROUNDING
BULK CARRIER *AMAKUSA ISLAND*
PRINCE RUPERT, BRITISH COLUMBIA
14 JULY 2014**

Marine Investigation Report M14P0150

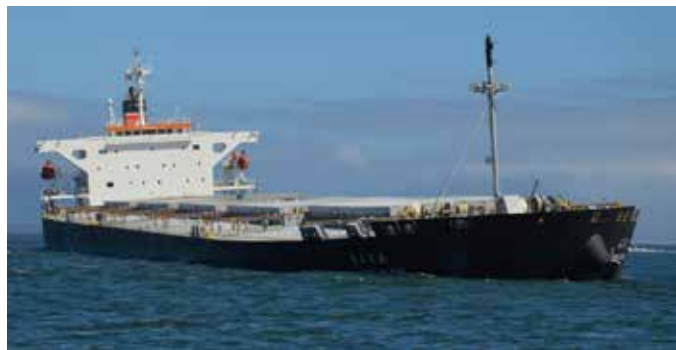
Photo 1. *Amakusa Island* following the grounding

- a longitudinal crack (approximately 30 cm long and 2 cm wide) on the forepeak tank bottom plating at frame 227;
- a longitudinal crack (approximately 12 m long and 50 cm wide) on the bottom plating, 8 m from amidships on the starboard side, which extended from the forepeak tank to water ballast tank No. 1, between frames 224 and 210;
- a longitudinal crack (30 m long and 100 cm wide) on the bottom plating, 6 m from amidships on the starboard side, which extended from water ballast tank No. 1 to water ballast tank No. 2, between frames 210 to 178;
- a transverse crack (50 cm long) located at frame 180.

By 08 September, temporary repairs had been completed under the guidance of the vessel's classification society, and the vessel departed the next day for Japan.

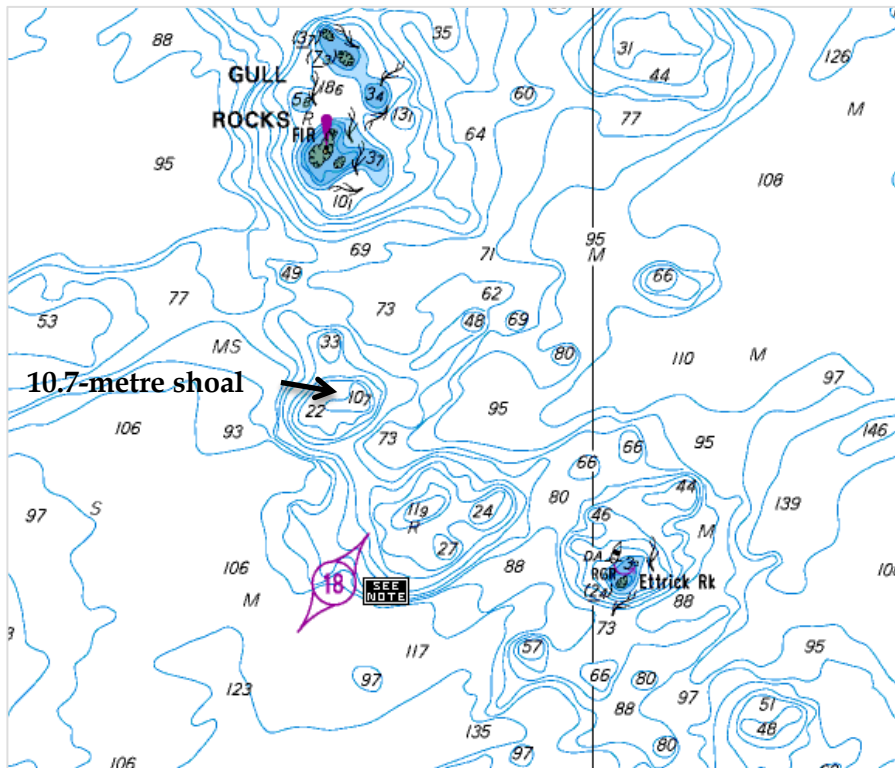
CHS Chart 3957 depicts the shoal on which the *Amakusa Island* grounded using bathymetric lines. The number of bathymetric lines around the 10.7-metre shoal indicates that the seabed rises at this location. The shoal is also marked with a 10.7-metre sounding measurement (Figure 1). The shoal is not shaded or tinted because its depth is greater than 10 m (for depths less than 10 m, the CHS adds blue tint or shading). With depths that have a decimal value associated with them, the decimal value is depicted by a subscript number, in this case “10.7.” The sounding measurements are printed in 7-point font.

An 11.9-metre shoal just to the south of the 10.7-metre shoal is depicted on the chart and marked with an “R” to indicate a rocky bottom composition.

Figure 1. The 10.7-metre shoal, as shown on Chart 3957 (not to scale) [Source: Canadian Hydrographic Service, with TSB annotation]

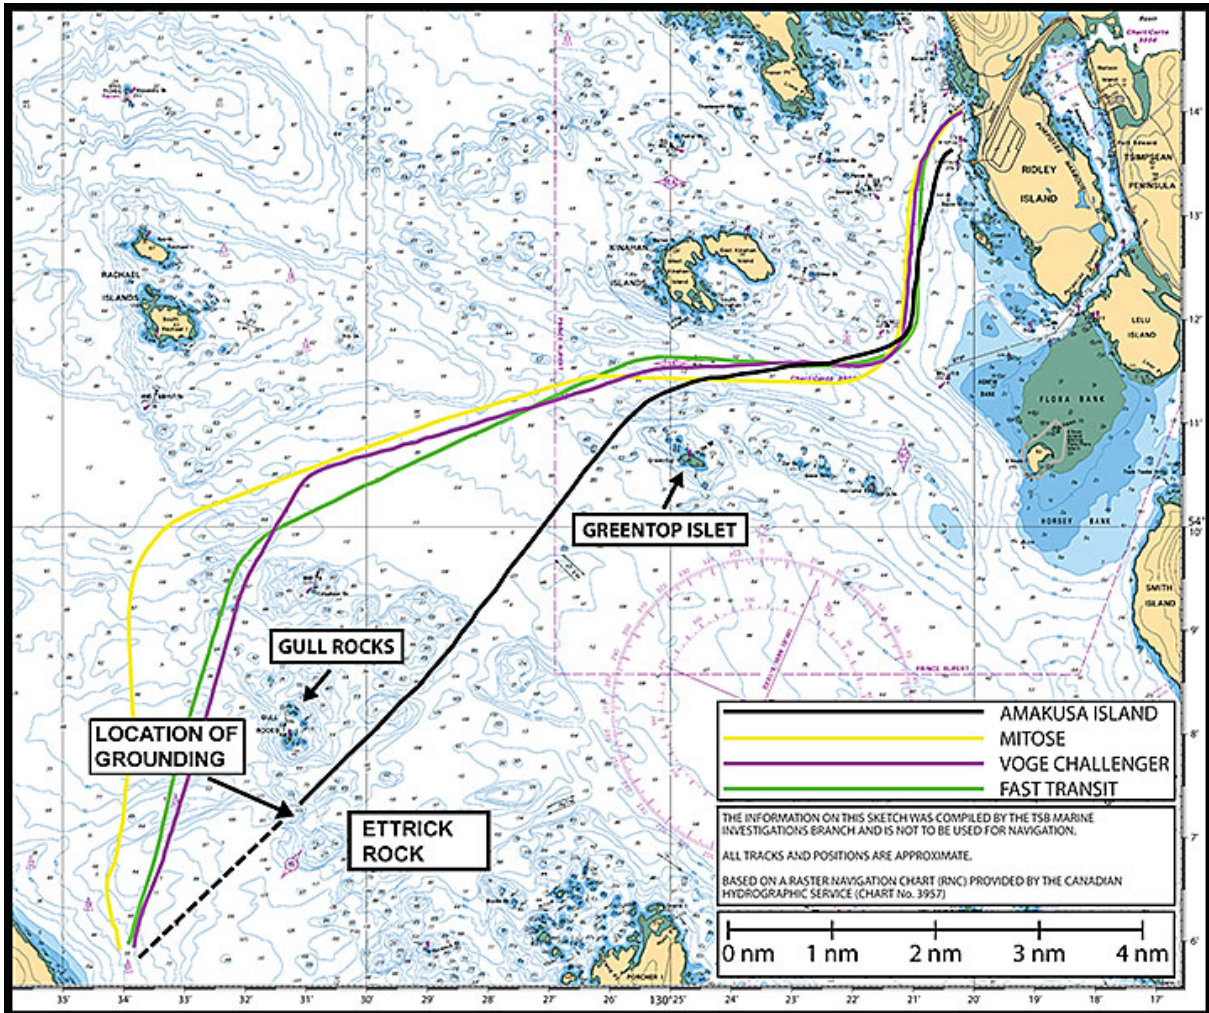
Records from the Canadian Coast Guard’s Vessel Traffic Management Information System (called INNAV or VT MIS-INNAV) indicate that the occurrence voyage was the first time a vessel under the conduct of a pilot had taken the route passing south of Gull Rocks on its way to Anchorage 25 since November 2012.¹⁹ Since 2012, three other vessels, *Mitose*, *Voge Challenger*, and *Fast Transit*, had sailed from Prince Rupert to Anchorage 25 with pilots on board. On all 3 occasions, the vessels took a route that passed north of Gull Rocks (Figure 2).

Figure 2. *Amakusa Island's* route to Anchorage 25 compared to the routes of 3 other vessels since 2012

The route that passes south of Gull Rocks is approximately 1.5 nm shorter than the route to the north.

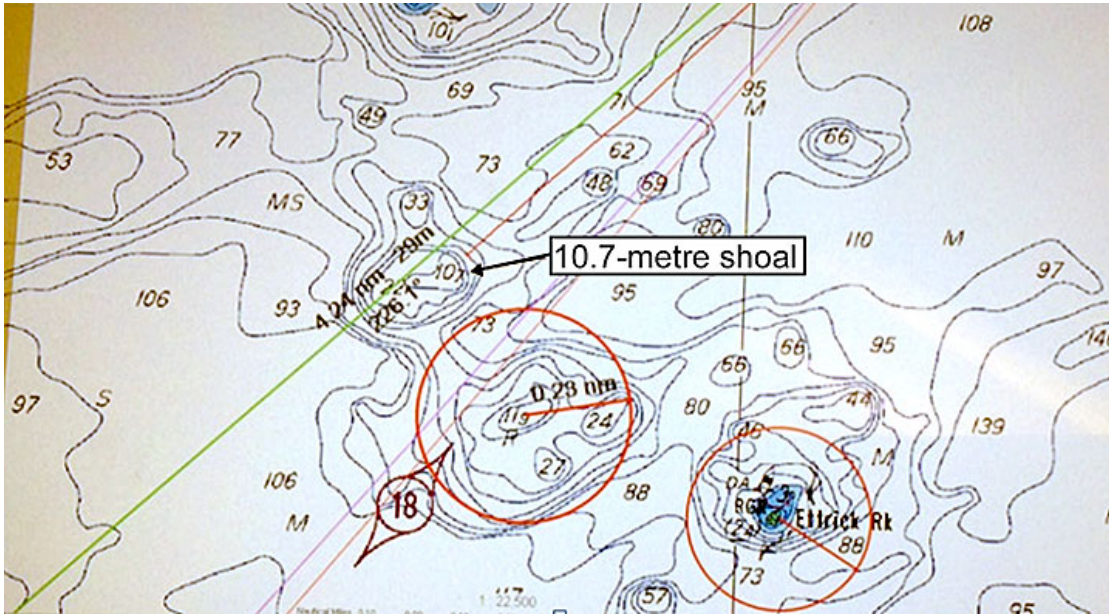
The PPA and the BCCP leave passage planning to the expertise of the individual pilot, who determines the courses to steer based on experience, local knowledge, and an assessment of the environmental conditions for the voyage. Pilots are not required to have passage plans,²¹ but they will discuss the intended route with the master and indicate go/no-go areas during a transit as part of the bridge resource management process.

Figure 3. Screenshot of no-go zones marked on pilot's portable pilotage unit (with TSB annotation)

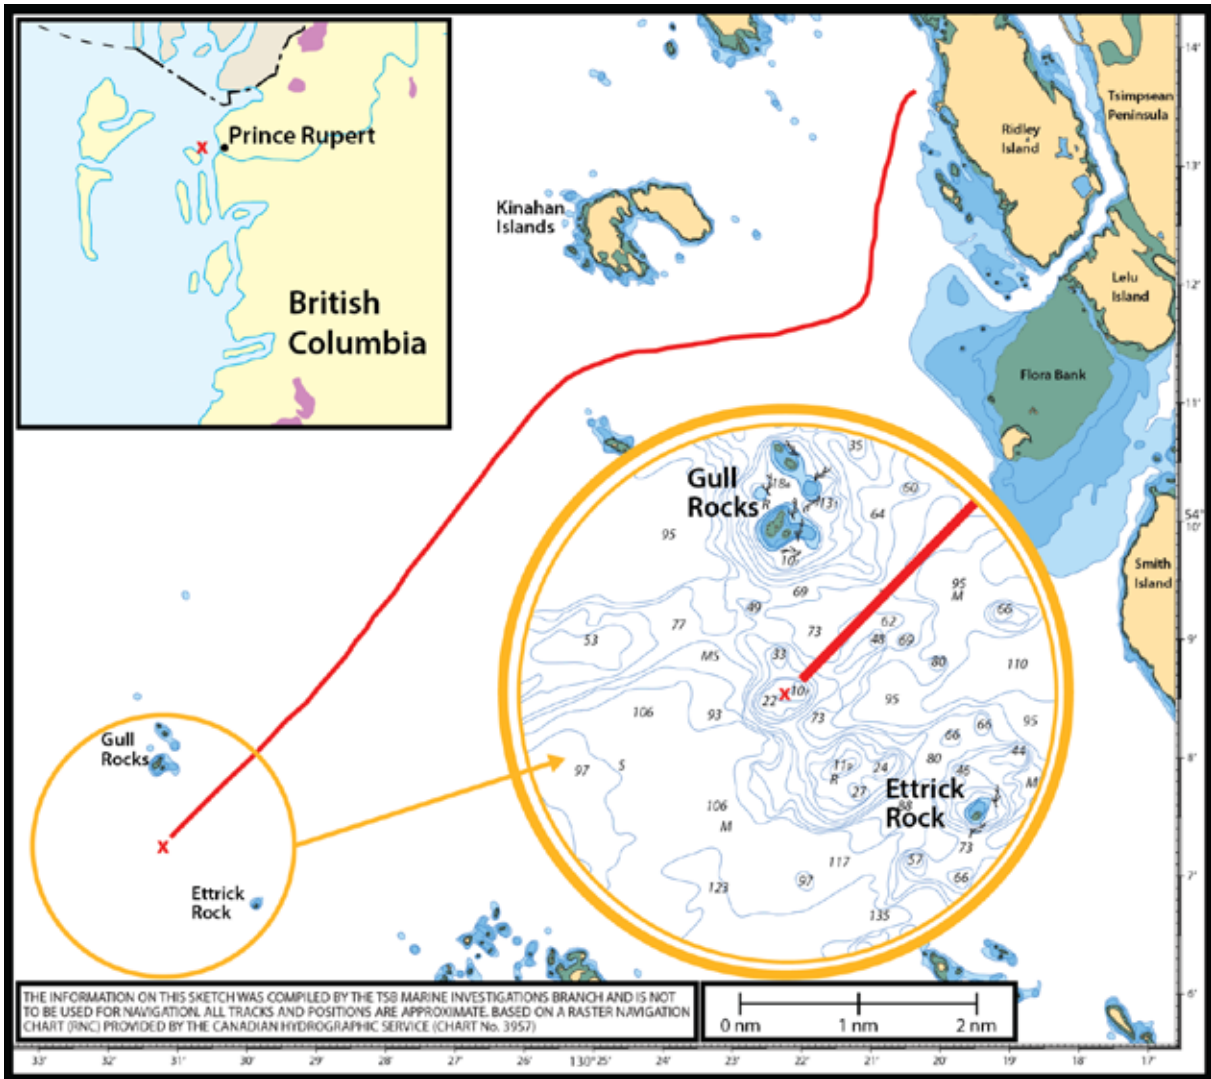
Appendix A – Area of the occurrence

The master ordered the crew to sound all the tanks, and the pilot advised MCTS of the situation. The tug *Smit Star*¹² arrived at 2228 and was asked to take depth soundings around the vessel. Approximately 10 minutes later, after the master and pilot had examined the chart in detail, it was confirmed that the vessel was aground on a shoal with a charted depth of 10.7 m. The vessel was in position 54°07.308' N, 130°31.042' W, approximately 140 m south of the plotted course line (Appendix A).

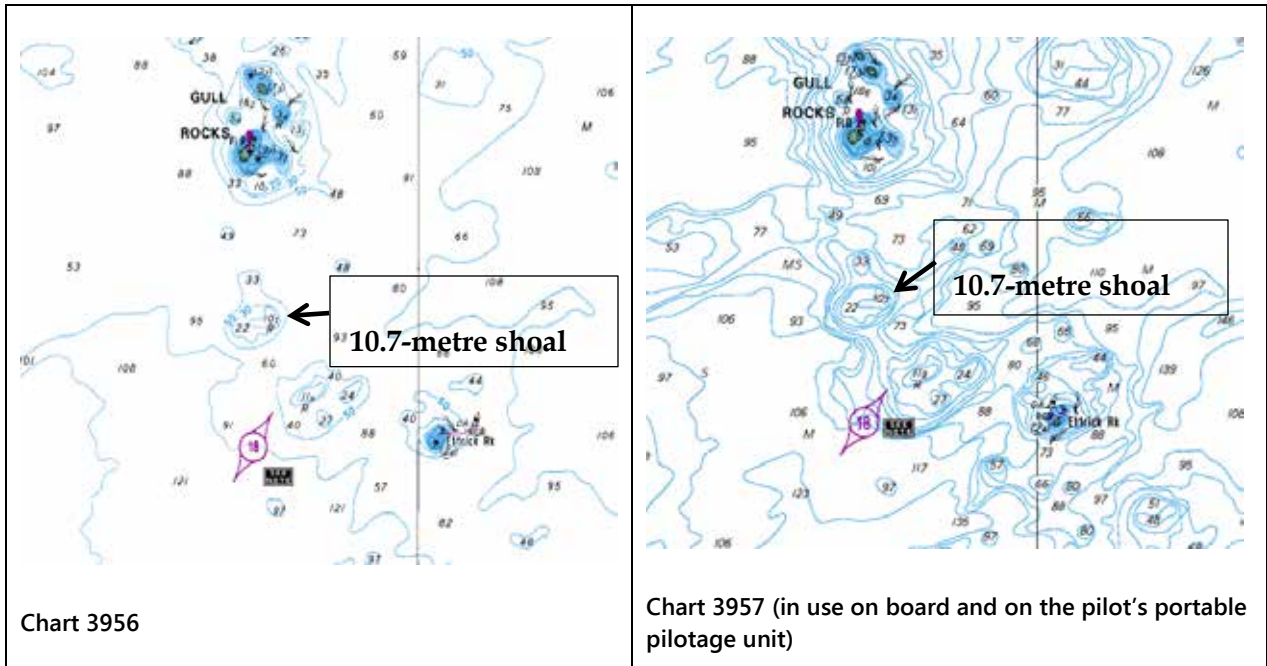
Appendix B – Comparison of Canadian Hydrographic Service charts 3956 and 3957

The following differences are of note: On Chart 3956, there are fewer depth contours and more soundings as compared to Chart 3957. As well, on Chart 3956, the 10.7-metre shoal has the nature of the seabed indicated, using the letter "R" for rock, while on Chart 3957, this was not indicated at the time of the occurrence.
