**MARINE INVESTIGATION REPORT
M15A0189**

**LOSS OF VESSEL AT SEA WITH 3 FATALITIES
SMALL FISHING VESSEL *CFV 130214*
PLACENTIA BAY, NEWFOUNDLAND AND LABRADOR
16 JUNE 2015**

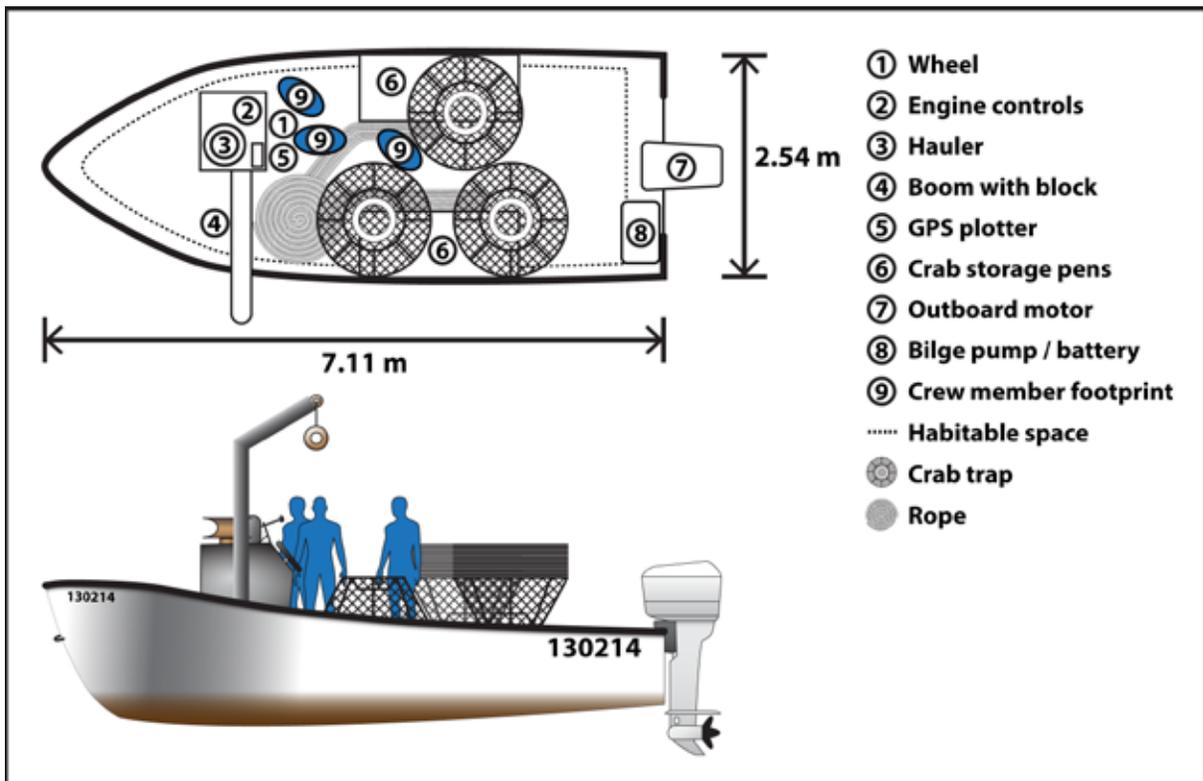
The master's primary fishing vessel, the *KSL Enterprises*, had been undergoing modifications that were taking longer than expected. As the scheduled closure of the crab fishing season was in 4 weeks,² the crew hastily modified the secondary vessel, the open boat, during the 2 weeks prior to the occurrence in order to fish the full quota in time. They fitted plywood crab/ice storage pens, measuring 183 cm long by 76 cm wide, near midships on either side of the vessel (Figure 1). A small console with steering/engine controls and a gasoline-operated hydraulic hauler was fitted in the forward part of the vessel, including an aluminum crab boom on the port side. The main trawl line with the crab traps attached would pass over the block hanging from the boom and then around the vertical hauler gurdy mounted on the forward part of the console when hauling the strings of crab traps.

Figure 1. The open boat, overhead and profile views with 25 crab traps on board

4. Given the time constraints, the master modified the secondary vessel for fishing. These modifications were not assessed or tested for stability.
5. The increased load on the small vessel caused by its modifications, the weight of the crew members, additional equipment, and cargo, would have lowered the freeboard and made it more challenging to operate in the weather and sea conditions present on the day of the occurrence.

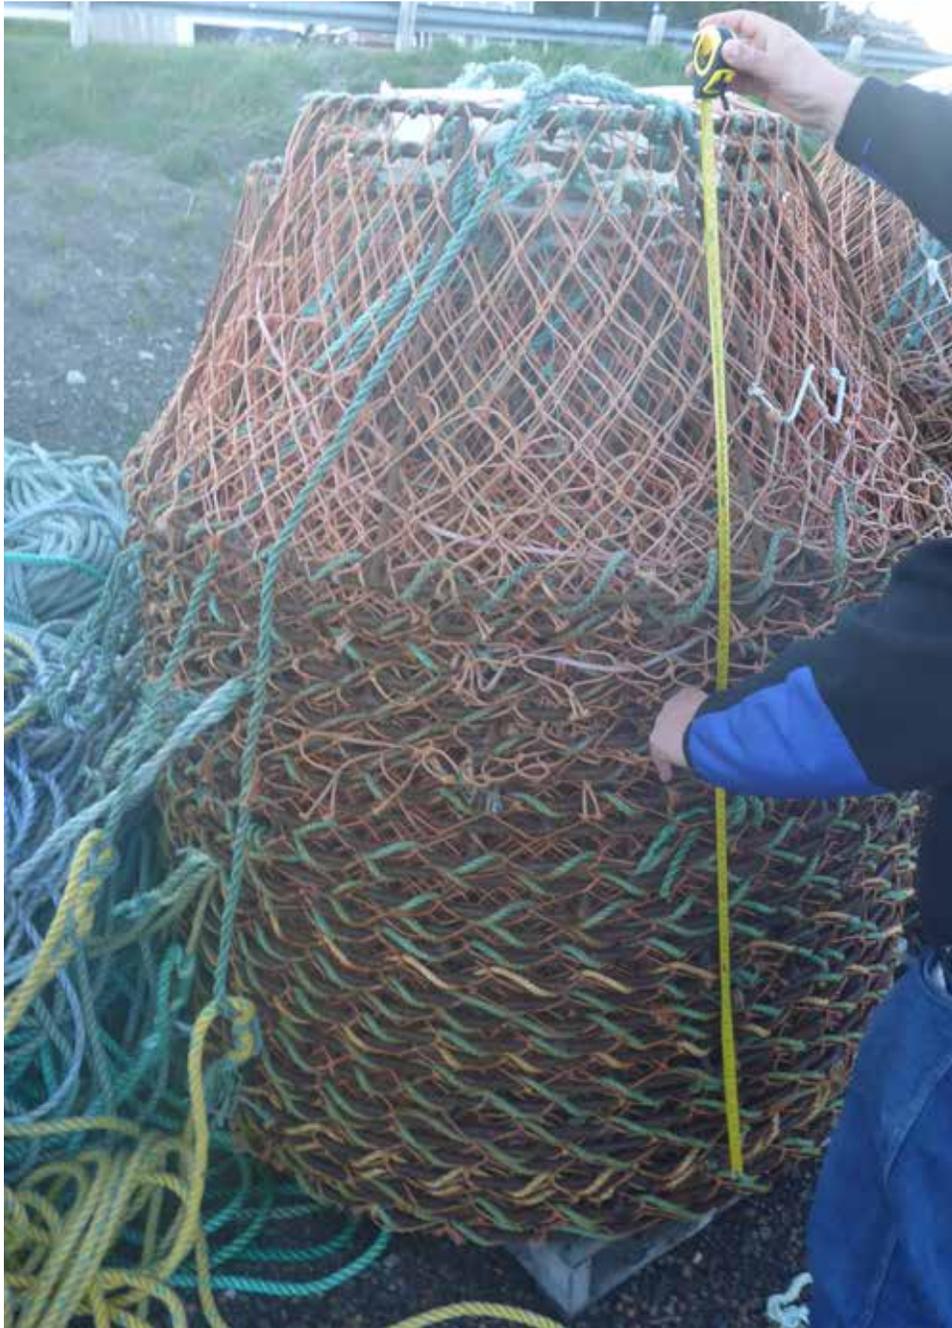
Appendix B – Stack of 25 snow crab traps
