**MARINE INVESTIGATION REPORT
M15P0035**

FOUNDERING AND ABANDONMENT

**SELF-PROPELLED BARGE *LASQUETI DAUGHTERS*
SUTIL POINT, BRITISH COLUMBIA
14 MARCH 2015**

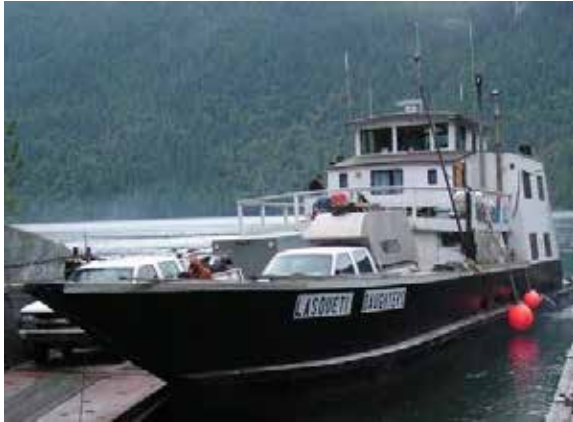
Photo 1. *Lasqueti Daughters*, Stuart Island, British Columbia, 2004
