MARINE INVESTIGATION REPORT

M15P0286

Capsizing and loss of life

Fishing vessel *Caledonian*

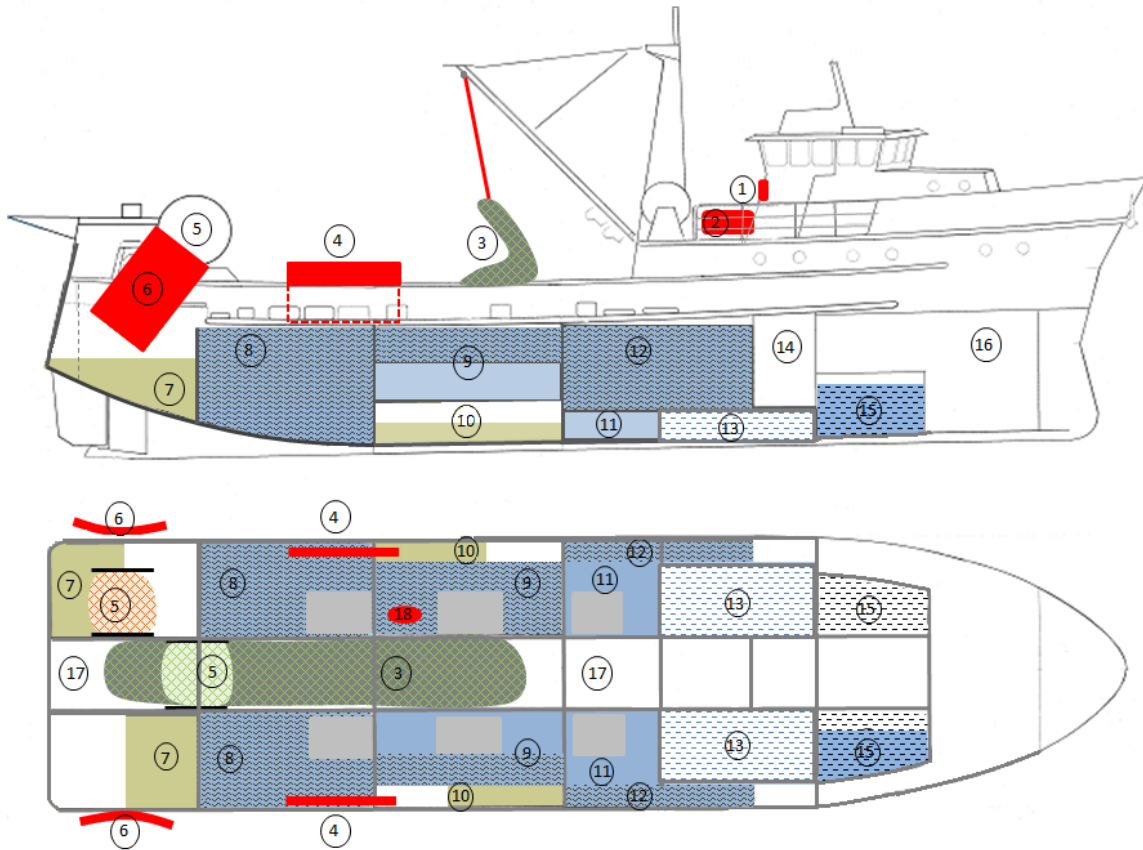
Appendix A – General arrangement of the Caledonian

1. Emergency position indicating radio beacon
2. Life raft (stored on middle deck)
3. Second bag of hake (approx. 24 T)
4. Spare trawl door
5. Net drum
6. Trawl door
7. Fuel tanks 7 and 8 - 55% full
8. Fish holds 5 and 6 - full
9. Fish hold 3 – full
Fish hold 4 – 50% full
10. Fuel tank 5 – 60% full
Fuel tank 6 – 60% full
11. Fresh water tanks – full but not used
12. Fish holds 1 and 2 - full
13. Unused fuel tanks - 3 and 4 empty
14. Void space - empty
15. Fuel tanks 1 and 2 converted to fresh water
(1 – empty, 2 – 75% full)
16. Engine room
17. Trawlway
18. Deck hatch for centre port fish hold
