Marine Transportation Safety Investigation Report M18C0328

POSSIBLE BOTTOM CONTACT

Bulk carrier *Maccoa*
Kahnawake, Quebec
06 November 2018

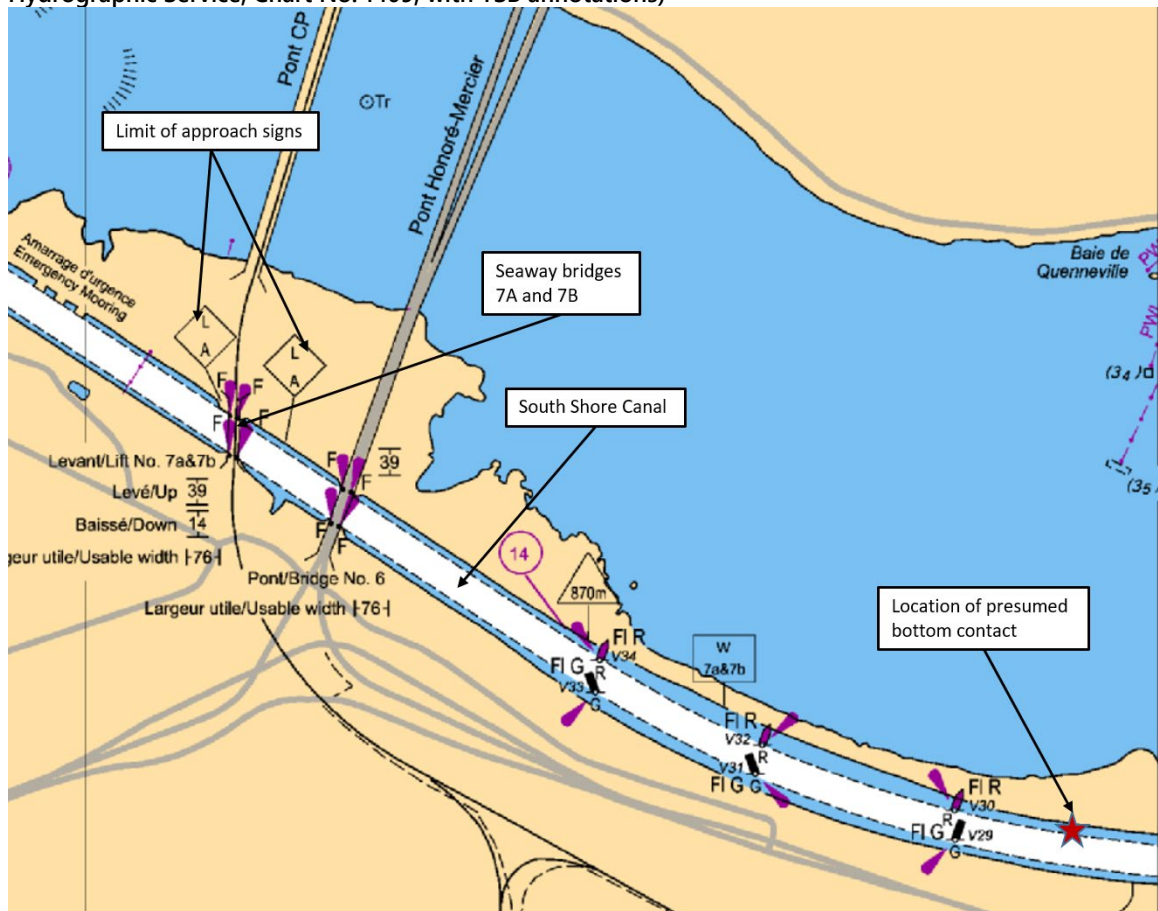
Figure 2. Chart showing the occurrence location and Seaway bridges 7A and 7B (Source: Canadian Hydrographic Service, Chart No. 1409, with TSB annotations)

At 1145, the Seaway traffic controller used the very high frequency (VHF) radiotelephone to inform the *Maccoa's* pilot of the situation. At that time, the *Maccoa* was 2.06 nm⁵ from the limit of approach sign,⁶ indicated on the nautical chart by a diamond labelled with "L A" (Figure 2), and 2.09 nm from the bridges.

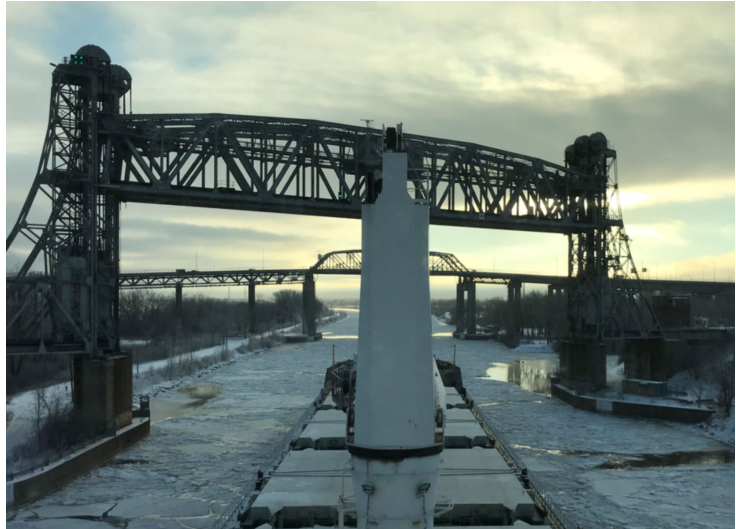
Figure 3. Seaway bridges 7A and 7B with spans lifted, downbound view. The Honoré-Mercier Bridge is visible in the background. (Source: third party, with permission)

Situated in Kahnawake, Seaway bridges 7A and 7B (Figure 3) span the St. Lawrence Seaway's South Shore Canal. The bridges are equipped with 1 lift span each to allow maritime traffic to pass along the canal. Commuter trains and freight trains use the bridges several times a day. Commuter trains take priority over maritime traffic and cross the bridges according to their predetermined daily schedules, whereas freight trains can be stopped when necessary to allow vessels to pass.

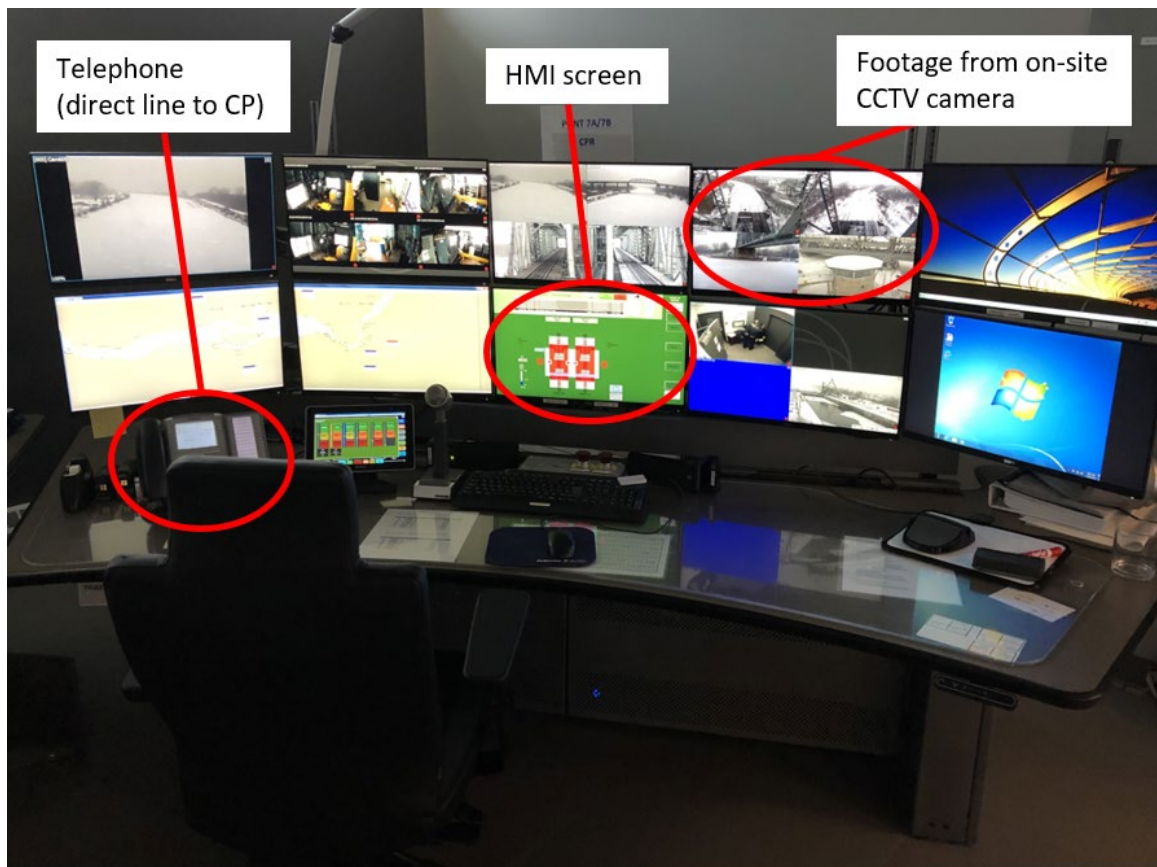
Figure 4. Seaway bridge operator workstation (Source: St. Lawrence Seaway Management Corporation)

The workstation used to operate bridges 7A and 7B is equipped with a human-machine interface (HMI) screen, as well as several monitors displaying footage from the CCTV cameras installed at the Côte Sainte-Catherine Lock, the bridges, and the canal structure. The workstation also has a direct telephone line to the CP traffic controller (Figure 4).

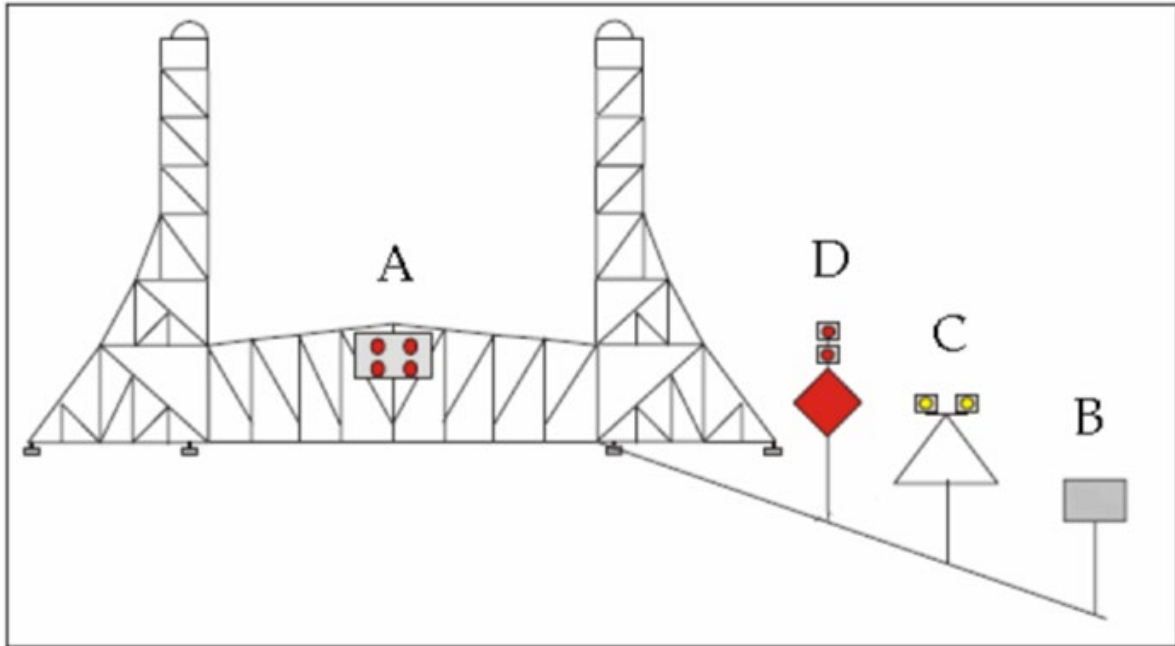
Figure 5. Diagram illustrating the lights and signs at Seaway bridges (Source: St. Lawrence Seaway Management Corporation)

To provide approaching vessels with information on the status of each bridge, an identical set of signal systems are mounted on either side of each bridge.⁷ These systems consist of navigation lights mounted on each bridge and a set of 3 shore signs at varying distances from the bridge (Figure 5).
