MARINE TRANSPORTATION SAFETY INVESTIGATION REPORT M18P0014

ENGINE ROOM FIRE

Container vessel *MOL Prestige*

31 January 2018

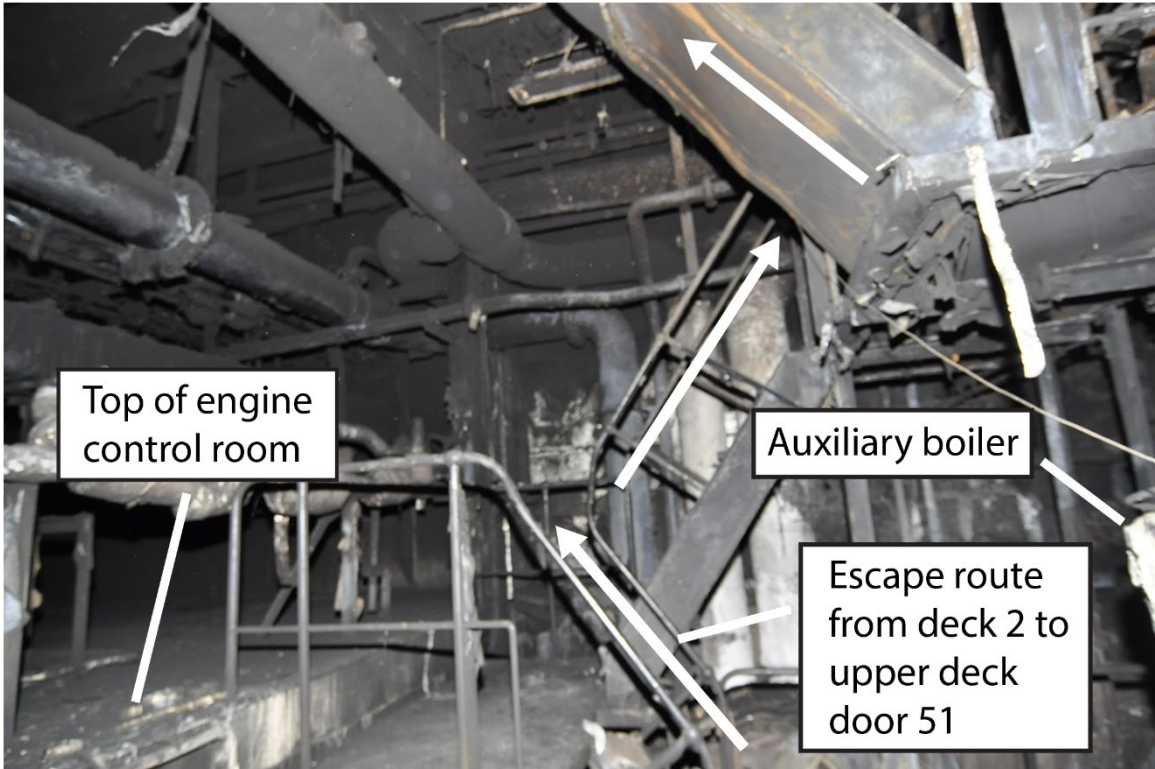
Figure 9. Route used by the crew to exit the engine room, showing the stairs from deck 2 to door 51 on the upper deck (Source: United States Coast Guard, with TSB annotations)

At 2138, 3 of the 6 crew in the ECR donned the EEBDs and followed the chief officer out of the engine room using the lifeline attached to the chief officer. As the 4 crew members made their way up the stairs (figures 9, 10, and 11), they encountered dense smoke and heat from the fire. The chief officer tripped while making his way up the stairs and grasped the railings to regain his balance, burning the palms of his hands. The chief engineer also tripped on the stairs and burned his arms upon making contact with the railings. The second engineer similarly sustained burns to his palms and forearms. The fourth engineer slipped and hit his head, which dislodged his EEBD and caused burns to his ears.

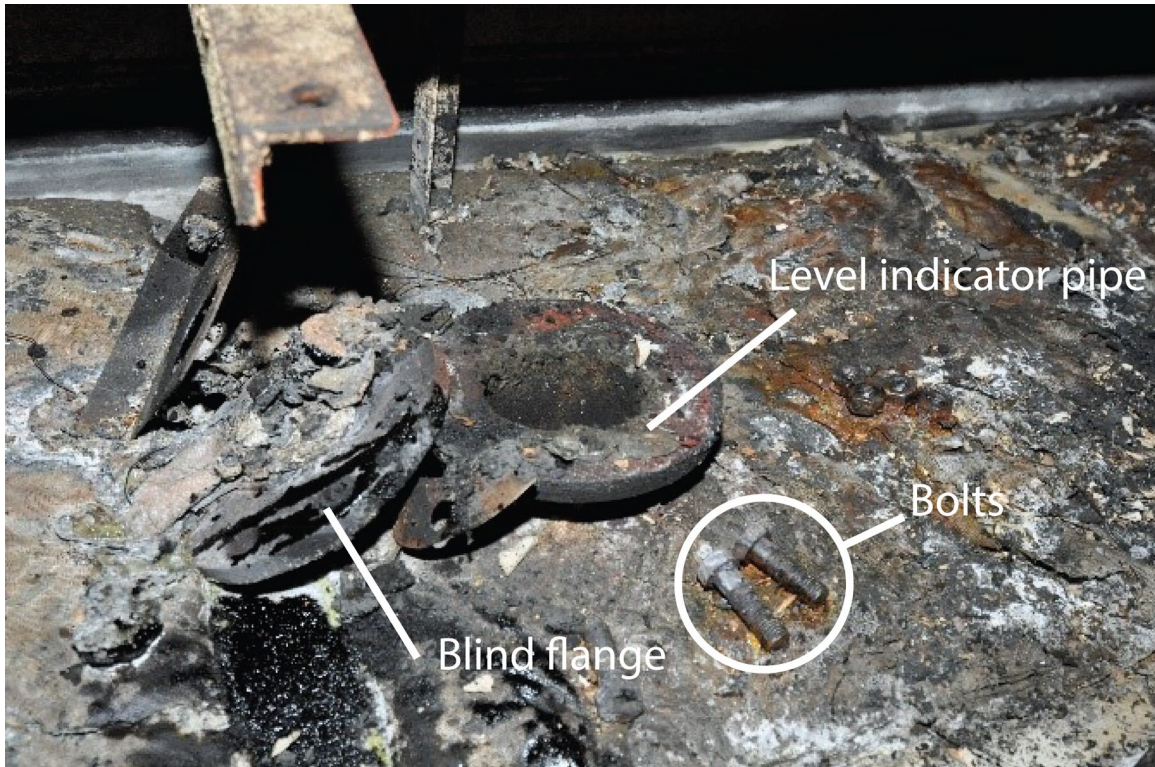
Figure 15. Opening of the level indicator pipe on top of the settling tank as found post-fire. Also shown are the blind flange, nuts, and bolts on top of the tank. (Source: TSB)

At the time of the occurrence, the temperature of the HFO in the settling tank was 120 °C. Following the occurrence, the TSB examined the alarm logs from 15 January until the day of the occurrence and found that the high-temperature alarm for the settling tank had activated on 26 January on the engine room alarm panel. The TSB could not determine if the HFO settling tank temperature was checked or whether any other action was taken as a result of the alarm.

Information gathered from the CCTV footage indicated that oil was initially expelled from the settling tank through the open level indicator pipe, and fell onto decks 3 and 4 and onto the oily water separator on the bottom deck. The fire then started on deck 3 between the auxiliary boiler and the settling tank, where there was evidence of heat sources, including uninsulated steam lines, the exhaust manifold for generator engine No. 3, and electrical fittings.

Fire patterns determined that this was the area of origin of the fire. Soon after, the burning oil then flowed down to deck 4 near generator engine No. 3 and onto the bottom deck near the oily water separator. The fire also travelled back to the top of the settling tank, where the bulk of the spilled oil was located. This became the seat of the fire fuelled by the HFO overflowing from the level indicator pipe on the settling tank.

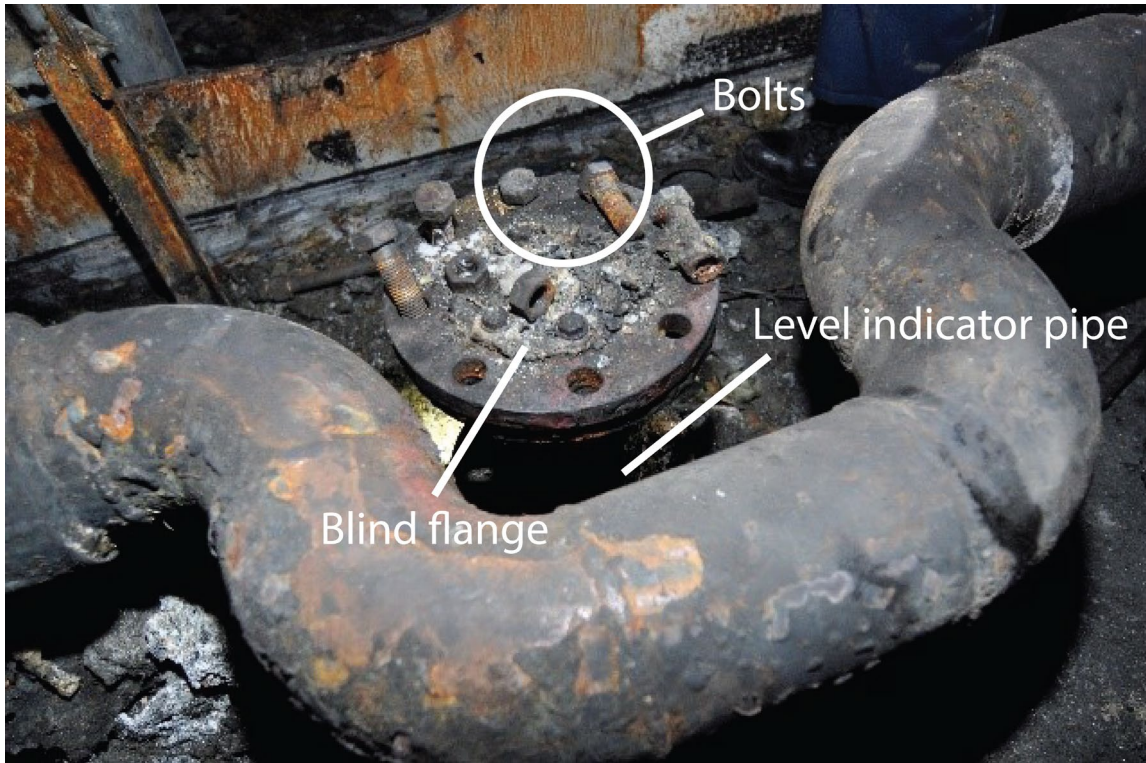
Figure 16. Blind flange secured by 1 bolt on the level indicator pipe on the heavy fuel oil service tank (Source: TSB)

On 24 January, the chief engineer recorded the quantity as 70 m³. The tank was sounded after the fire and was found to be at 94.6 m³, which is 83% of the total tank capacity

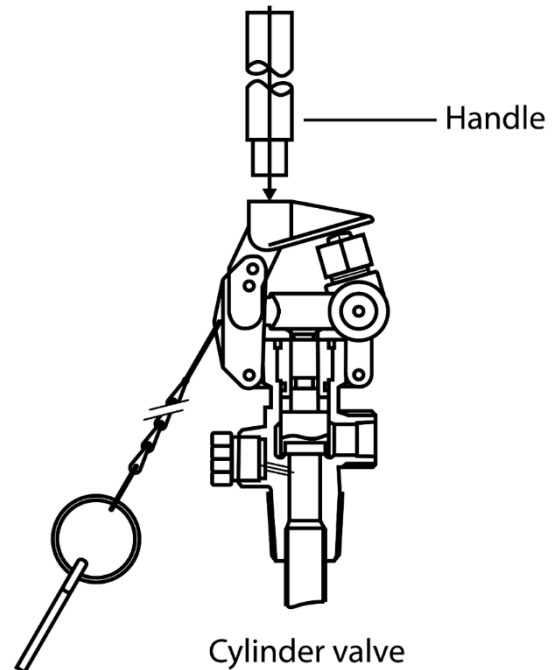
Figure 25. CO₂ cylinder valve (Source: Original equipment manufacturer manual, with TSB annotations)

- The stop valve for the main engine room was leaking.
- The crew manually released 84 cylinders (Figure 25), which included some cylinders marked for the cargo holds.

- A total of 258 cylinders were used to fight the fire.
