MARINE TRANSPORTATION SAFETY INVESTIGATION REPORT M19P0029

GROUNDING

Search and rescue vessel (*Spirit of Sooke*)

07 February 2019

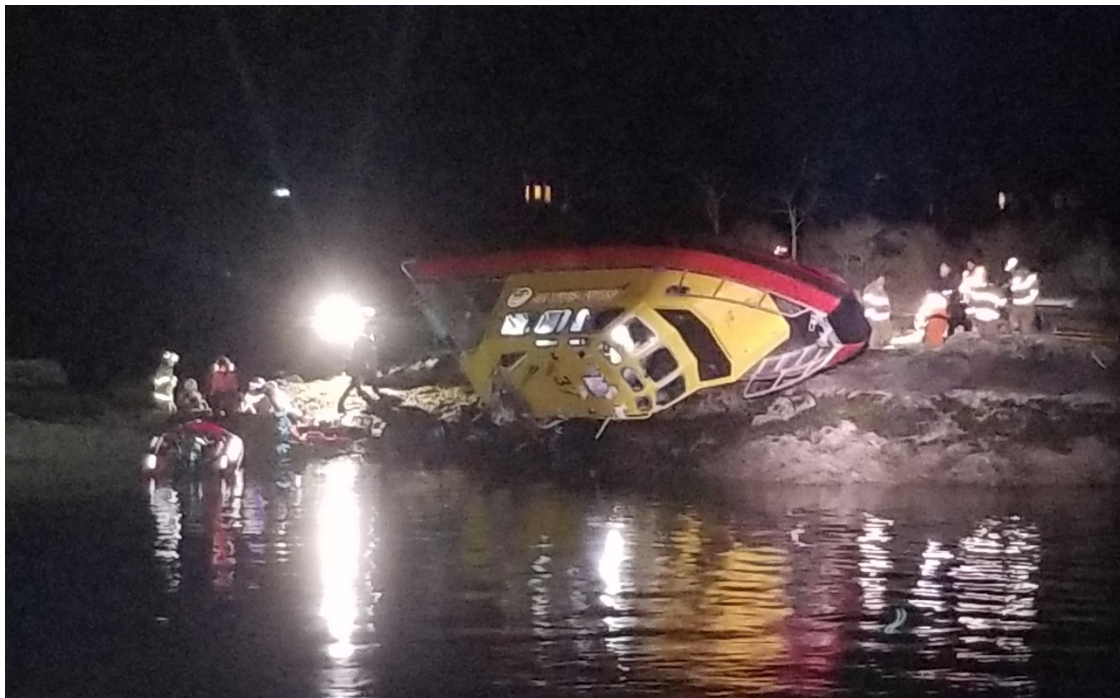
Figure 4. Spirit of Sooke after grounding (Source: Canadian Coast Guard)

The *Spirit of Sooke* was damaged as a result of the grounding and the subsequent salvage operations. The vessel's hull had various scrapes, deformations, and indentations below the waterline, and the vessel's hybrid-foam collar fender was damaged. One of the cabin windows was broken, and some electrical wiring inside the cabin had water damage, as did the 2 inboard diesel engines. The *Spirit of Sooke* has since been repaired and RCMSAR is in the process of putting the vessel back in service.

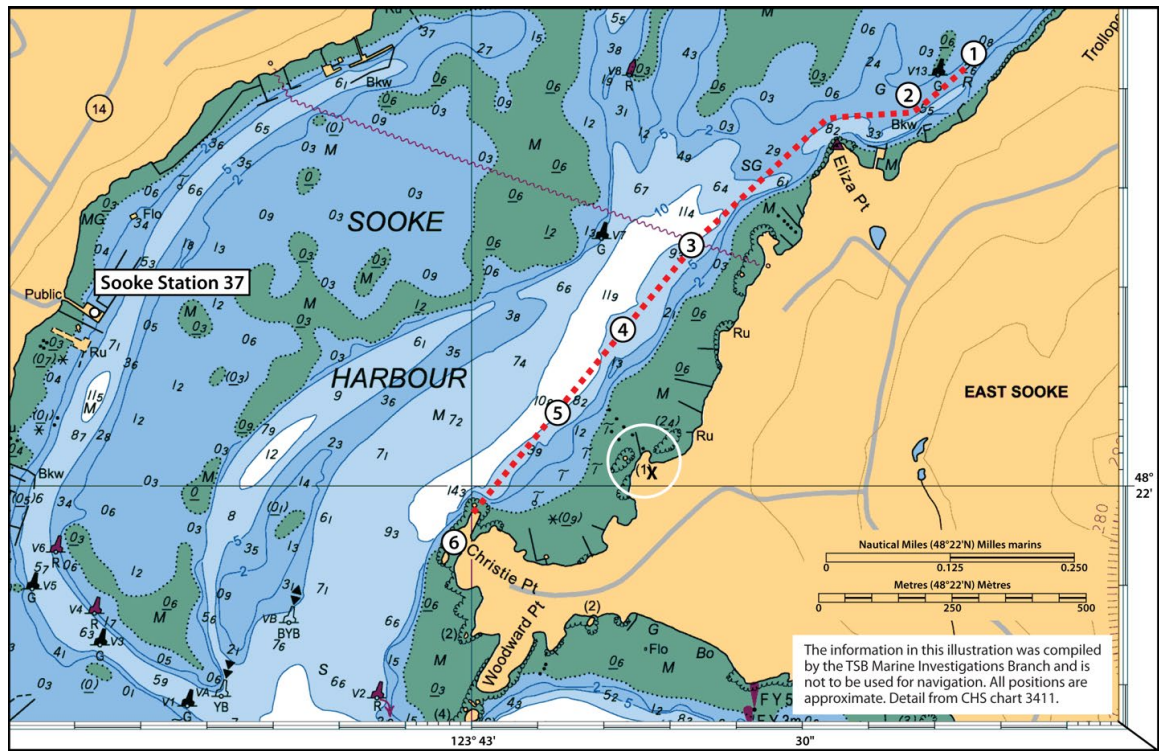
Examination of the vessel's radar showed that the radar range setting was at 0.125 NM and the display was in head-up mode when the vessel ran aground. The vessel speed and the radar ranges were varied throughout the various simulations for comparison purposes. A simulated vessel track depicts the 1.5 minutes leading up to the grounding, based on a vessel speed of approximately 27 knots (Figure 8).

Figure 8. Simulated vessel track leading up to occurrence (Source: Canadian Hydrographic Service with TSB annotations).

Position	Event
1	Last AIS signal sent before grounding at 2131:53; vessel speed is 14.2 knots
2	Coxswain asks the crew member to select speed and course to return to base
3	Vessel speed reaches approximately 27 knots
4	Vessel is 0.25 NM from Christie Point, and coxswain indicates course is good
5	Vessel is 0.125 NM from Christie Point, and vessel speed is about 27 knots; northernmost tip of Christie Point appears on the radar display
6	Vessel grounds on Christie Point at approximately 2133:30

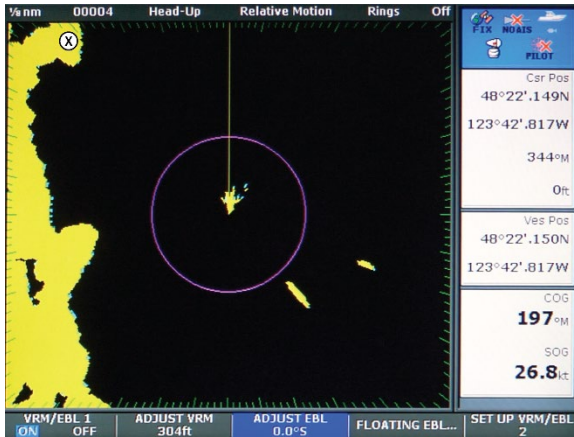
Figures 9 and 10 show screenshots of the radar display from simulations of the vessel at different positions, with the radar range set at 0.125 NM. RCMSAR noted that the small point of land before Christie Point (marked with an X on Figure 9) appears similar in shape to Christie Point (marked as Position 6 on Figure 10).

Figure 9. Vessel at 0.25 NM from Christie Point; coxswain indicates course is good (Source: TSB screenshots of RCMSAR simulation videos; annotations by TSB)

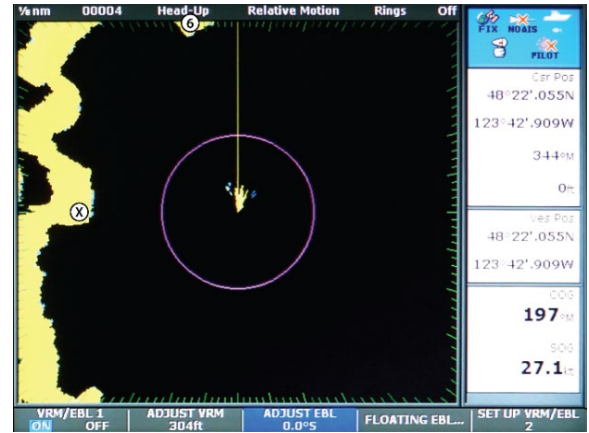
Figure 10. Vessel at 0.125 NM from Christie Point (Source: TSB screenshots of RCMSAR simulation videos; annotations by TSB)

Christie Point would have appeared on the radar display when the vessel was 0.125 NM away from it. When a vessel's speed is 27 knots, it will travel 0.125 NM in approximately 16 seconds.

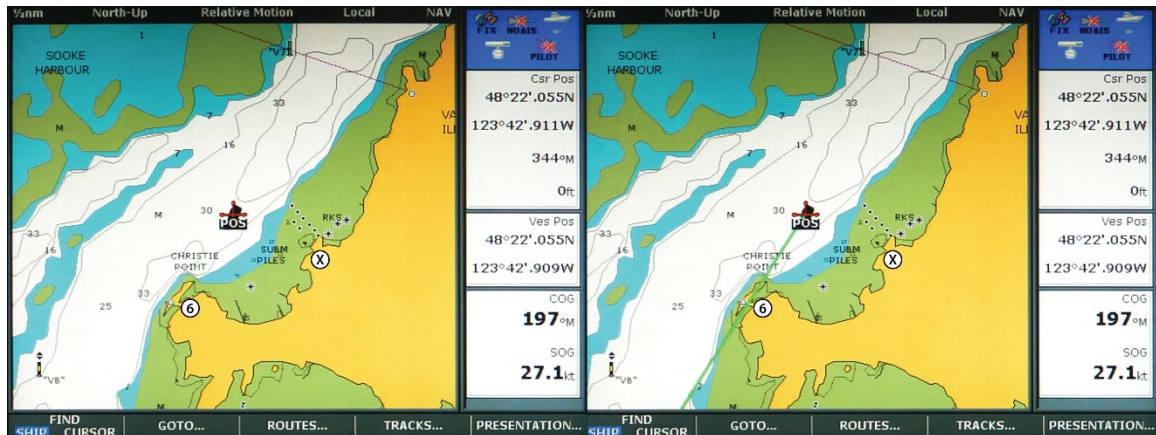
Figure 11. Chart plotter with vessel's course line not enabled (Source: TSB screenshots of RCMSAR simulation videos; annotations by TSB)

Figure 12. Chart plotter with vessel's course line enabled (Source: TSB screenshot of RCMSAR simulation videos; annotations by TSB)

When Christie Point became visible on the radar display, it likely did not conform to the coxswain's understanding of the vessel's position and probably caused momentary confusion. Given the speed of the vessel and the time required for the radar and the chart plotter displays to update, the vessel was even closer to Christie Point than indicated by the navigational equipment. Once the impending grounding was detected, there was insufficient time to respond, given the vessel's high speed.
