MARINE TRANSPORTATION SAFETY INVESTIGATION REPORT M22C0005

MOORING ACCIDENT

Roll-on/roll-off ferry *Madeleine II*
Cap-aux-Meules, Quebec
09 January 2022

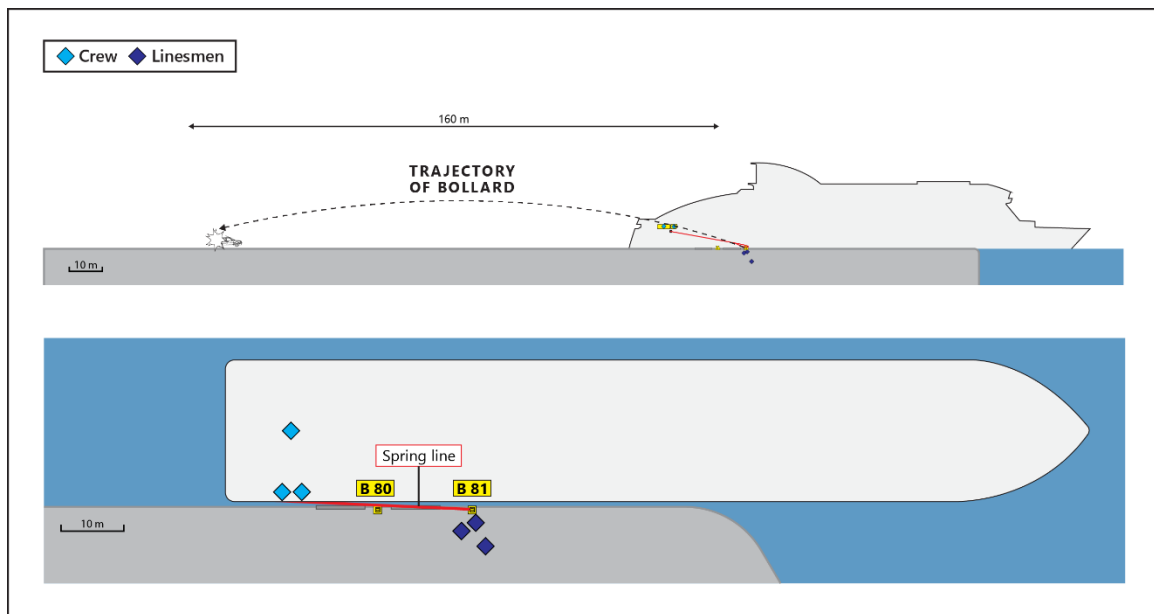
The linesmen on the wharf were preparing to place the 2nd spring line on bollard B81. A few seconds later, the chief mate stood upright behind the bulwark. At that moment, the mooring bollard snapped, and the 1st spring line suddenly snapped upwards in a whip-like movement. The 1st spring line flew high above the bulwark on deck 5 and struck the chief mate. The chief mate, who was not wearing a safety helmet, was hit on the head and fell unconscious on impact. Part of the bollard was thrown almost 160 m back from the wharf toward the parking area, where it hit a truck and came to rest a few metres away from the truck (Figure 4).

Figure 4. Illustration of the *Madeleine II* along wharf no. 2 showing the position of personnel, the location of the spring line and mooring bollard, and the trajectory of the bollard after it broke (Source: TSB)

The minimum certified breaking strength of the mooring line used for the 1st aft spring line was 73 tonnes, while the capacity of the B81 bollard was 20 tonnes. The B81 bollard failed because its maximum load capacity was far exceeded by the tension in the spring line created by the vessel moving astern at a speed of around 1.0 knots. Following this occurrence, the TSB laboratory examined the B81 bollard to determine the cause of its failure and found that the bollard had been subjected to a load exceeding its breaking strength.

When the winch failed, while the vessel was in motion, neither the winch operator nor the officer was in a position to react to and correct the situation. The B81 mooring bollard failed under the tension of the spring line, which suddenly snapped free. The potential energy in the spring line's synthetic fibres caused it to whip upwards toward the *Madeleine II*'s aft mooring station.

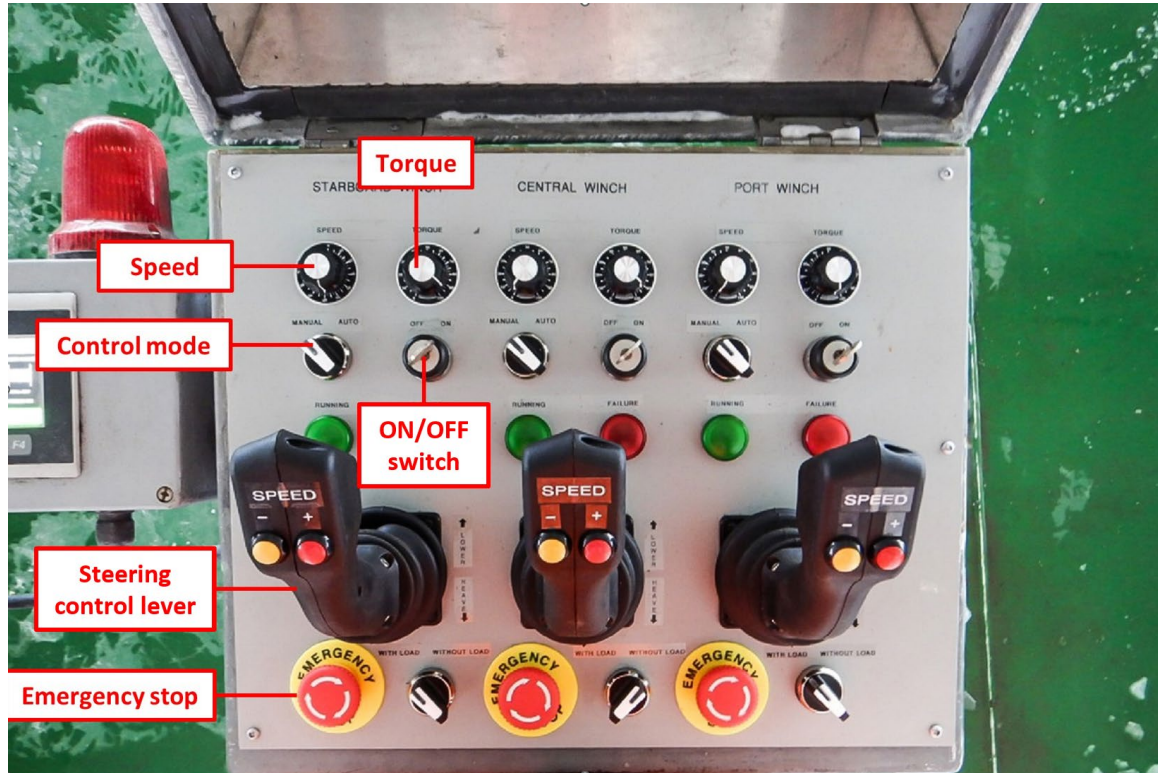
The control unit is divided into 3 sections, one for each winch. Each section contains controls for the winch's direction of rotation, speed, and torque; indicator lights showing the status of the winch (RUNNING or FAILURE), and an emergency shutdown button (Figure 7). The 3 emergency shutdown buttons are not covered by a protective channel or cover.

Figure 7. Main control unit (Source: TSB)

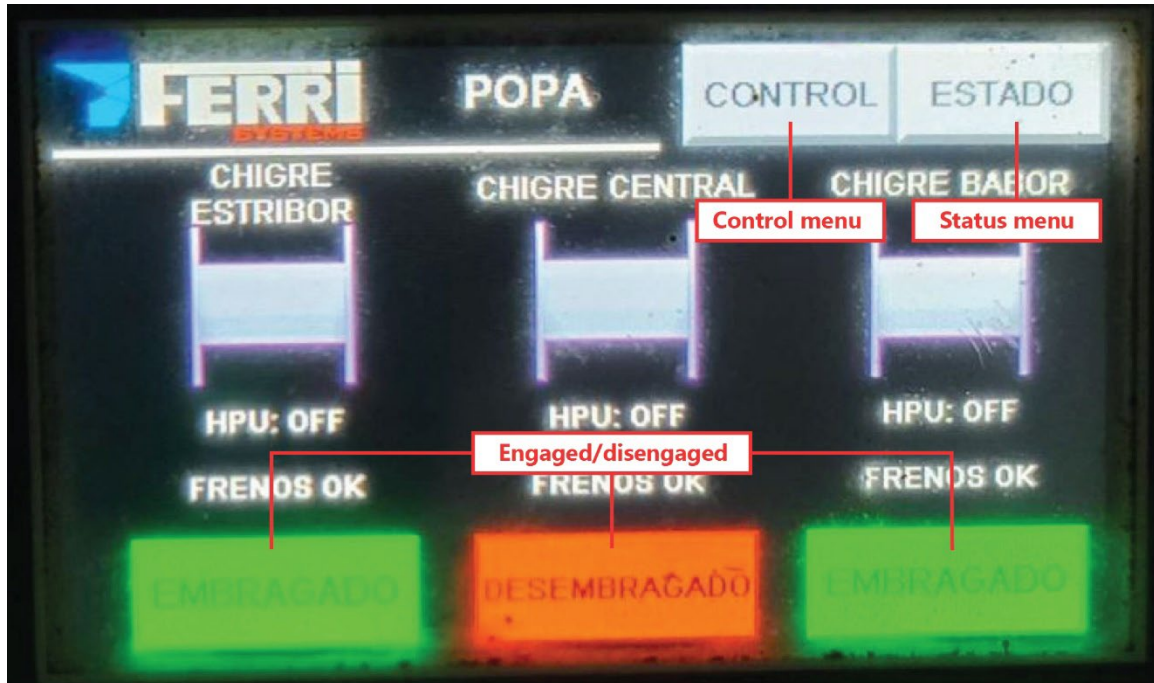
Figure 8. Advanced control panel (HCD) (Source: TSB)

Because operating the advanced control unit requires fine motor skills, the operator is likely to use their dominant hand. The control unit is located to the left of the main control unit. Because most operators are right-handed, they will tend to use their left hand to control the winch and their right hand to reset the winch after an alarm, which requires crossing hands. Furthermore, touch screens are not ideal control interfaces, especially in winter conditions, because they are difficult to use while wearing protective equipment such as gloves and mittens.

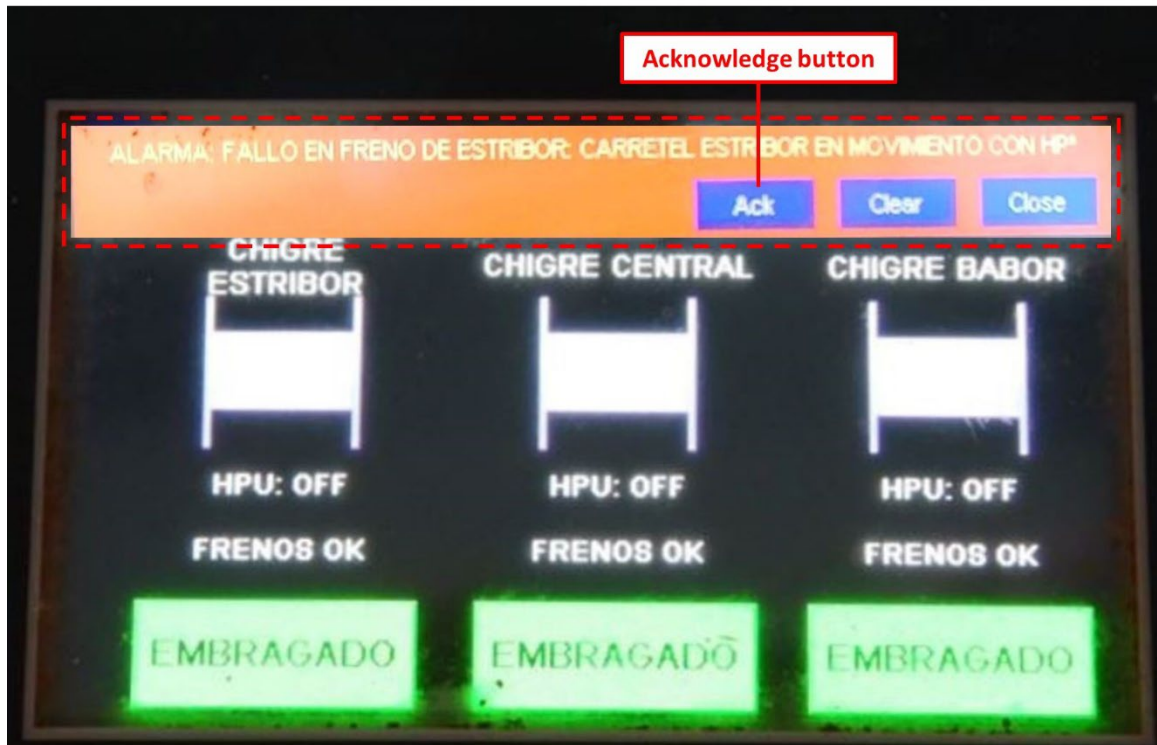
This alarm does not deactivate the winch. The engaged/disengaged button for the winch remains green. To stop the 1st alarm, the operator must press the “Ack” (acknowledge) button on the advanced control unit, which returns the display to its initial menu (Figure 9).

Figure 9. The advanced control panel (HCD) displaying the 1st alarm (Source: TSB)

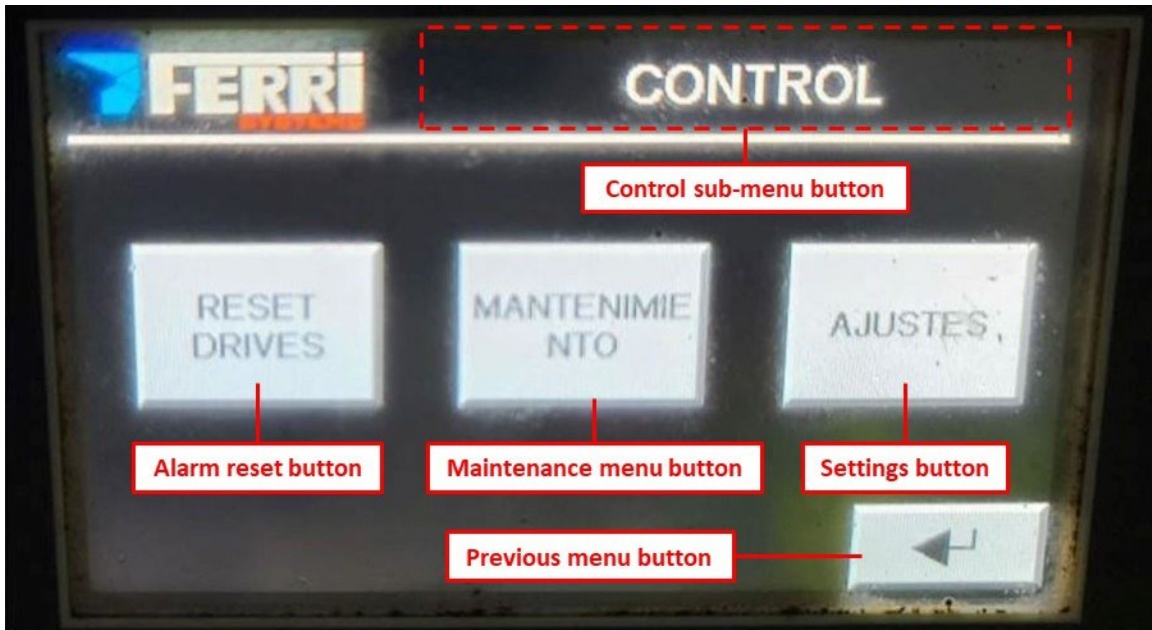
The operator is alerted by an audible signal and the flashing brake alarm light. The FAILURE light of the affected winch also lights up on the main control unit. To reactivate the winch, the operator must press the control menu on the advanced control unit and access the submenu. In the submenu, the operator must press the alarm reset button. To return to the previous menu and resume winch operation control, the return button must be pressed. If the anomaly is still present, the alarm will reset until the problem is resolved (Figure 10).

Figure 10. Control menu (Source: TSB)

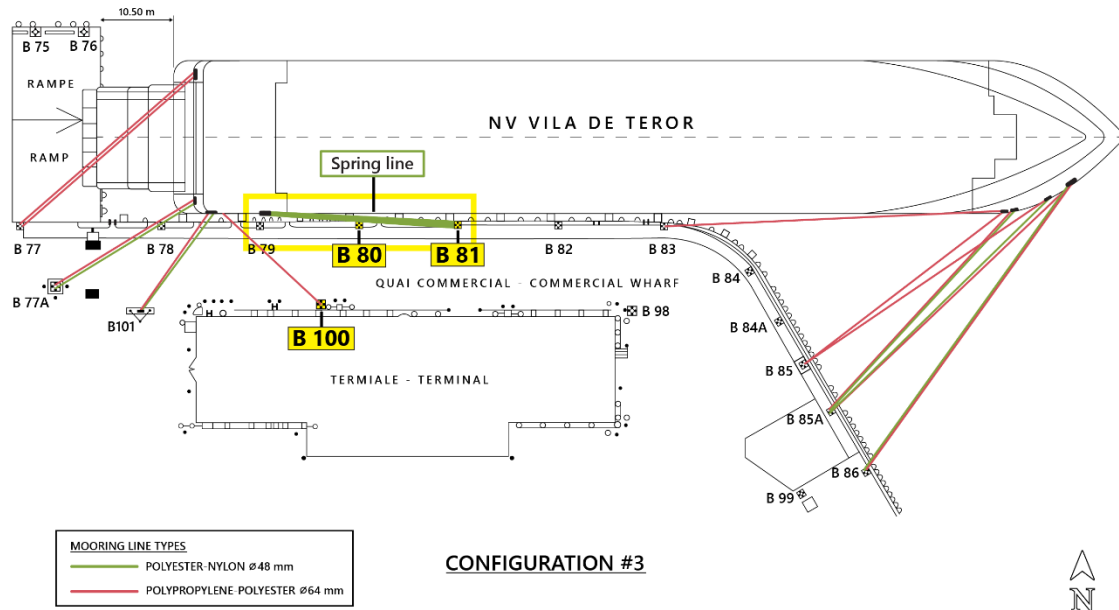
Three static mooring configurations were studied: a configuration using the B80 bollard, a configuration in which the B80 bollard was out of use and 2 mooring lines used the B100 bollard, and an optimized configuration based on the 2nd mooring configuration, where only 1 mooring line used the B100 bollard (figure 11). For all 3 configurations, there is only one spring line being used on bollard B81.

Figure 11. 3rd mooring configuration from study (Source: Coopérative de Transport Maritime et Aérien, with TSB annotations)

In the absence of upgrades (configuration #3), the results indicate that the vessel MV Madeleine II should not be moored at wharf no. 2 in winds of 19 knots or more from the southwest (SW) to the east-southeast (ESE), and a maximum speed of 65 knots in other directions, without the compensatory measures of tension reduction by tugs, traffic management, deployment of the starboard anchor, repositioning of the vessel towards the wharf ramp and active tidal management of the ballast tanks.

To improve mooring capacity in the configurations studied, it is recommended that the B80 and B100 bollards be replaced to increase their capacity in line with operational requirements.
