MARINE TRANSPORTATION SAFETY INVESTIGATION REPORT M22P0029

GROUNDING

Water taxi C12997BC (*Rocky Pass*)
Coomes Bank, British Columbia
25 January 2022

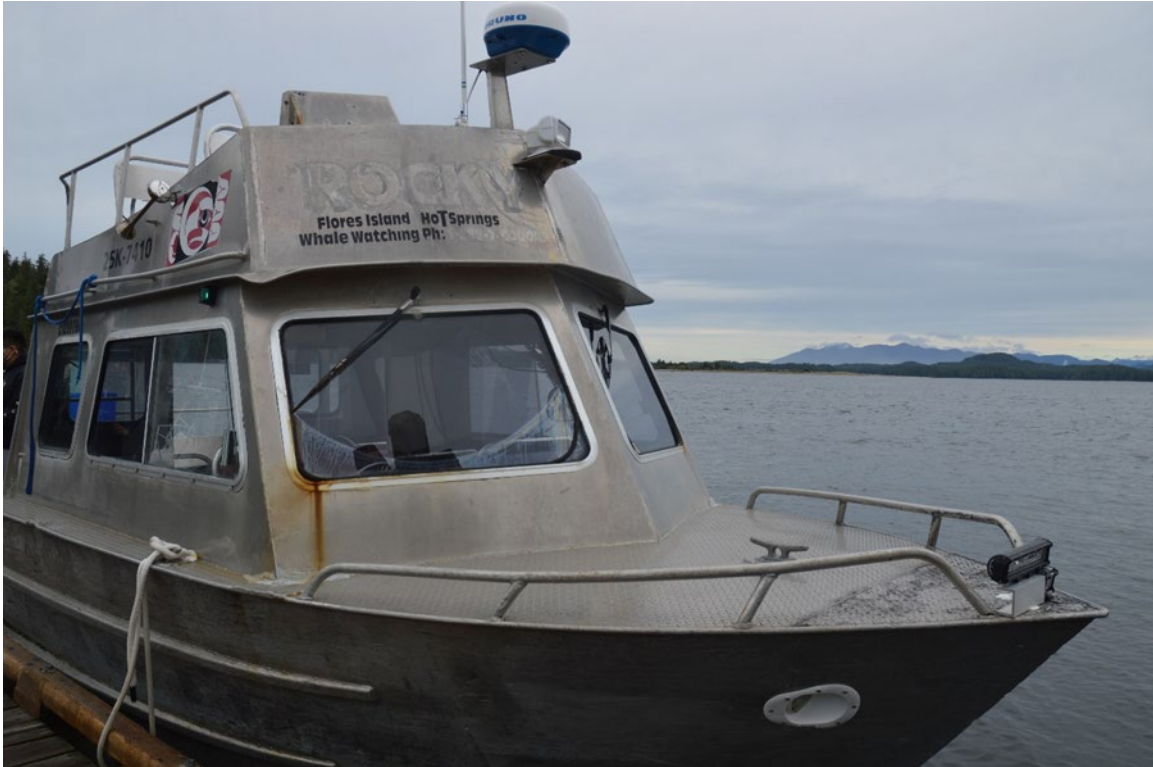
The *Rocky Pass* (Figure 1) is a water taxi that has an aluminum hull and an enclosed cabin. The cabin contains the conning station and a passenger seating area. The conning station, located on the forward starboard side of the cabin, has a seat for the operator, propulsion controls, a very high frequency (VHF) radiotelephone, and navigation equipment that includes a radar, a magnetic compass, and a GPS (global positioning system). The passenger seating area consists of rows of seats arranged on either side of a centre aisle. The cabin has front, side, and rear windows that provide the operator with a generally unobstructed view. The 2 outboard engines that propel the vessel are of 150 hp each and were fitted in 2021.

Figure 1. The Rocky Pass (Source: TSB)

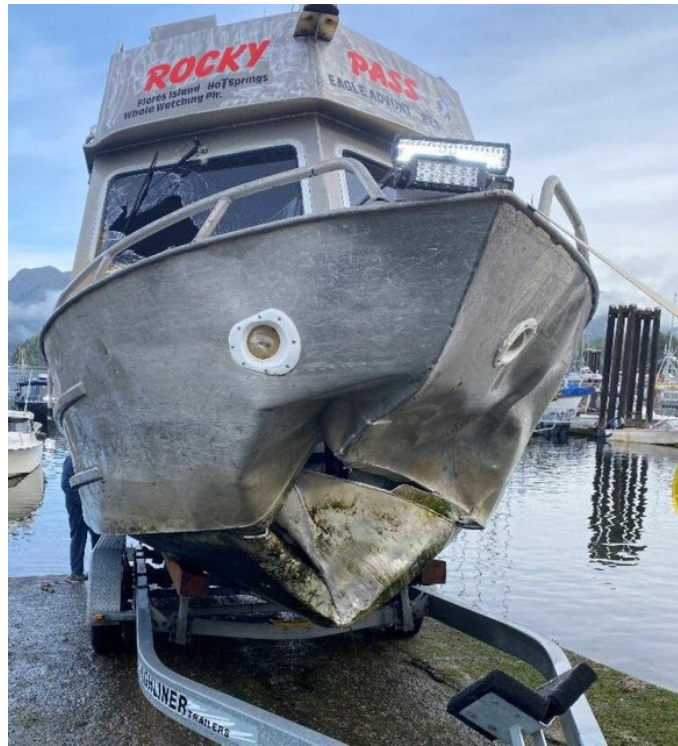
As the vessel was transiting Coomes Bank, the GPS display froze and, as a result, the operator could no longer view the vessel's actual position on the display. The operator was attempting to reset the GPS by using the zoom feature when he observed a rock directly in front of the vessel. The vessel hit the rock at approximately 0928 in position 49°13.96' N, 125°59.79' W.

Nearby vessels, the Coastal Nations Coast Guard Auxiliary, and the Canadian Coast Guard responded to the Mayday call. First aid was administered to the operator and the 4 passengers, and they were transported to the hospital in Tofino. The *Rocky Pass*, which had a hole punctured in the bow from the impact with the rock (Figure 2), was towed to Tofino.

Figure 2. Damage sustained by the Rocky Pass following the occurrence (Source: Royal Canadian Mounted Police)

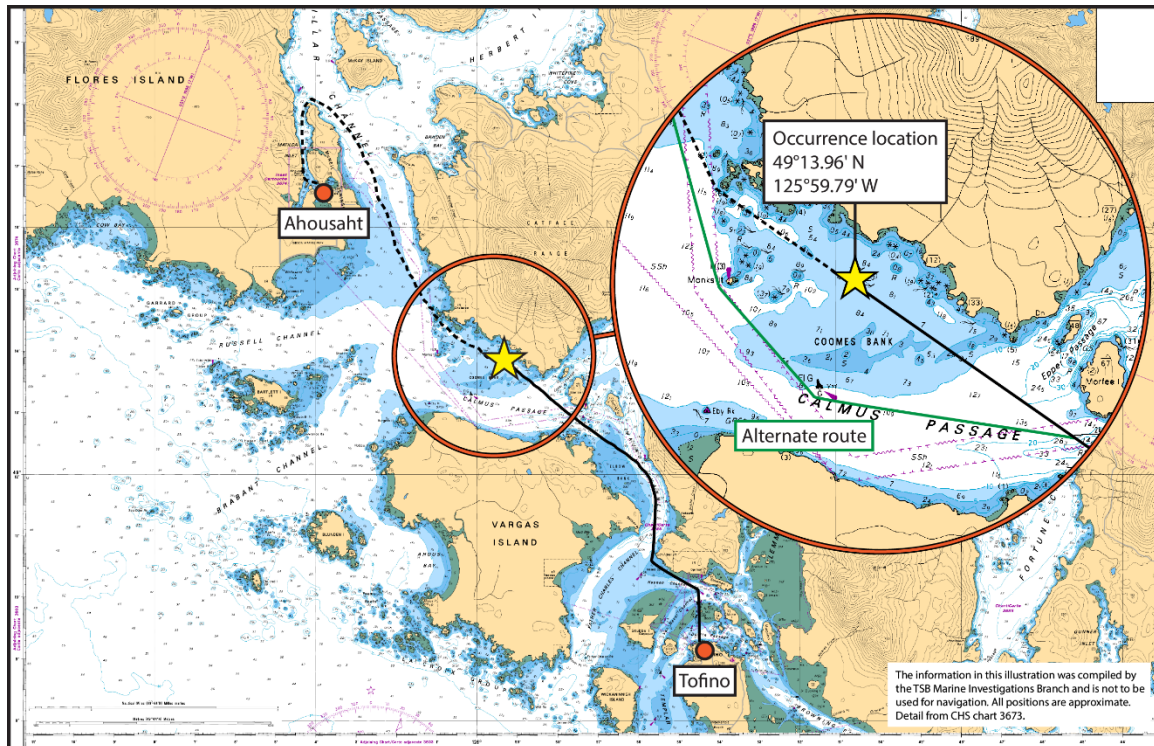
The typical route between Tofino and Ahousaht that water taxis use traverses Coomes Bank near the shoreline (Figure 3). This route is the most direct; however, in several areas, it requires vessel operators to navigate between or near navigational hazards, including drying rocks. Restricted

An alternative route exists along Calmus Passage, which is marked with navigation buoys (Figure 3). Along this route, the water is deeper and there are no drying rocks. It was not a practice for water taxis operating in the area to use this route on regular transits or when in restricted visibility.

Figure 3. Map of the occurrence area, with inset image showing a close-up view of the occurrence location on Coomes Bank and the alternate route along the Calmus Passage (Source: Canadian Hydrographic Services, with TSB annotations)

It is important that vessel operators, regardless of the size of their vessel, make a careful assessment of their intended route and safe speed by considering potential dangers to navigation; prevailing weather, particularly visibility; and other relevant factors.

Reliance on a single electronic navigational aid, especially in restricted visibility, can result in an accident. Mariners should continually cross-check their vessel's position using all available means, including visual aids and radar.
