## Marine Occurrence Report

### Fatal Accident to Passenger Vehicle

Involving the Ferry  
"QUEEN OF NEW WESTMINSTER"  
Departure Bay, British Columbia  
13 August 1992

Report Number M92W1057

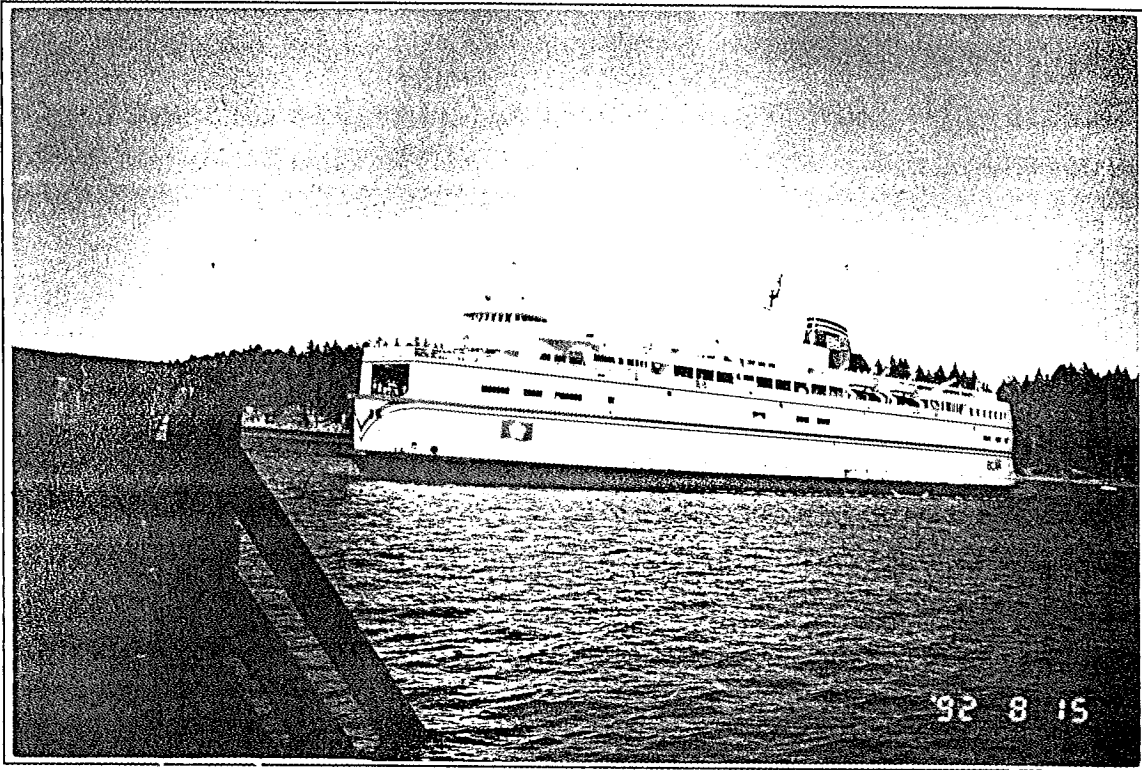
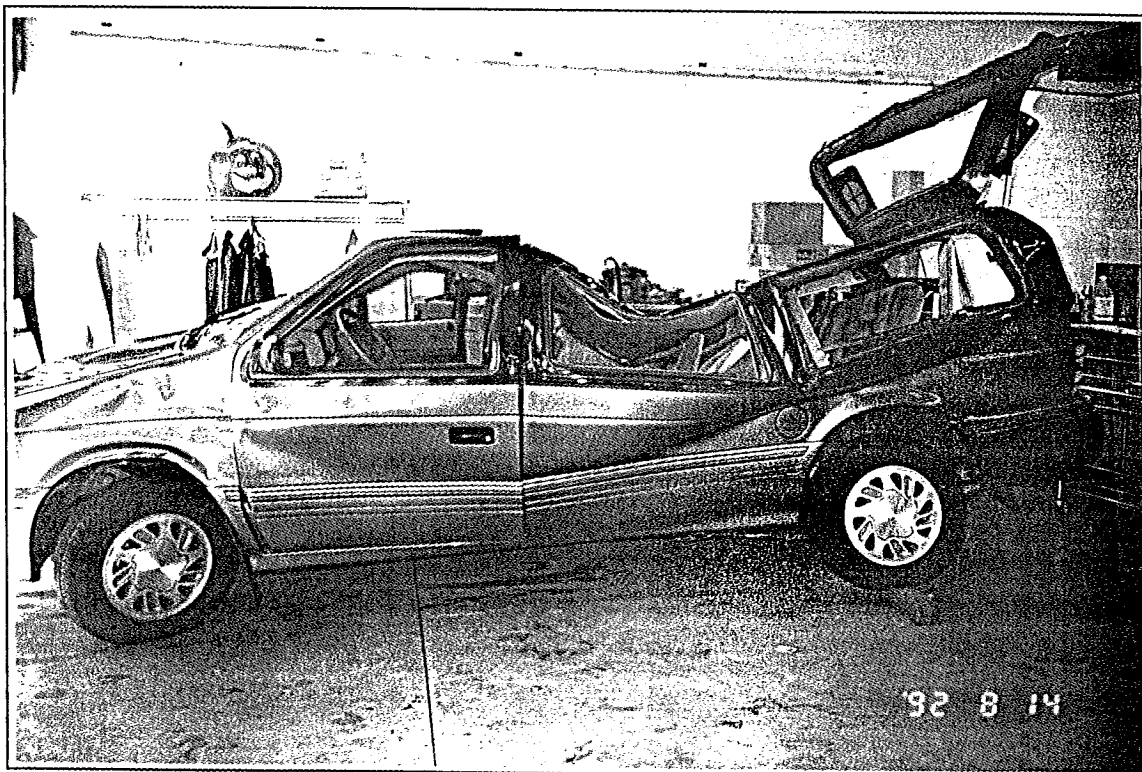
Neither the vessel nor the shore ramp installation sustained damage. The van was a total write-off, and a small quantity of gasoline which spilled from it quickly dispersed (photograph - Appendix B).

Damaged van after recovery.

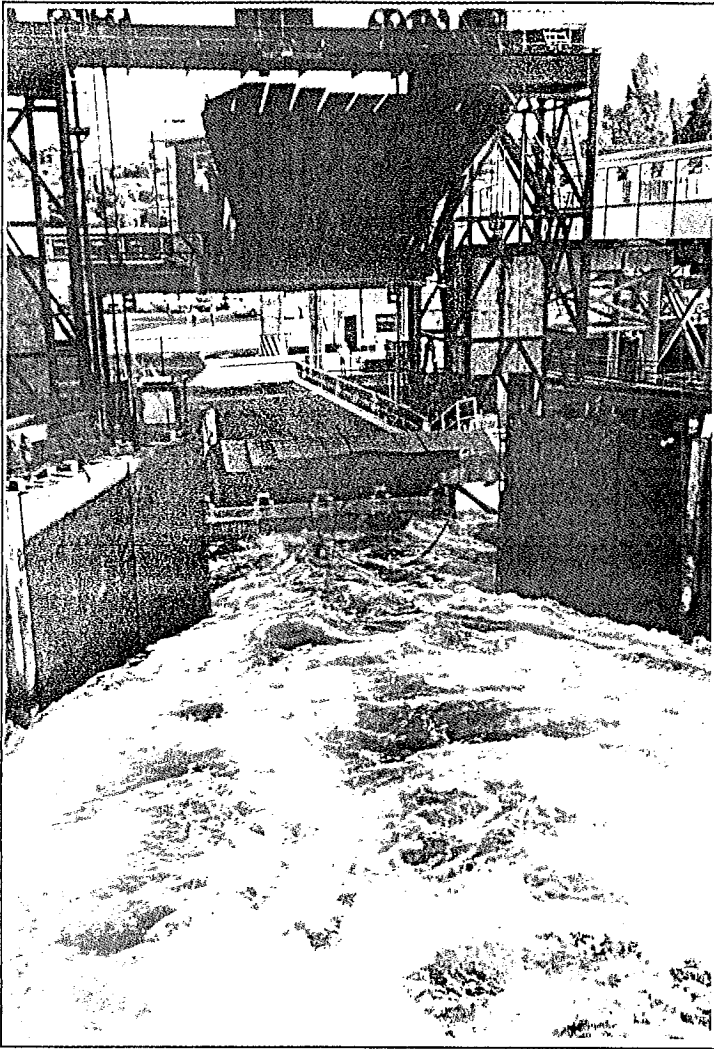
"QUEEN OF NEW WESTMINSTER"  
departing No. 3 berth at  
Departure Bay. Note: Wake turbulence .

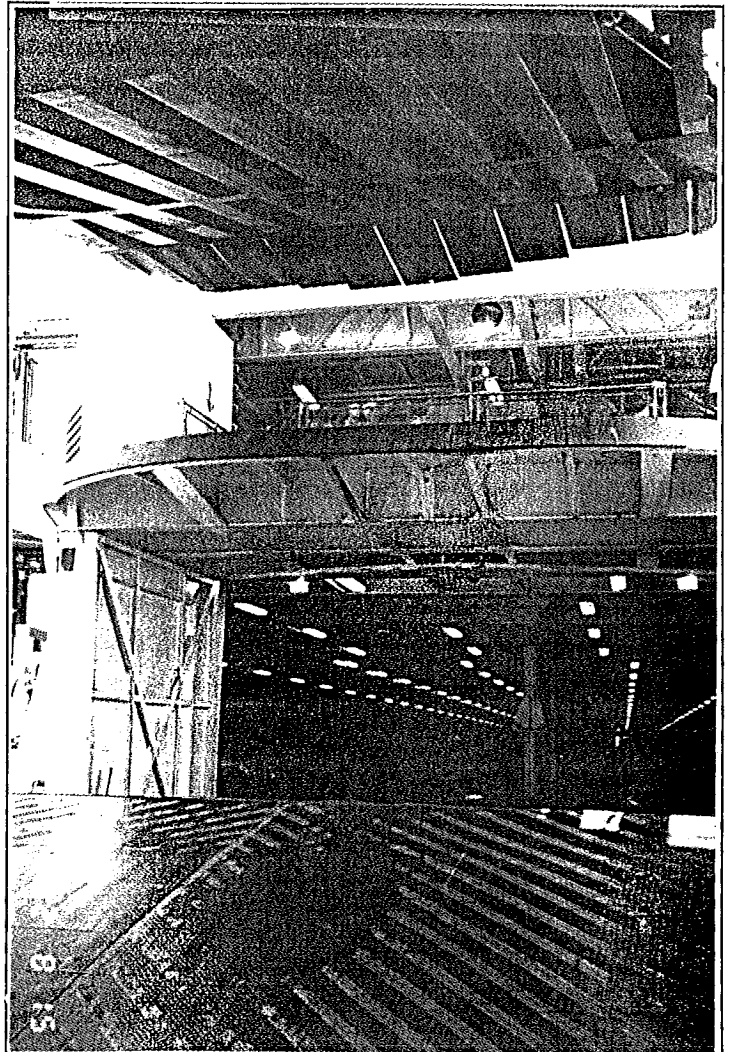
Both aprons in raised position  
prior to departure.

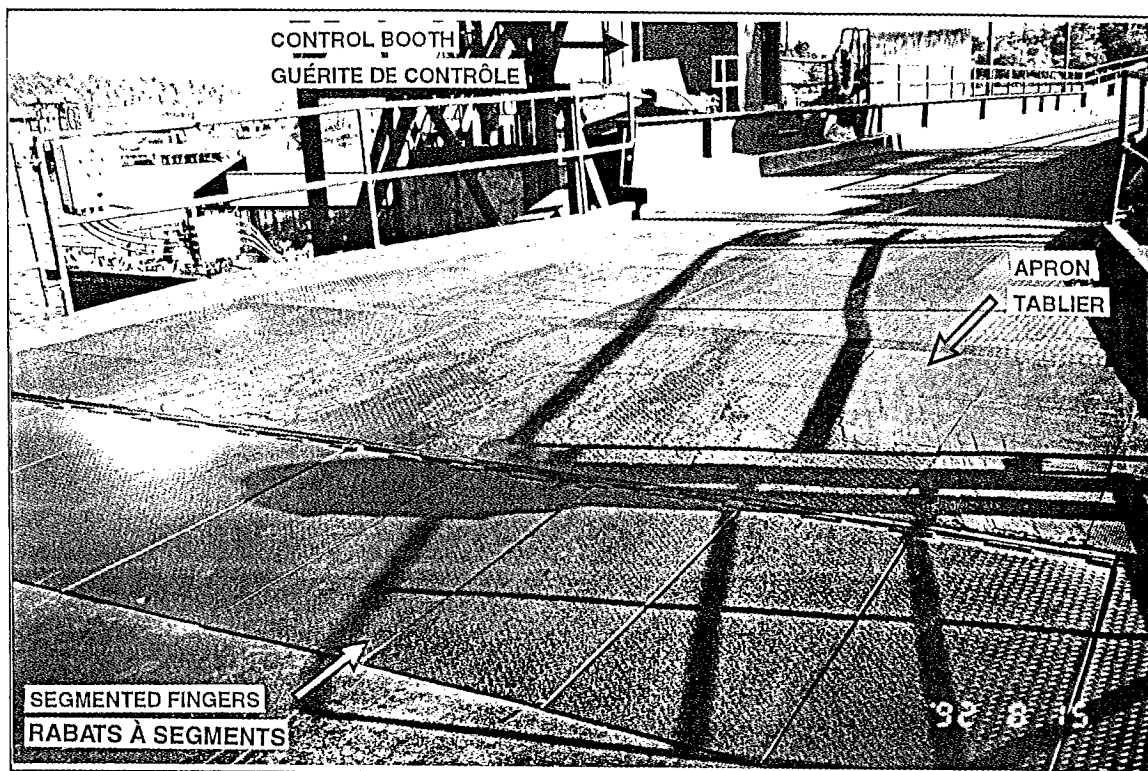
Upper apron on upper deck. Note: Narrow approach.

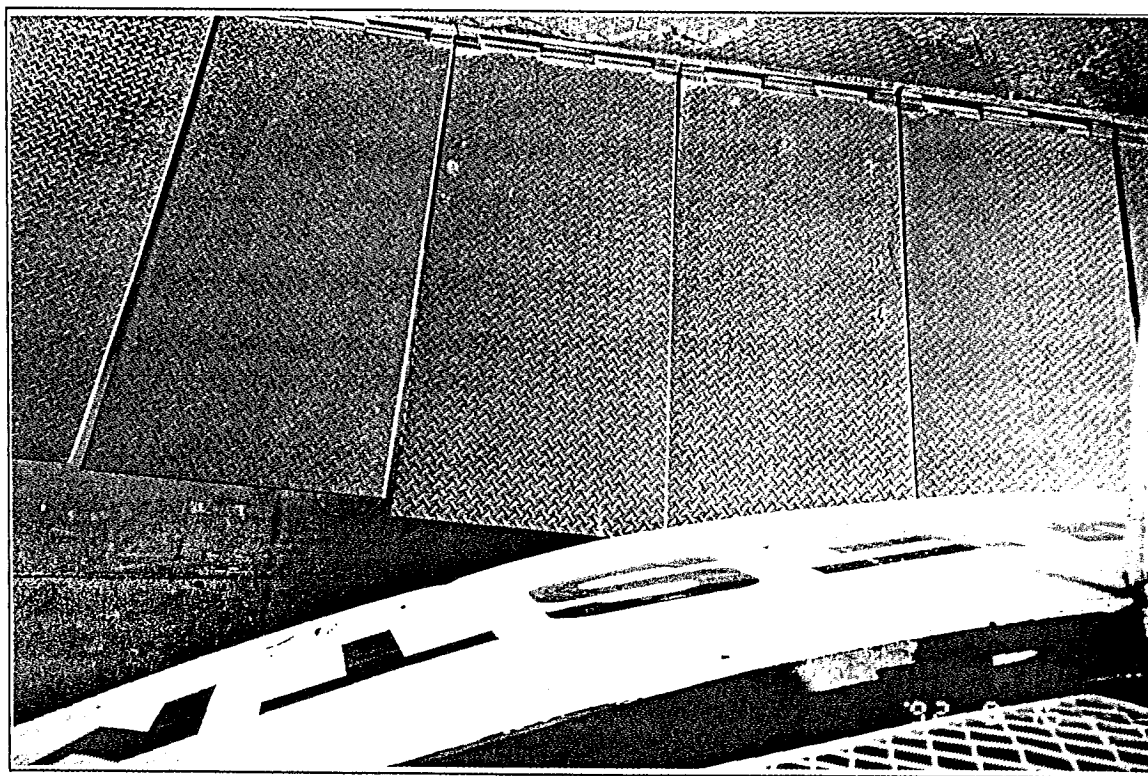
Monochrome video cameras are installed on the ship's lower deck only. They provide a view of either the bow or stern doors to the nine-inch monochrome bridge monitor, through a selector switch. The overhang on the after end of the promenade deck, which is the deck above the upper car deck, precludes the upper

apron from being fully raised before the ferry leaves the berth (photographs - Appendix B). This is only necessary at No. 3 berth, Departure Bay.

Overhang of the promenade deck precludes the upper ramp apron from being fully raised.

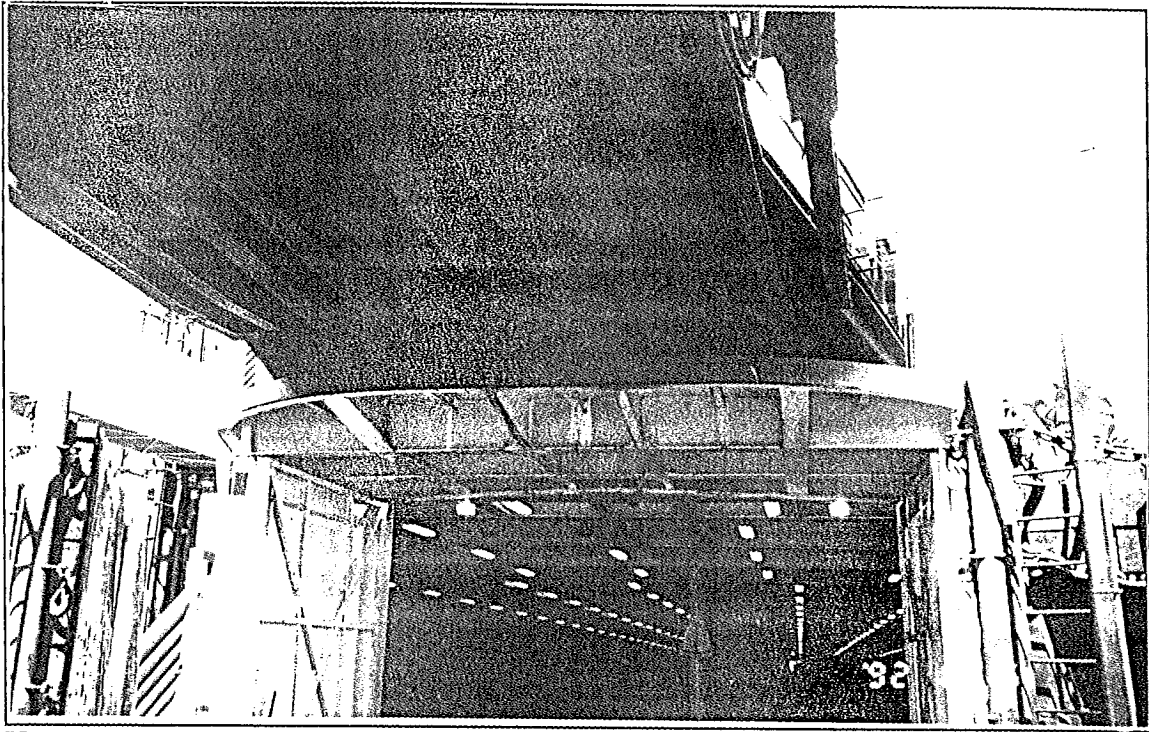
Upper ramp apron resting on the upper deck.

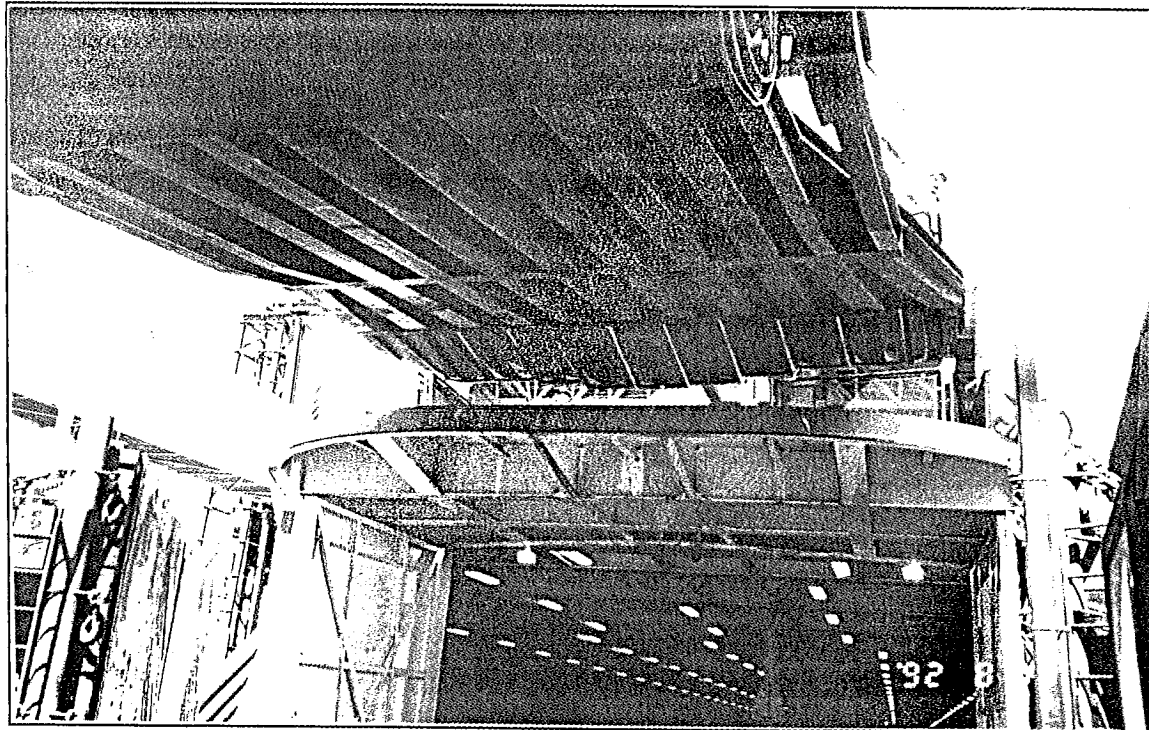
Upper ramp apron clear of the upper deck.
