Marine Occurrence Report

Grounding

Loaded Bulk Carrier "ZIEMIA CIESZYNSKA"
Bridge 11, Welland Canal, Ontario
22 September 1993

Report Number M93C0002

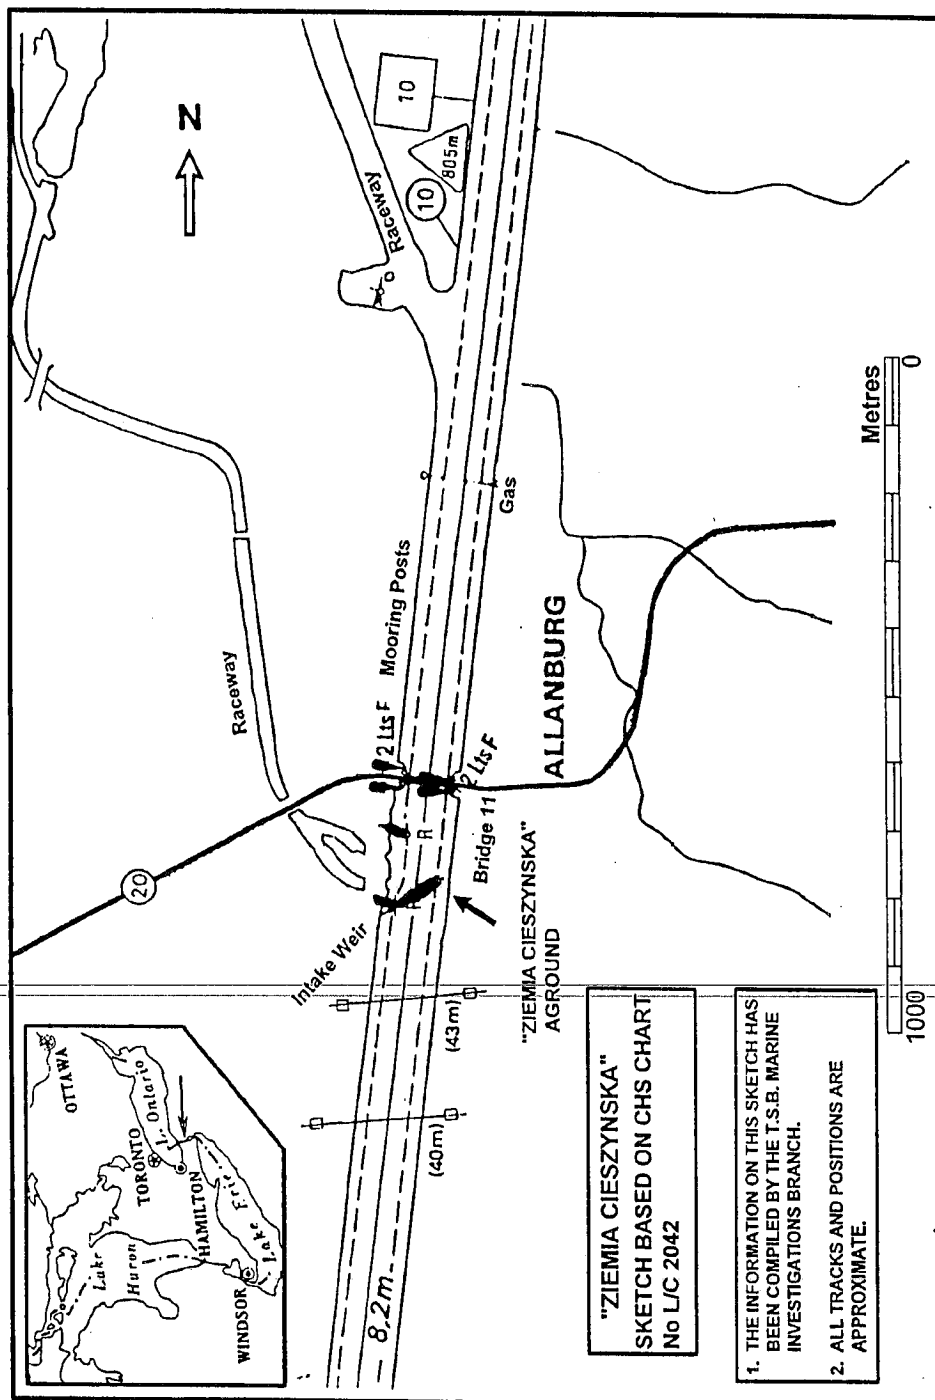
Appendix A - Sketch of the Area of Occurrence

The pilot initially could not remember and later denied giving the hard-a-starboard order, but the bridge course recorder clearly shows a dramatic alteration of course to starboard at 0013. The vessel's original heading was 188° (G), and she grounded heading 248° (G) (see Appendices A and B). The helmsman testified that he had been ordered to alter course to starboard by the pilot and that there had been no inadvertent movement of the helm.

South of the position of the grounding, on the eastern shore, between Bridge 11 and Mile 11, two lights are set well back from the canal edge. At the turn in the canal at Mile 11, there is a white light on the eastern bank.

Lights on the western shore of the canal are spaced approximately 100 m apart and set some 15 m from the canal edge. At Mile 11, a white light on the western bank is positioned higher than the white light on the eastern bank.
