Marine Occurrence Report

Bottom Contact

of the Bulk Carrier "CANADIAN EXPLORER"
St. Lawrence River
Near Lotbinière, Quebec
16 April 1993

Report Number M93L0001

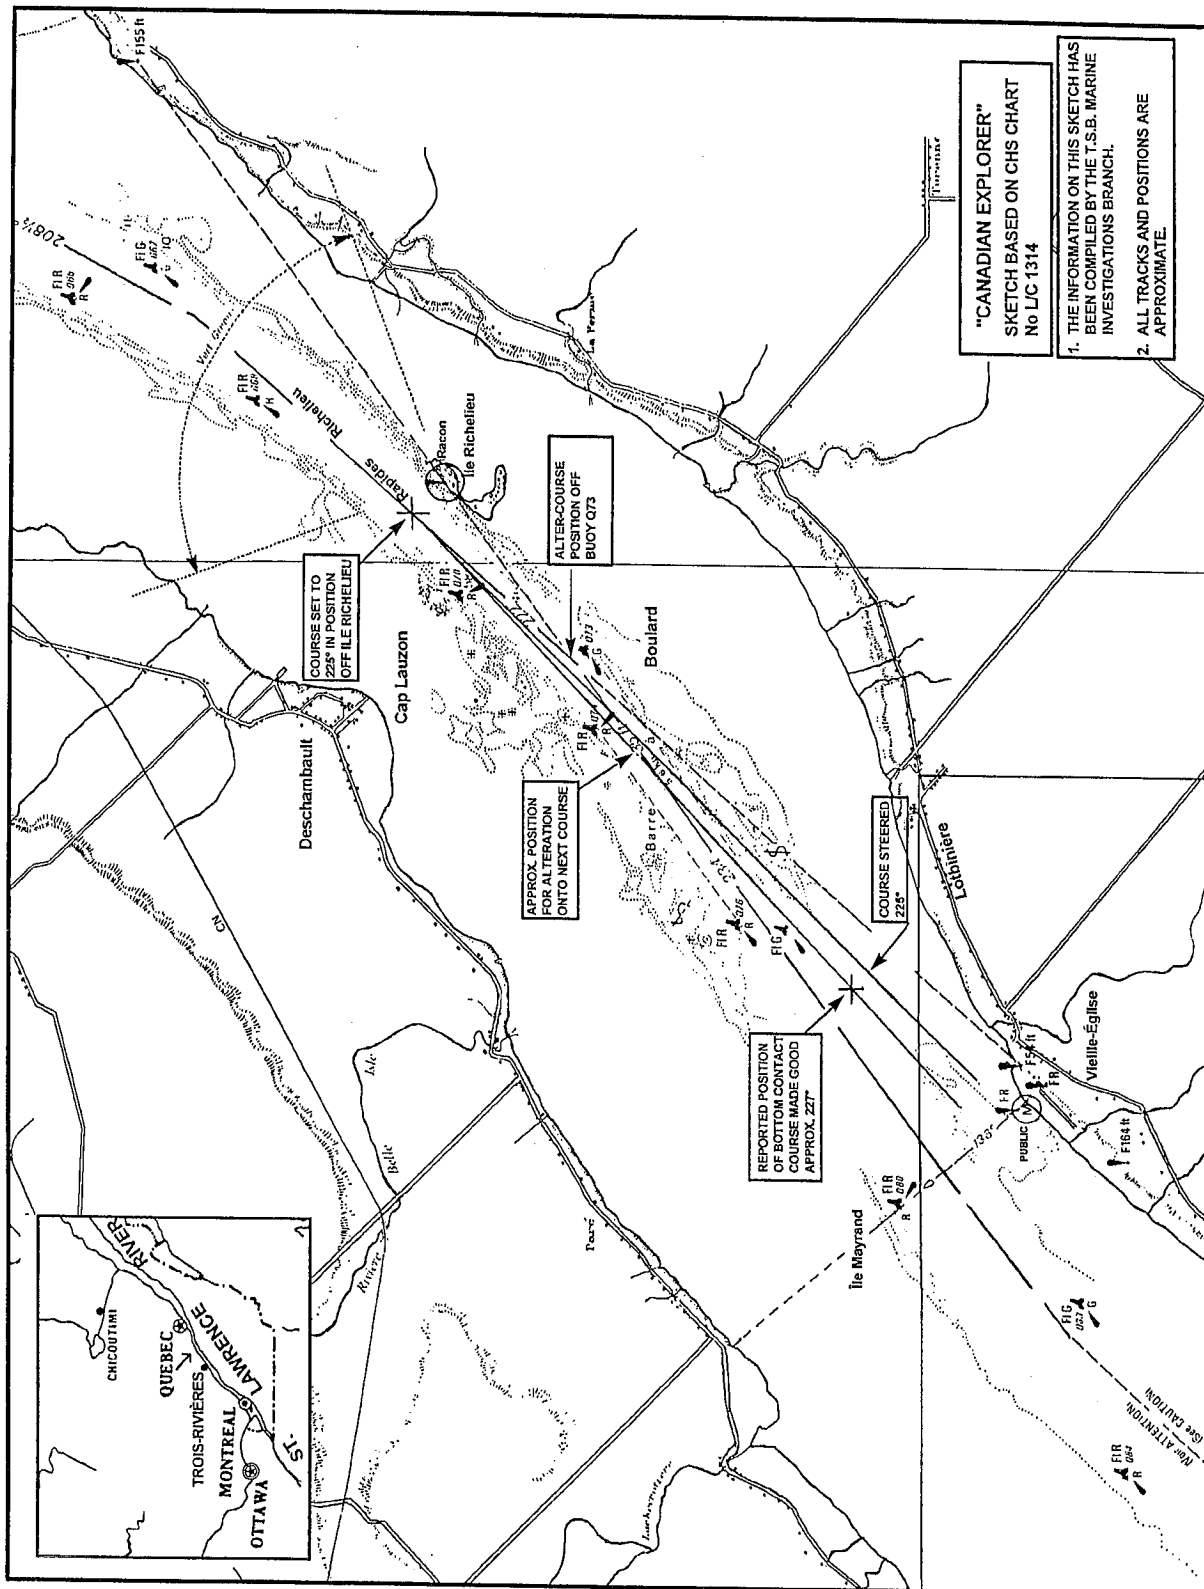
Appendix A - Chart Depicting the Track of the Vessel

At about 0640, under orders from the pilot, the vessel's course was altered to 222° Gyro (G) as the vessel entered the Richelieu Rapids (see Appendix A). The vessel was stemming a strong ebb tide. There is conflicting evidence respecting the vessel's speed. The pilot maintained that the vessel's average speed over the ground in the Richelieu Rapids was three to four knots (kn).

The OOW immediately summoned the master and plotted the vessel's position. The time of bottom contact was 0707, and the position was recorded as 46°37'15"N,071°57'W.

The depth at the position where the "CANADIAN EXPLORER" touched bottom was, therefore, more than the charted depth (see Appendix A).

If the position reported to the VTC was accurate, then the vessel would have made good a course of 227°(G). The vessel's average speed over the ground between 0647 and the time of bottom contact would have been about 6 kn. As can be seen from Appendix A, the distance between the position of bottom contact and the point at which the vessel would have crossed the next course line is about one mile, and the "CANADIAN EXPLORER" would have continued past the alter-course position for about 10 minutes before bottom contact was made.

On the other hand, had the vessel made good a course of 225°(G), her position at the time of bottom contact would have been some 0.75 M in a north-easterly direction from the reported position. This would have given the vessel an average speed over the ground of about 4 kn, and the vessel would then have continued on a course of 225°(G) for an additional 6 minutes past the alter-course position before bottom contact was made.
