Marine Occurrence Report

Fire on Board and Subsequent Loss

of the F.V. "JUDITH SUZANNE"
Georges Bank, South-west of Nova Scotia
18 September 1993

Report Number M93M00005

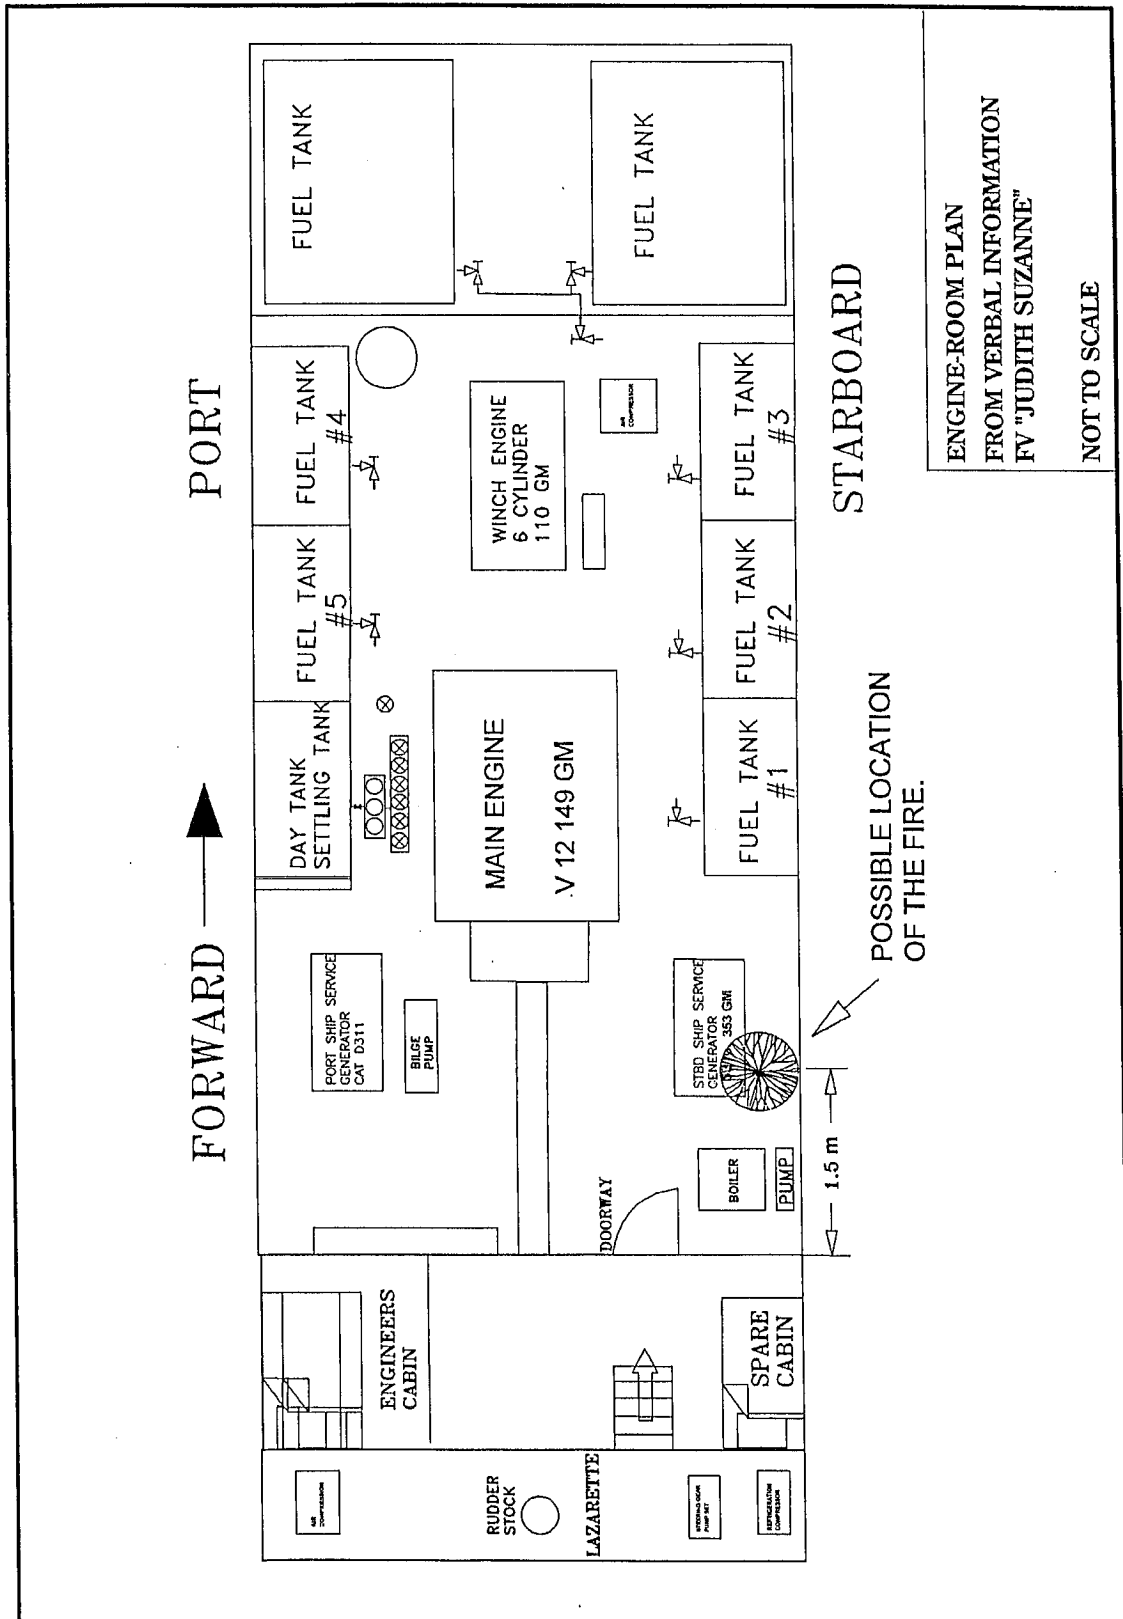
Appendix A - Engine-room Plan

The "JUDITH SUZANNE" was not considered salvageable. The vessel sank in some 40 fathoms (73 m) precluding any possibility of examining the wreck to determine the point of origin of the fire or examine the flame spread pattern. Testimony pointed to the fire having started in the area of the engine-room in which the starboard generator and the boiler were located.

The fire started in the engine-room, in the area in which the starboard generator and the boiler were located, but there was no conclusive evidence which would suggest that one of these two pieces of machinery may have been the cause of the fire. The electrical interference heard on the radio might suggest a malfunction of the generator's electrical components, and the explosion could be symptomatic of a problem with the furnace or a problem in the crankcase of the generator. However, sparking or a loose connection in any electrical circuit could have caused the electrical interference. The evidence was that the smoke could be smelled, and the fire had probably therefore started, before the explosion occurred. There was no other evidence linking the start of the fire to either the generator or the boiler; the precise cause of the fire was thus not determined.

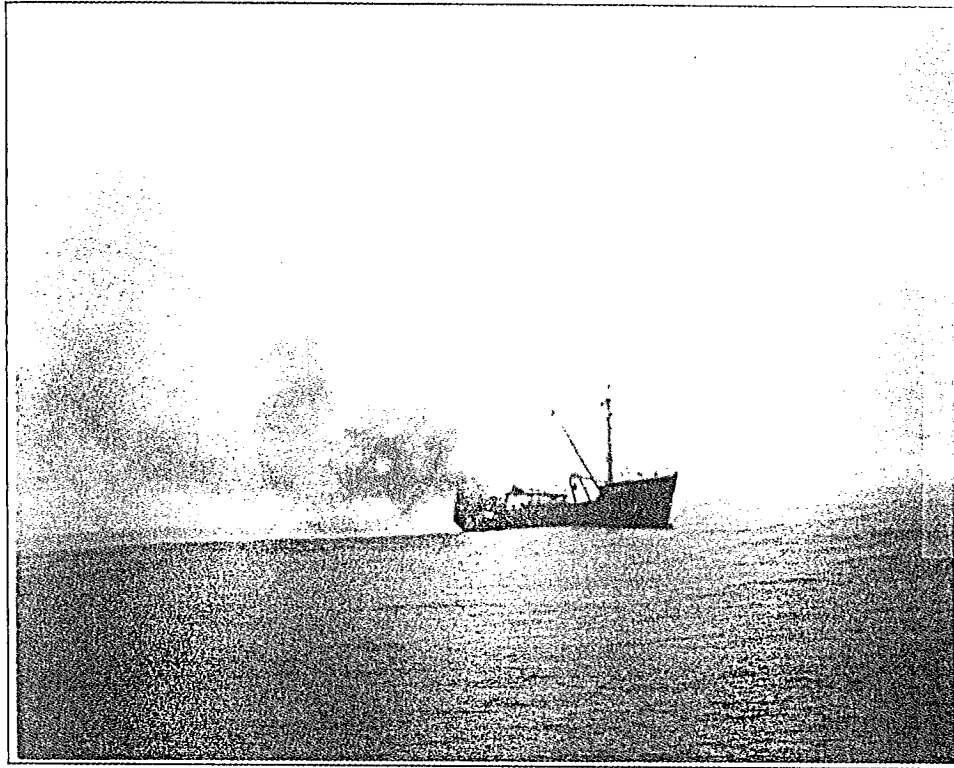
The "JUDITH SUZANNE" was lost as a result of an engine-room fire of undetermined origin. The fire was not detected promptly because the compartment was not continually manned and the vessel was not fitted with a fire alarm system. The fire spread and intensified beyond the vessel's fire-fighting capabilities.

"JUDITH SUZANNE" burning on 18 September 1993.
