Marine Occurrence Report

Fatal Injury to Crew Member

F.V. "CAPE BRIER"

Report Number M93M0006

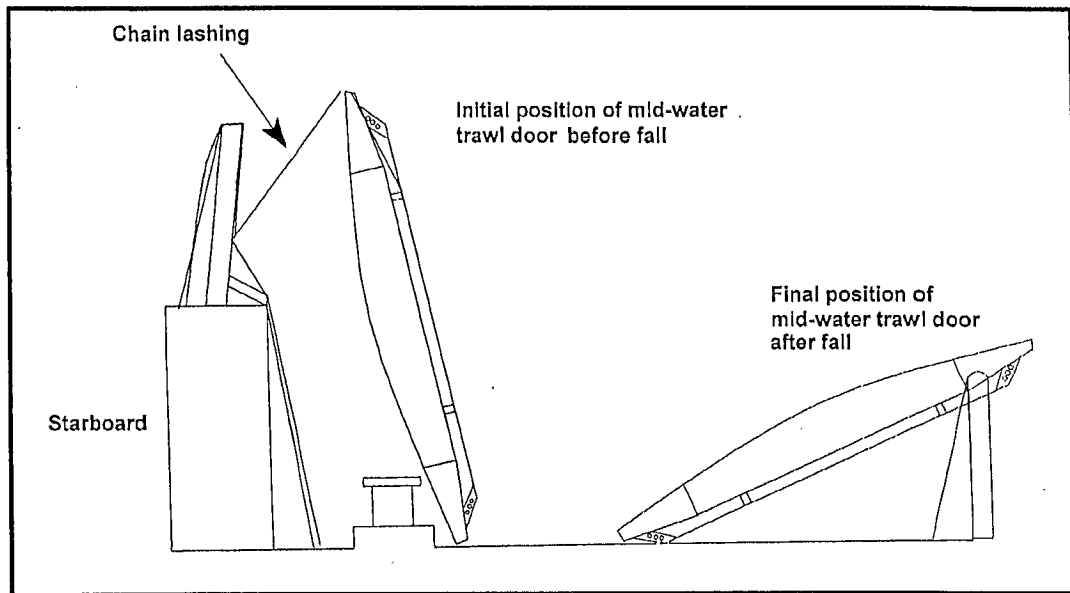
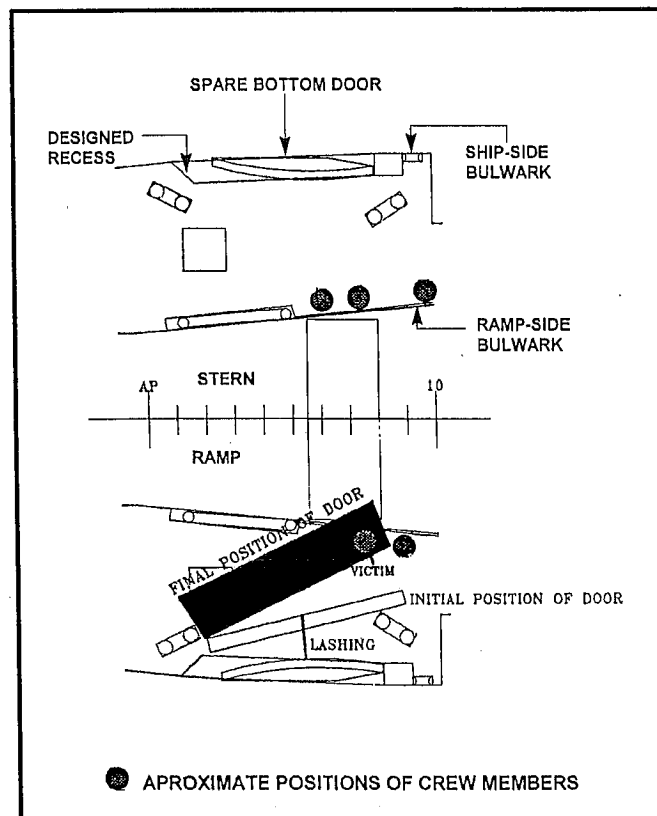
Appendix A - Stowage Arrangement

The mid-water trawl doors were reportedly stowed upright, with one side resting on the deck at a slight angle to the ship-side bulwarks. The stowage arrangement is depicted in Appendix A. The doors were secured by means of a chain which led from the end of the centre web of the door over the upper edge of the door and down to the chain securing

the spare bottom trawl door in the bulwark recess. No turn-buckle or other tightening device was incorporated in the securing chain and there was no chocking arrangement to secure the lower edge of the door which was in contact with the deck. Scratch marks were noted on the deck in the area. Coupling links were used for all securing chain connections. During the investigation, the securing chain and the coupling link used in the connection to the bulwark were recovered, but all parts of the coupling link used in the connection to the trawl door were missing.

Because no turn-buckles or other tightening or wedging devices were used and because there was no arrangement to secure the door where it was in contact with the deck, it would not have been possible to render the door completely immobile. The scratch marks on the deck could be considered as being consistent with movement of the door when in the stowed position. The rolling of the "CAPE BRIER" as she operated in the seaway would subject the securing arrangement to repeated snatch/shock loads.

The intended stowage recesses in the ship-side bulwarks had not been modified to take the larger doors, but proper immobilization of the doors could have been achieved without major structural alterations. The addition of minimal fittings such as eye-pads and angles to the deck and bulwarks would have permitted a rigid stow of the doors in the alternate location.

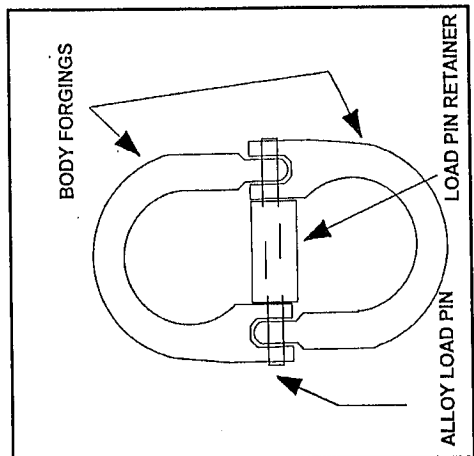
COUPLING LINK

Because of the many variable factors involved, it was not possible to determine the load to which the securing arrangement would have been subjected. The manufacturer's minimum breaking load for the coupling links, which the tested links exceeded, was in the order of 30 times the weight of the door. No parts of the coupling link which connected the securing arrangement to the door were

recovered, suggesting that the alloy pin failed in shear or that the pin worked its way out. The TSB Engineering Laboratory report suggests that the most probable failure scenario was that the load pin could have slipped out of the missing coupling link if there was wastage of the stud assembly due to corrosion.

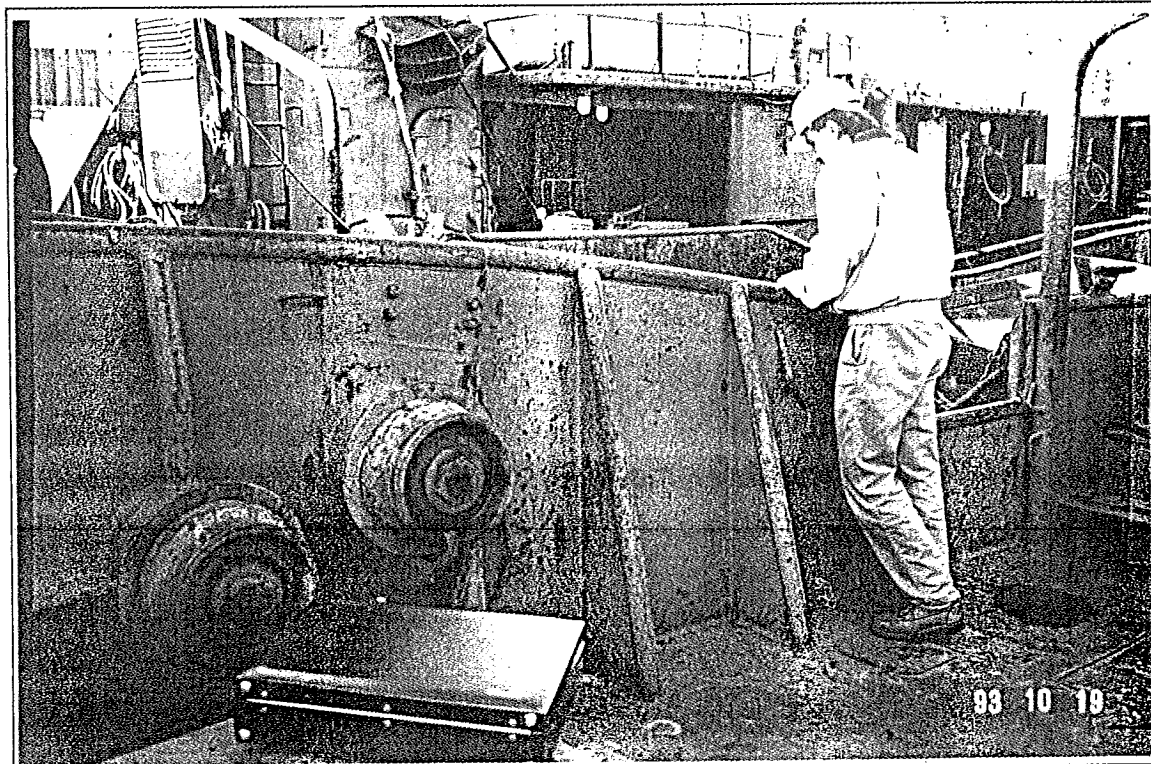
On a roll to port, the chain securing a spare trawl door parted and the door, a mid-water door that had been stowed upright against the ship-side bulwark on the starboard side, fell inboard. As the door fell, it struck one of the two crew members positioned at the side of the stern ramp, pinning him against the ramp-side bulwark. On the next roll, the trawl door shifted and another crew member was able to pull the victim clear of the door. The haul-back of the net was stopped and aid to the injured crew member was immediately begun. Despite the crew's efforts, the crew member was pronounced dead after radio consultation with a doctor in Halifax, Nova Scotia.

View of accident site.

Following the accident, the vessel owners fitted storage pockets on two similar class vessels in order to properly secure large mid-water trawl doors. Since there are only two pairs of large mid-water doors in the fleet, they will be permanently assigned to the modified vessels. A total of four vessels of the same class were modified and fitted with storage pockets for the proper securing of ground trawl doors.
