Marine Occurrence Report

Striking

of the Canada Place Dock by the
BC Transit Ferry "BURRARD BEAVER"
Vancouver Harbour, British Columbia
06 January 1993

Report Number M93W0001

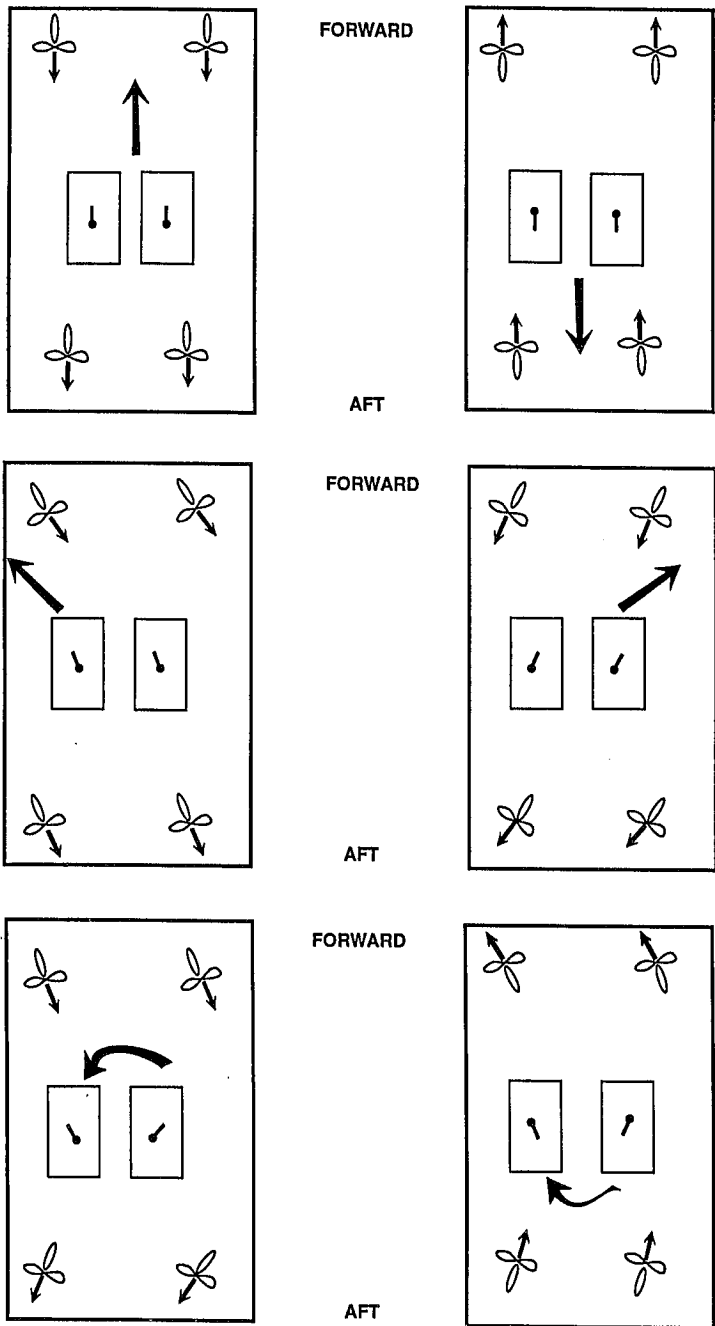
Appendix A - Sketch Showing Manoeuvring Capabilities of the "BURRARD BEAVER"

Because the "BURRARD BEAVER" and her sister ship, the "BURRARD OTTER", are equipped with a unique system of controls, their manoeuvrability differs from that of a conventional ship which has rudder and propeller(s) aft. These two ferries can, at normal service speed, with judicious control movement, almost stop in their own length, spin in their own length, move sideways or at an angle of up to 45° (see Appendix A).

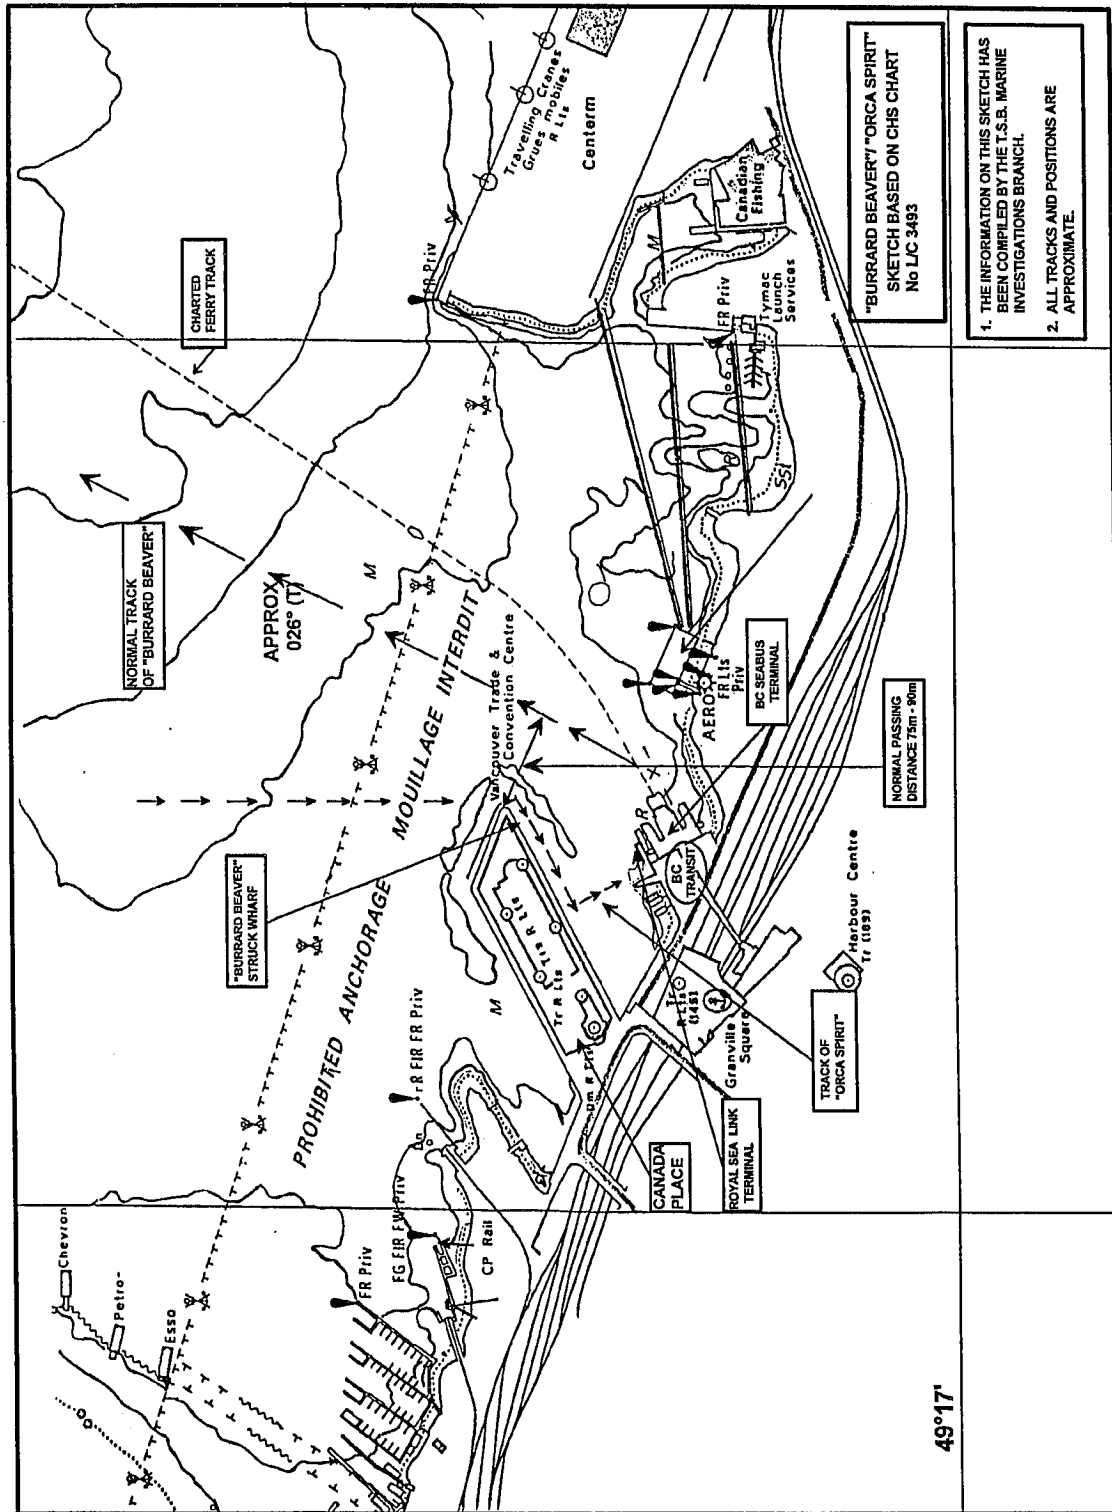
Appendix B - Tracks of the "BURRARD BEAVER" and the "ORCA SPIRIT"

The normal and usual track of the ferry is indicated on the chartlet (see Appendix B). From departure at Vancouver Terminal, the direction of travel is approximately 063°(T) for approximately 60 m after which the course is altered to head on a "navy buoy" (approximate heading 026°(T)). This would ensure that the vessel passed clear of the north-east corner of Canada Place dock by some 75 m to 90 m.

The track the Royal Sea Link vessel "ORCA SPIRIT" generally followed as she approached her berth is reproduced on the chartlet (see Appendix B). This ferry from seaward and First Narrows approaches the north-west corner of the Canada Place dock, then proceeds on a course parallel to the north face of the dock. She then rounds the north-east corner, staying close to the eastern side of the Canada Place dock after which she turns in the basin and approaches her berth on the western side of the SeaBus Terminal.

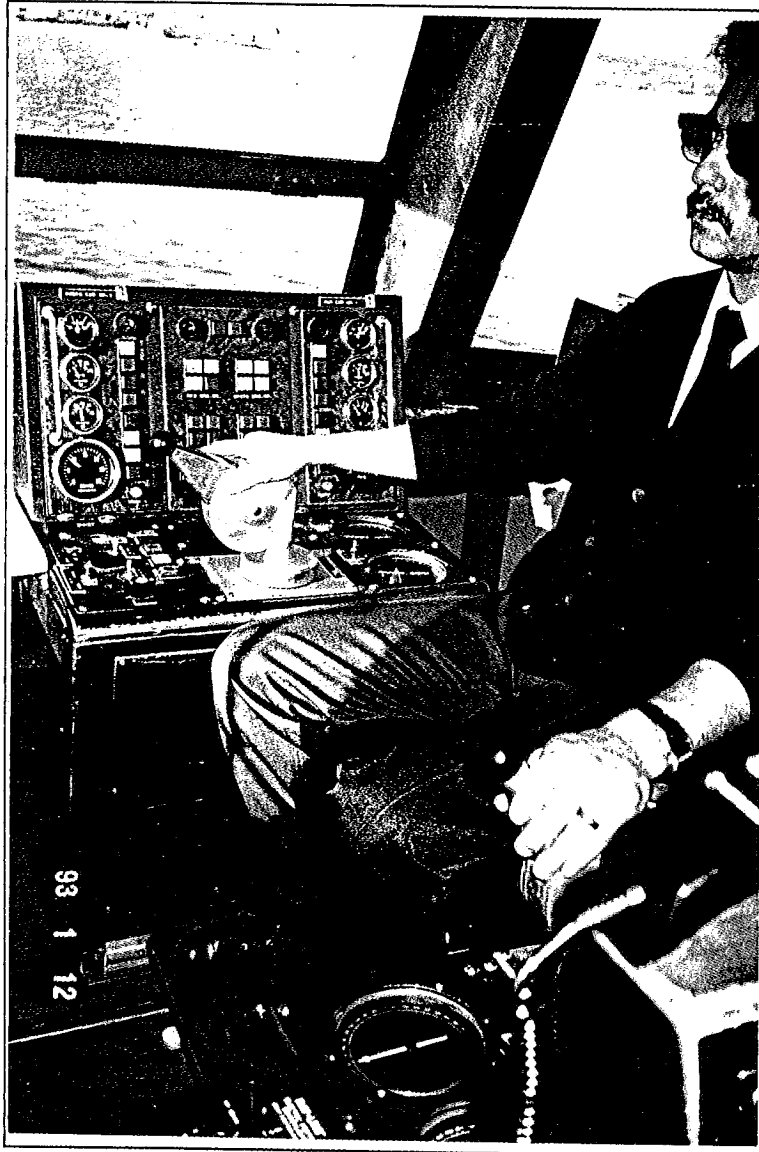
The position of the mate between the consoles and the layout of the engine controls precluded the master from gaining access to the other two engines. However, this action proved insufficient and, at a recorded time of 0748, the port side of the "BURRARD BEAVER" struck the north-east corner of the Canada Place dock approximately 20 m from the knuckle and between the fenders.

The person who has the conduct of the vessel (operator) sits in the wheel-house on a track-mounted swivel chair, facing the direction of travel, located between and within easy reach of both joysticks (see Appendix C). A vertical screen for radar display and a magnetic compass are mounted in front of the operator. It is the operator's responsibility to ensure that the radar is properly adjusted and visible. Identical units are fitted at both ends of the wheel-house and are clearly visible to another officer. (For wheel-house layout, see Appendix D.)

Operator seated between the consoles; steering and manoeuvring controls.

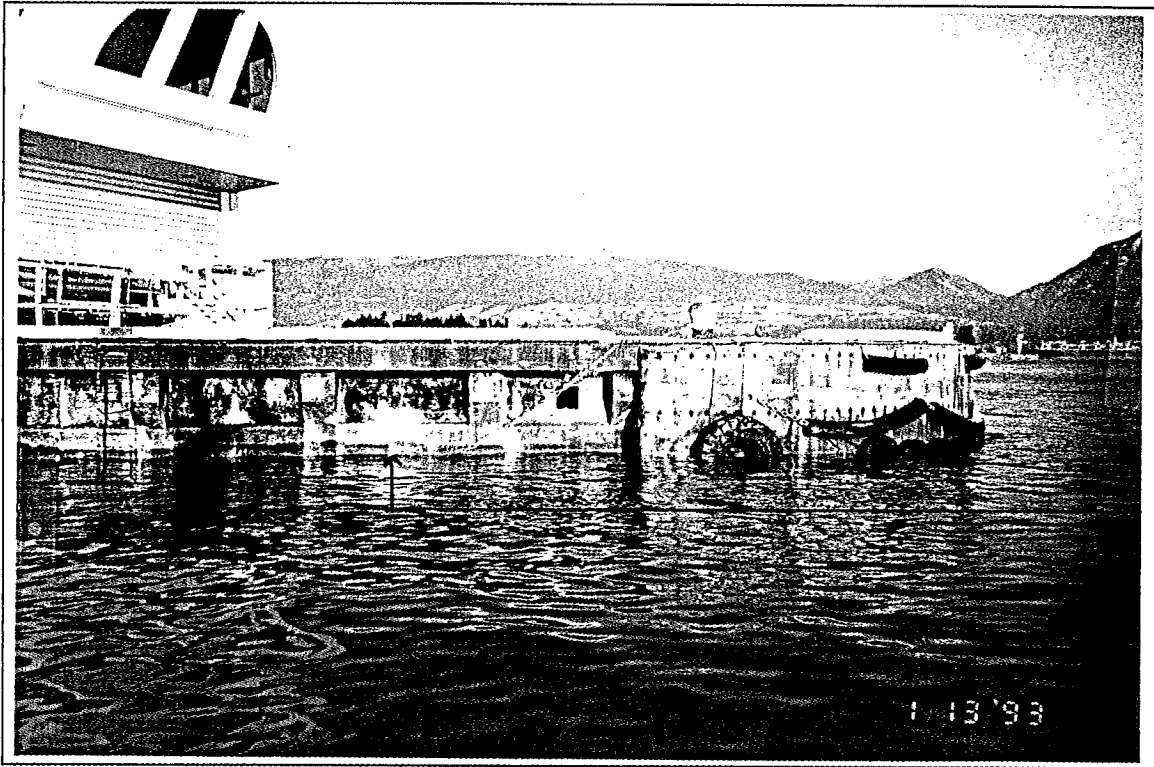
Point of Striking

The concrete face of the Canada Place dock was slightly broken and flaked in way of contact (see Appendix C).

East side of Canada Place dock.

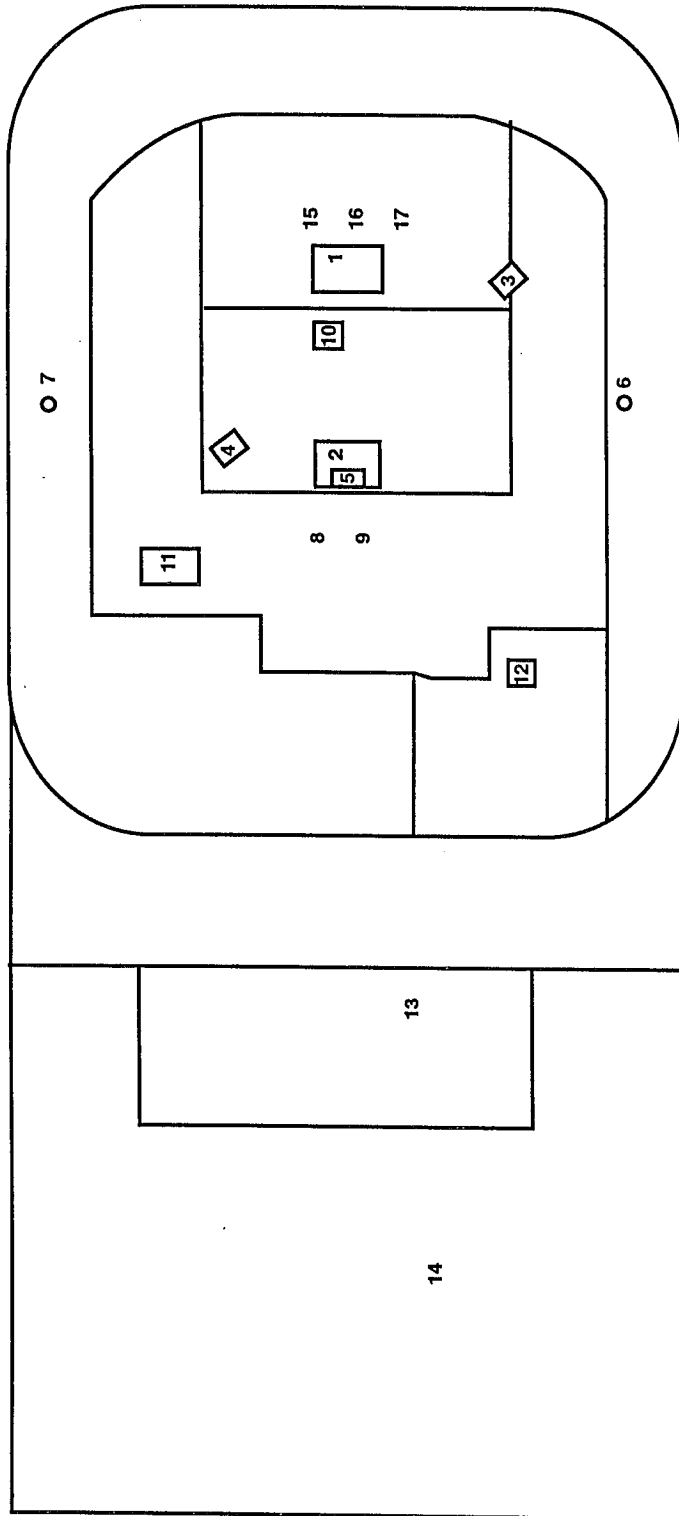
Appendix D - "BURRARD BEAVER" - Wheel-house Layout

There is conflicting evidence with respect to the positioning of the radar screen. While the master maintained that he had not moved the radar screen from its initial position, the mate maintained that the master had turned the radar screen (which was facing him) in azimuth, thus preventing him from seeing it.
