MARINE OCCURRENCE REPORT

M97M0005

TAKING ON WATER

FISHING VESSEL "SCOTIA GOLD"

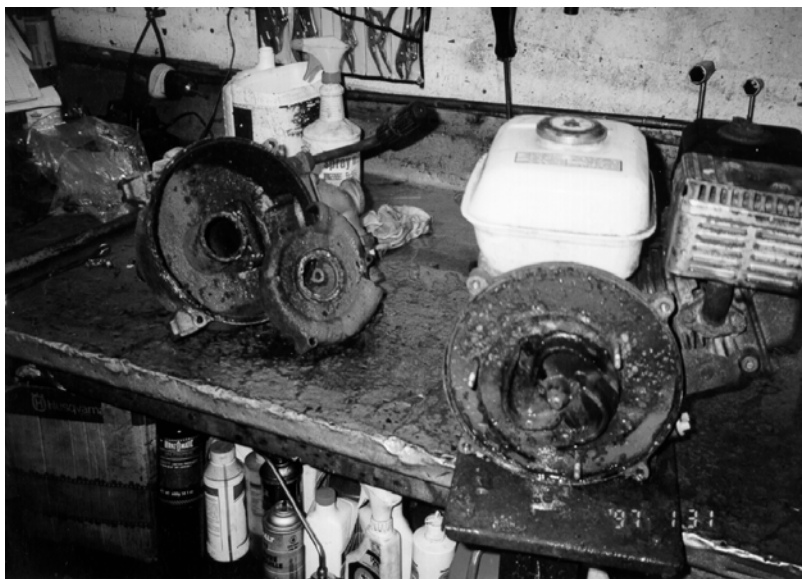
The portable Honda pump, carried as ship’s equipment onboard the “SCOTIA GOLD”, was dismantled ashore soon after the occurrence. The interior of the aluminium pump casing and steel impeller parts were found to be so heavily corroded that the pump could not work. (See Appendix A, Photo 2.)

The use of an aluminium pump casing with steel impeller parts in the corrosive environment of seawater will cause galvanic action resulting in accelerated corrosive attack of the aluminium, besides the normal oxidization of ferrous metal parts.

The portable Honda de-watering pump carried on board the “SCOTIA GOLD” was additional equipment to that required by TC regulations. Once on board, the pump’s general purpose use, lack of frequent maintenance and inability to operate safely in a seawater environment resulted, over time, in the aluminium and steel pump parts becoming so severely corroded that the unit failed to operate when needed in this emergency.

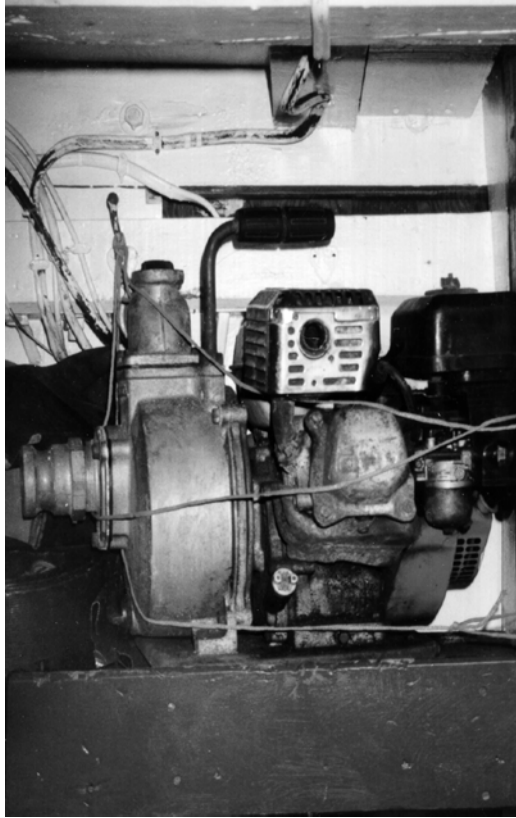
The “SCOTIA GOLD” was equipped accordingly, but the shipboard portable Honda pump had no drum container protection from the elements as provided in a SAR pump assembly. The bare unit was stowed in a compartment on the weather deck. (See Appendix A, Photo 3.)

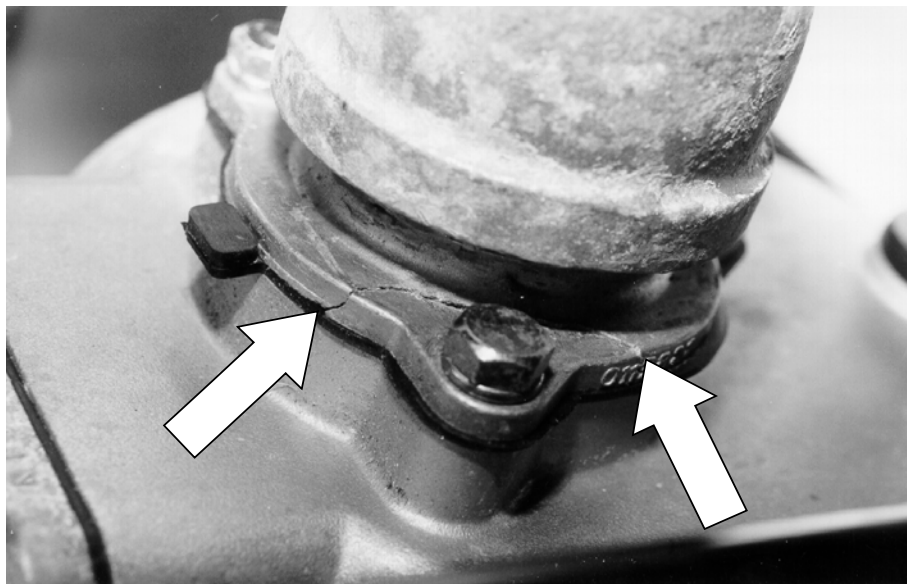
The portable Honda pump supplied to the “SCOTIA GOLD” by CCG helicopter 361 had a fractured coupling flange at the pump’s suction flap valve, which rendered the pump inoperative. (See Appendix A, Photo 4.)

A fracture discovered in the helicopter-supplied Honda pump's suction flange was established as the cause of pump failure.⁵ Although it is unknown precisely when the fracture in the suction flange occurred, the pump must have been damaged sometime after leaving the maintenance depot, while on board or being lowered to the water by the helicopter, or during its recovery by the "SCOTIA GOLD".

Given that the flanged suction fitting was hard against the inside of the container, an impact load at this point of contact would cause a shearing force at the flange corner. The crack in the flange was found to have propagated from this point. The incompatibility of the pump unit and container was such that the pump suffered damage during its “normal” handling between the depot and being hauled aboard the “SCOTIA GOLD”. It is thus unlikely that the assembly would have survived an air drop—the alternative method of delivery.

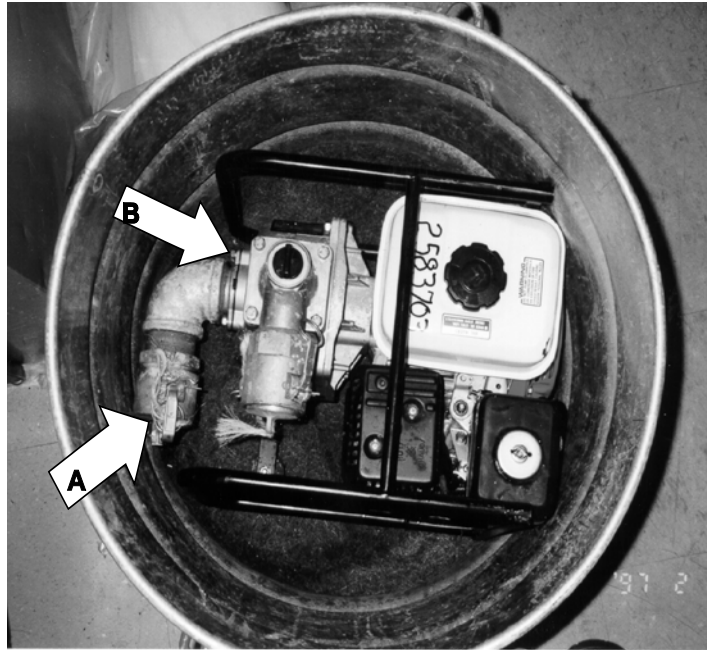
The CCG pump unit had been packaged for SAR using a drum container originally designed for a portable pump unit made by another manufacturer. As purchased from the dealer, the Honda pump unit will not fit into the mismatched aluminium drum container. This unit had been adapted to fit the drum container by a local industrial equipment rental company. The pump's carrying frame had been shortened by sawing off and reshaping one end. Fitting of the adapted pump unit into the container forced the flanged suction pipe hard against the inside of the container wall. (See Appendix A, Photo 5.)

The container is one component of an approved Briggs & Stratton/Ohler customized package and as such is designed to resist the forces normally associated with air drops and ship-to-ship handling of that particular assembly. The decision taken to make a pump unit from one manufacturer fit into the container made especially for a different pump unit compromised the protection afforded by the container.

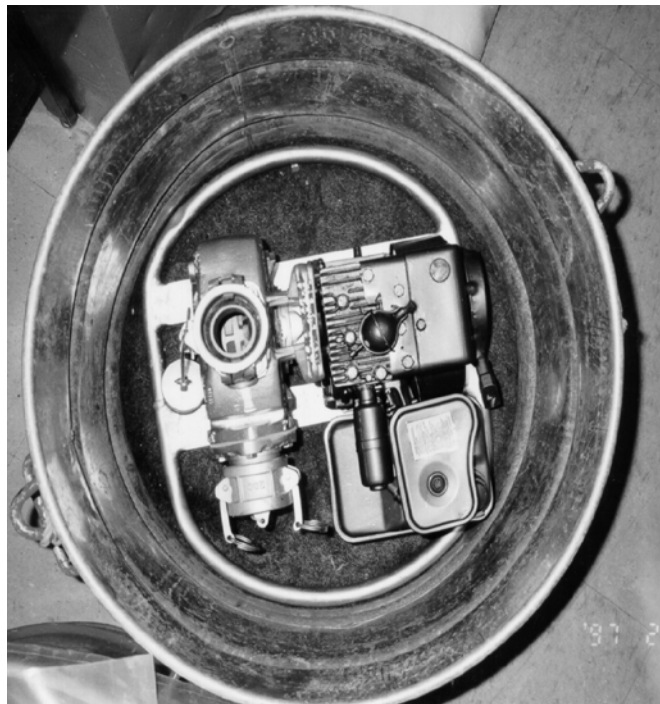
Briggs & Stratton-type portable pump assemblies, such as that carried on the "CUMELLA", are referred to herein as "SAR-approved". (See Appendix A, Photo 6.)
