MARINE INVESTIGATION REPORT

M97M0094

MAN OVERBOARD

“MACDONALD’S III”

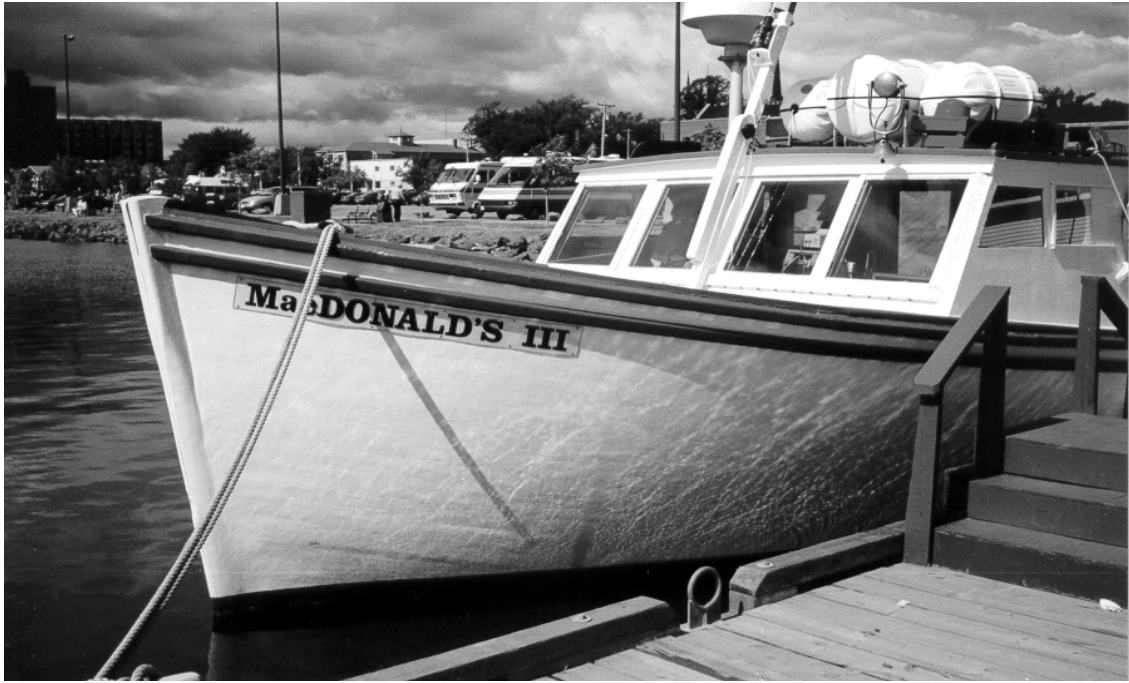
"MACDONALD'S III"

The lifejackets were stowed in an unidentified box in the well deck. There were no placards posted indicating the correct method of wearing and securing a lifejacket. There was also no announcement or demonstration made by any members of the crew regarding the safety equipment when the passengers boarded.

The man who fell overboard did so because he left the security of other areas of the vessel and recklessly danced on the narrow, cluttered area of the afterdeck.

- A. Unmarked box containing lifejackets
- B. Area from which man fell overboard
