MARINE INVESTIGATION REPORT

M98F0023

STRIKING OF A PLEASURE CRAFT

BY THE PASSENGER HYDROFOIL "SEAFLIGHT I"

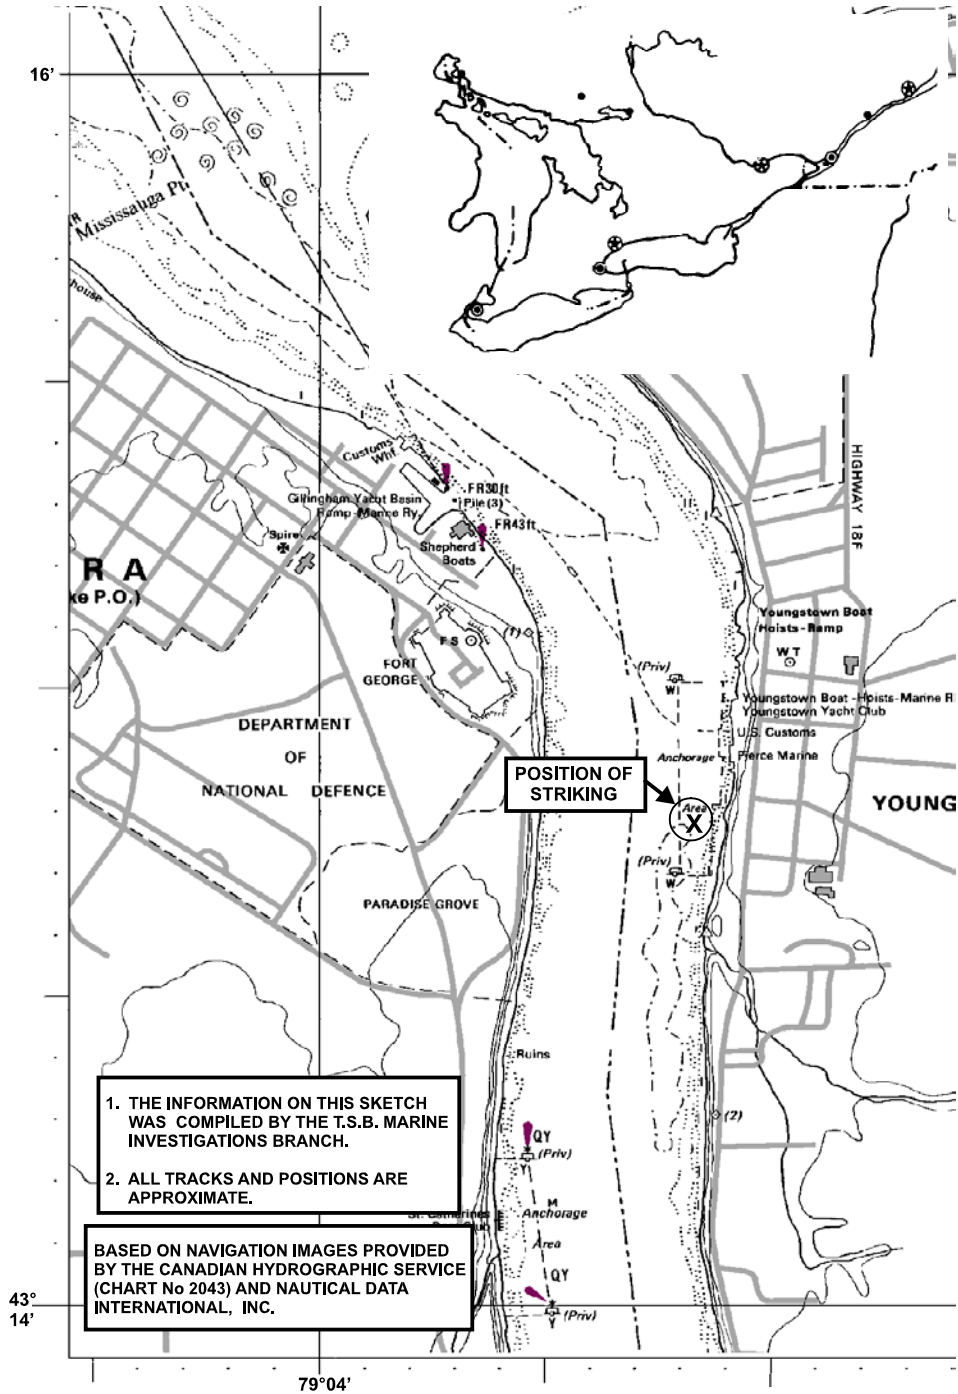
Appendix A - Sketch of the Occurrence Area

1. THE INFORMATION ON THIS SKETCH WAS COMPILED BY THE T.S.B. MARINE INVESTIGATIONS BRANCH.

2. ALL TRACKS AND POSITIONS ARE APPROXIMATE.
