MARINE INVESTIGATION REPORT

M98W0045

SWAMPING WITH LOSS OF LIVES

“OCEAN THUNDER”

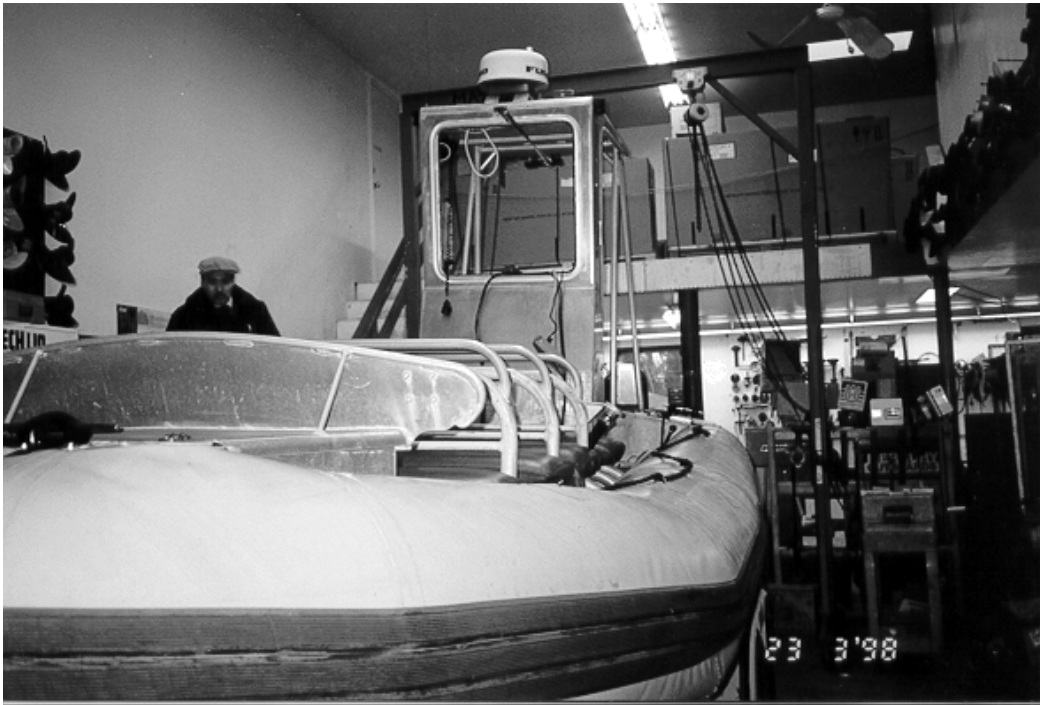
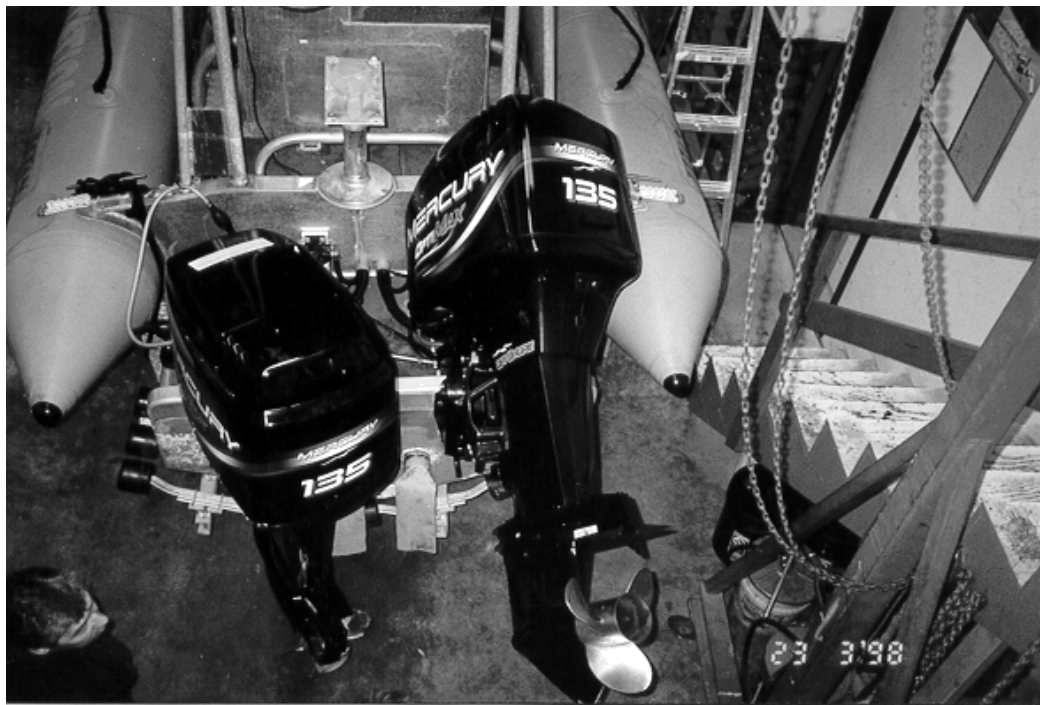
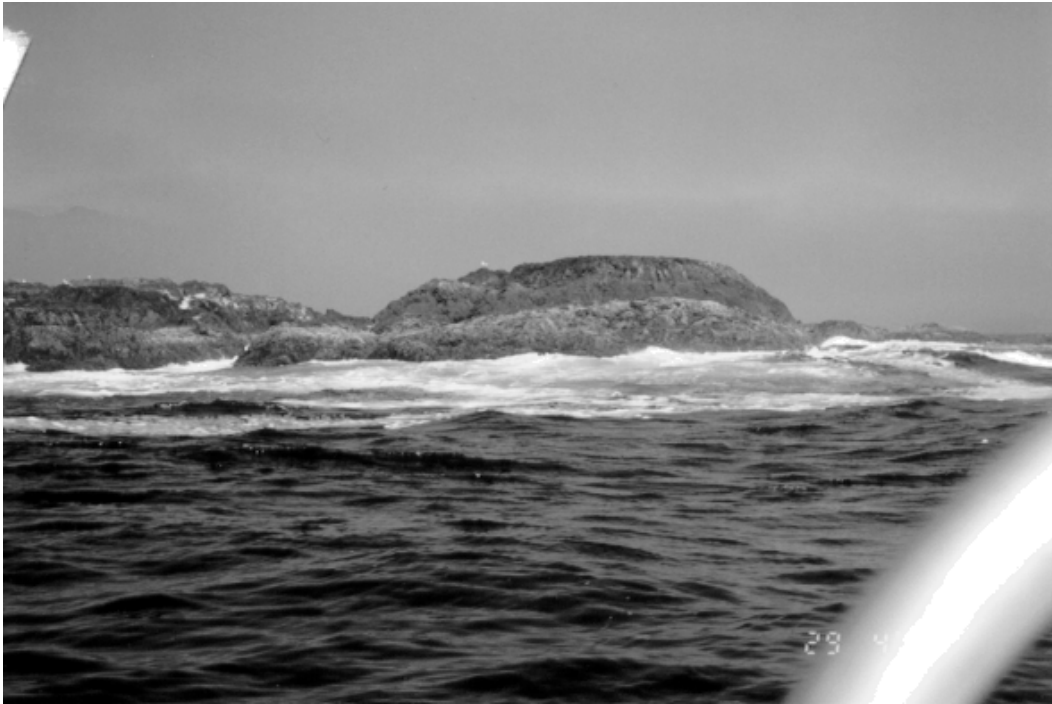
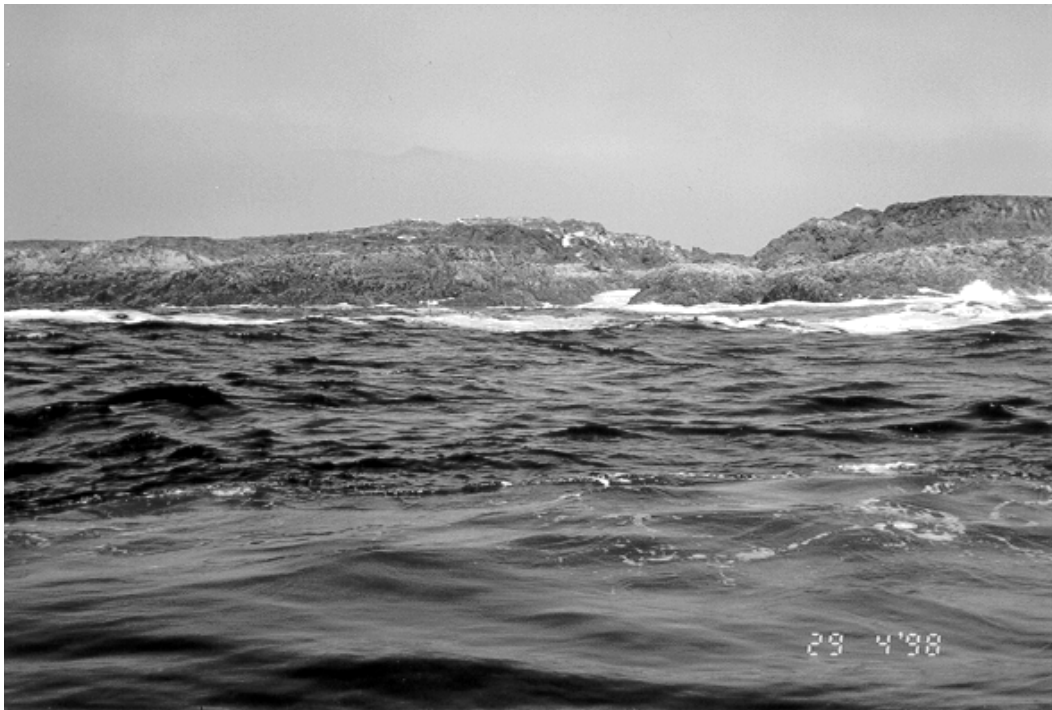
Appendix B - Photographs

- The throttles of both engines were found set at the half-ahead position.
- The port engine had a smashed lower cowling and a cracked upper cowling, its air filter was found soaked with water, and water was found on top of the air intake throttle plates. The number four cylinder was full of water and, in the other cylinders, there was indication of water on the spark plugs.

- The starboard engine was tilted up past its limit. There was damage to the cowling and the starter solenoid battery connection had deposits of green verdigris corrosion. Water was found throughout the cowling. All cylinders showed signs of water ingestion and cranking the engine expelled water from the spark plug holes.

- The tachometers, port hour meter, very high frequency (VHF) radio, Global Positioning System (GPS) and radar were found to be damaged by sea water; however, all other instruments and wiring on the main instrument panel were functional. The ignition safety cut-off lanyard was missing.

- The battery connections were green and corroded.
- The operator's cabin window pane was broken, and scratches and scuffs were found on the port side of the hull. On top of the operator's cabin, the radar dome, the antenna and lights were intact.
