MARINE INVESTIGATION REPORT

M99C0008

CONTACTING BOTTOM WITHOUT GROUNDING

BULK CARRIER "JEAN PARISIEN"

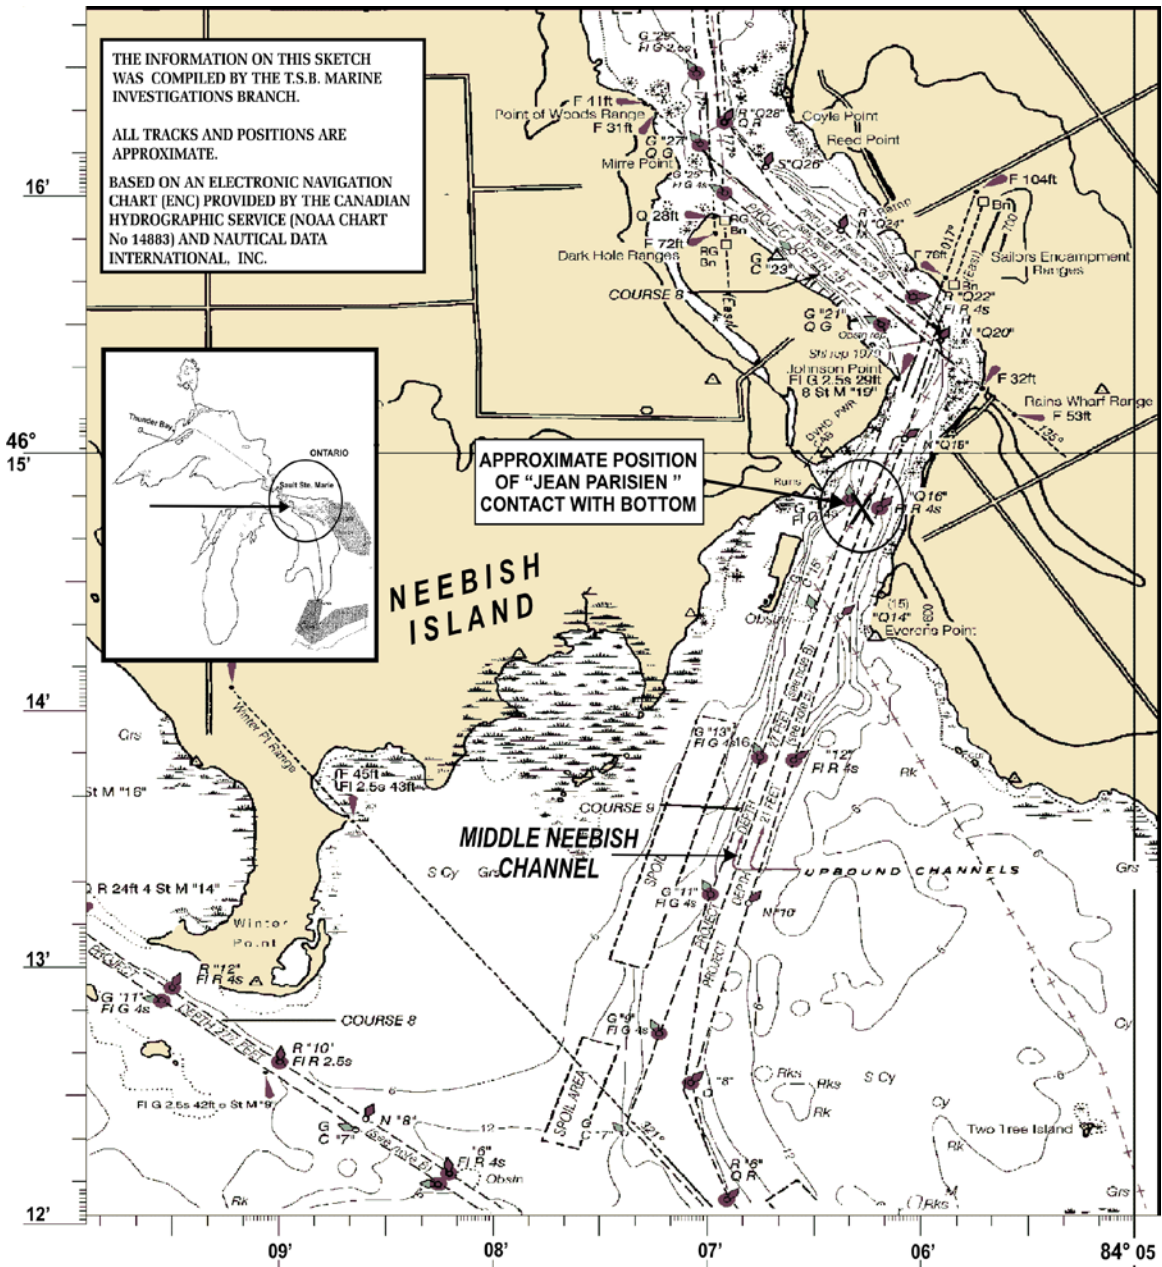
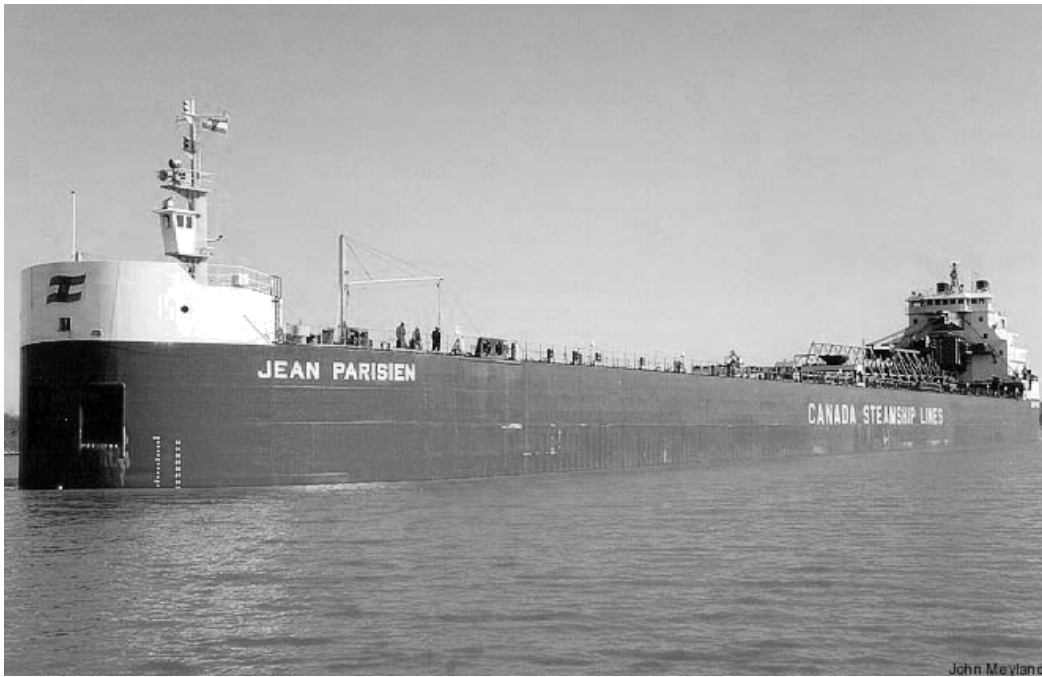
Appendix A – Chart of Area Showing Position of Grounding

Anticipating a port set after buoy Q16, the master favoured the centre of the Neebish Channel as he adjusted the course to steer between the two recommended navigable tracks provided by the sets of ranges and day beacons. The helmsman, as directed, adjusted the heading by steering 017°T. Upon completion of the new heading change, the vessel continued to set to starboard, not to port as anticipated. The ship's drift to starboard was confirmed visually by observing that right-hand day beacons continuing to close. At 1815, with more than half the ship's length past buoy Q16 and Q17 and the ship's speed at 6.7 knots, a noise was heard as the bottom shell plating contacted the river bottom. The vessel scraped the river bottom momentarily but maintained its course and heading as it passed buoy Q16. At that point the helmsman observed that the right-hand side day beacons were aligned, indicating that the vessel was in the eastern, shallower 6.4-m-deep section of the channel. The vessel contacted the river bottom at position latitude 46°14.75' N, longitude 084°06.3' W.¹ In this section of the channel, the river bottom is hard and forms a ledge with a minimal clearance below chart datum of 6.5 m (see Appendix A).

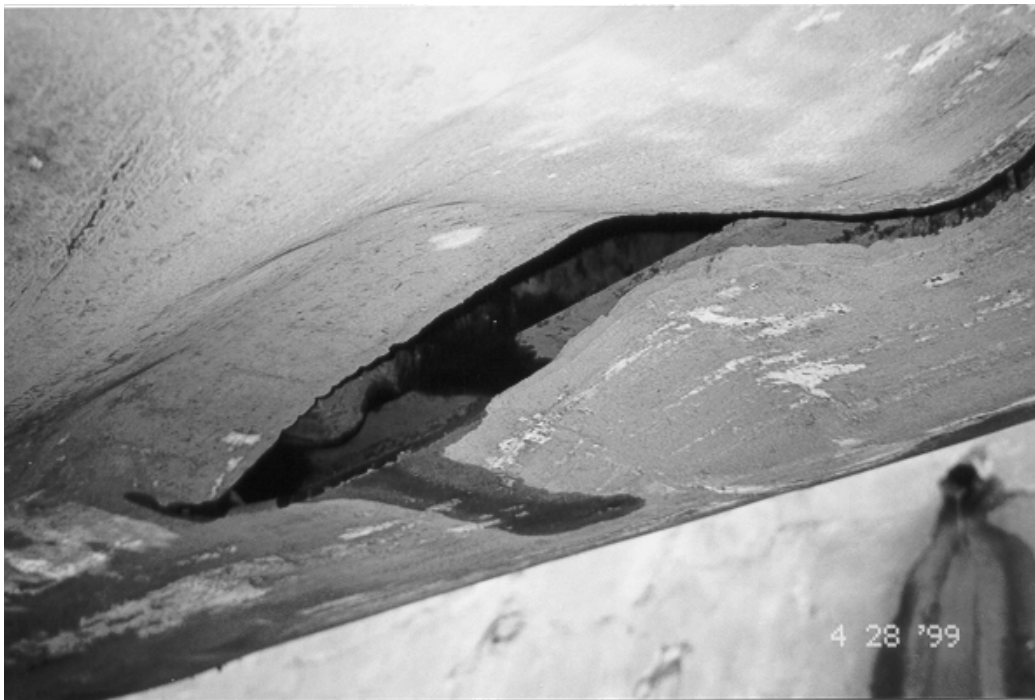
Appendix B – Photographs

Starboard water ballast tank No. 5 and the cofferdam at its forward end were breached. The bottom shell plating of the tank was buckled and penetrated between frames 33 and 36 by a split approximately 1.5 m long and 20 cm wide. The bottom shell plating was damaged and set in approximately 12 to 16 cm, and extended inboard from the turn of bilge at frame 55 and aft to frame 24.

The starboard side bottom shell plating was also buckled and set in between frames 21 and 14, with the damage outboard of and approximately parallel to the keel.

Normal navigation practices were followed on the “JEAN PARISIEN”. With a pronounced trim by the stern of 3.3 m and a draught of 7.0 m aft, the “JEAN PARISIEN” was too deep to enter the east side, 6.4 m-deep lane of the Middle Neebish channel. As a result, the ship’s bottom shell struck the river bank and the No. 5 starboard tank was set in some 20 cm.

Repairs requiring the replacement of approximately 14.4 tonnes of steel were completed to the classification society's approval and owner's standards.
