MARINE OCCURRENCE REPORT

M99C0016

BOTTOM CONTACT

PASSENGER VESSEL "CANADIAN EMPRESS"

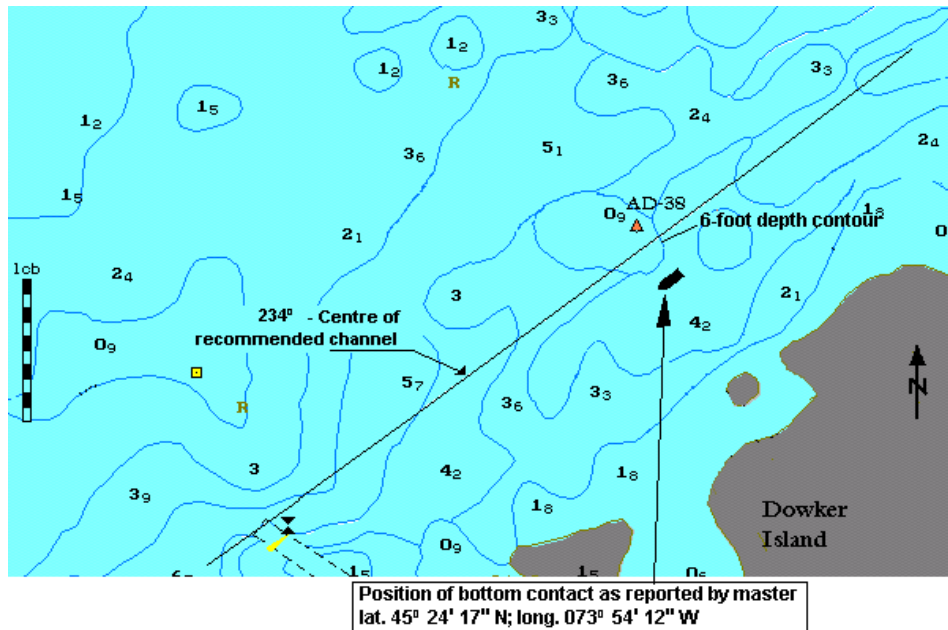
Although the master thought that he had correctly pushed the "man overboard" button on the DGPS to mark the position of the incident, no position was recorded. The master declared that he possibly did not hold the "man overboard" button down long enough for the function to register. Two days after the incident, the master reported the occurrence position to the Coast Guard Radio Station as latitude 45°24'17" N, longitude 073°54'12" W (see Figure 1) but qualified this position as "approximate" due to the numerous tasks and distractions immediately after the incident.

Both the master and mate had extensive experience in these waters, but they had never navigated in that area with water levels so low. The predetermined distances used successfully in the past by the master for passing up Lynch Channel and past buoy AD-38 have the vessel crossing the tip of a 1.83-m (6-foot) depth contour that overlaps the centre of the recommended channel, as seen in figures 1 and 2. In the past, with water levels consistently 0.9 m to 1.2 m (3 to 4 feet) above chart datum, this was not a problem. On this voyage, with the water level only 0.28 m (11 inches) above chart datum, the intended course brought the vessel in proximity to water depths of less than 2.10 m (6.9 feet).

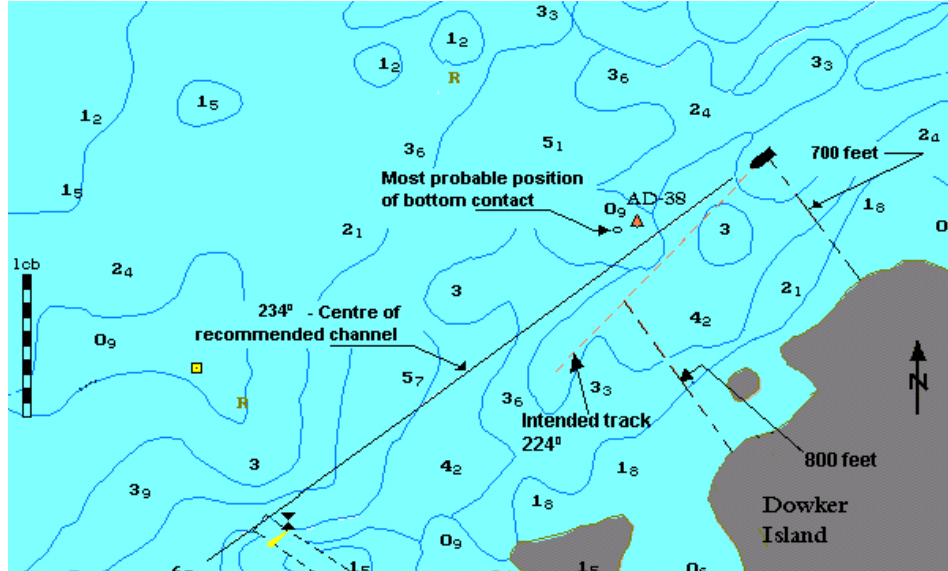
Once abeam the first point at the predetermined distance of 213 m (700 feet), the intended track would have to have been approximately 224° true in order to make the second point at the predetermined distance of 244 m (800 feet) (see Figure 2). A proper passage plan was not being executed by the navigation personnel, and the progress of the vessel was not being plotted on the chart. The vessel was being steered by DGPS and followed a path of 233° (DGPS), very nearly the 234° true that would follow the centre of the recommended channel. This would suggest that the vessel was in fact more to the northwest than the “approximate” position reported by the master.

Scarcely 30 m (100 feet) to the northwest of the “approximate” position given by the master is the 1.83 m (6-foot) depth contour mentioned earlier. The only individual sounding within this depth contour is a 0.91-m (3-foot) sounding 61 m (200 feet) to the northwest of the centre of the recommended channel. While all other depths within this contour are not known precisely, it is known that depths are less than 1.83 m (6 feet) above chart datum. At the time of the incident, the “CANADIAN EMPRESS” was drawing 1.6 m (5 feet 3 inches) aft, and the keel coolers were exceeding the hull by approximately 0.05 m (2 inches).

Given that the damaged keel coolers were covered with a clay-like substance and given the observation by a passenger of the muddied waters astern the “CANADIAN EMPRESS” subsequent to the rumbling sound heard throughout the ship, it may be concluded that the vessel made contact with the bottom. The Canadian Hydrographic Service later sounded the area around the position of the grounding as reported by the master, but no anomaly in depth was found. As illustrated in Figure 2, the vessel was most probably 61 m to 76 m (200 to 250 feet) to the northwest of the reported “approximate” position of the incident and thus inside the 1.83-m (6-foot) depth contour when contact was made with the bottom.

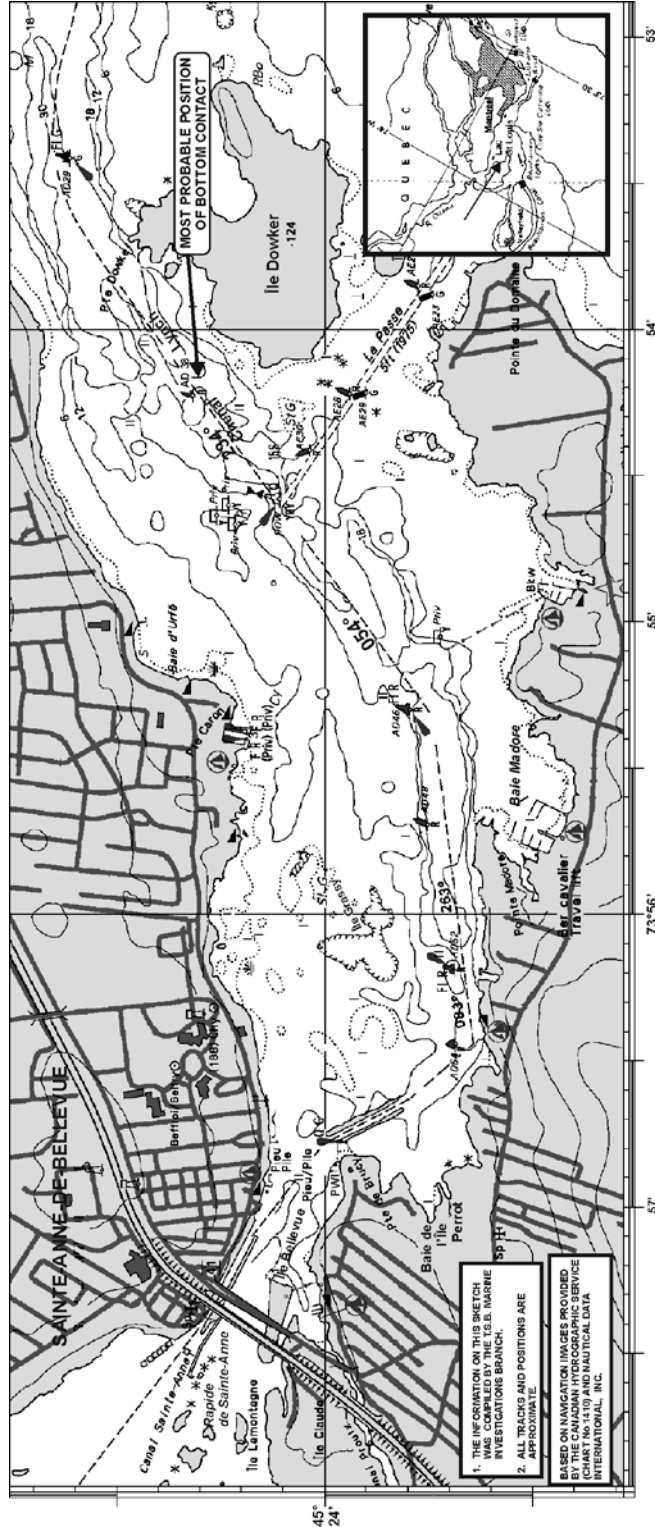
Appendix A

At approximately 0849, the master was satisfied with the ship's position abeam a small, unnamed point of land on the northwest side of Dowker Island at the predetermined distance of 213 m (700 feet). This put the vessel in the centre of the recommended navigation channel, and the master was now preparing to come abeam the next point of land on Dowker Island at 244 m (800 feet). Before 1996, the centre of the recommended channel was indicated by leading lights at Madore Point, but these lights had since been discontinued. The master and the mate had made numerous trips up and down the river in this area over the years, both before and after the leading lights at Madore Point had been discontinued. (See Appendix A.)

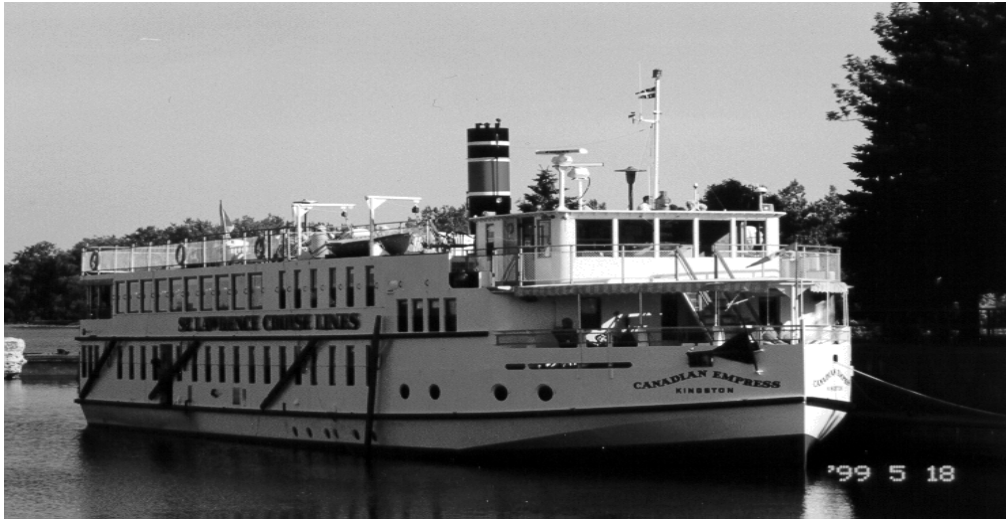
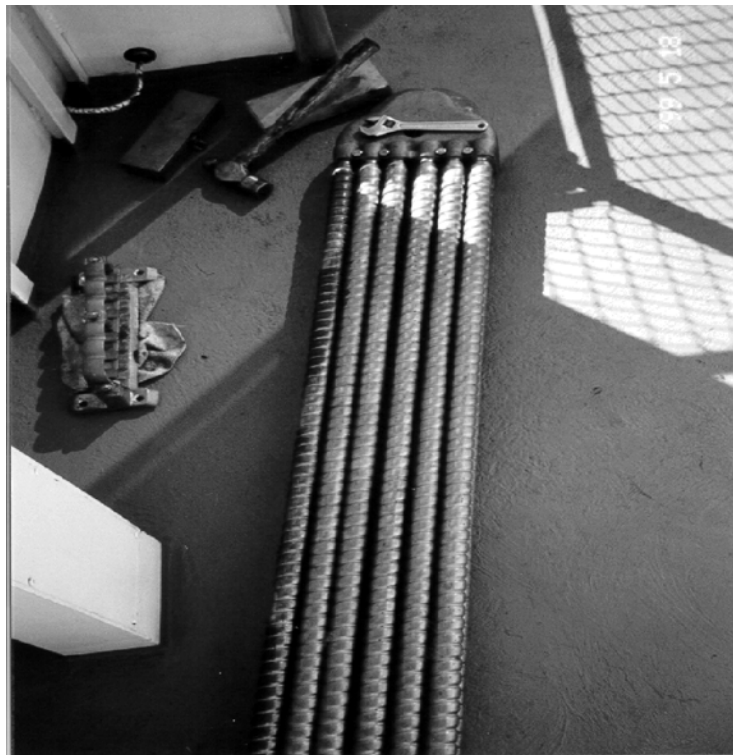
Appendix B

The underwater inspection confirmed damage to the starboard-side keel coolers. The damaged keel coolers were removed from the hull by the divers and found to be covered with a clay-like substance. A bypass arrangement in the engine room was installed that allowed cooling of the starboard-side machinery by way of the port-side keel coolers. On 14 May 1999, once the bypass was completed, the vessel continued on her voyage up the Ottawa River without incident.

9. When the damaged keel coolers were removed from the hull, they were found to be covered with a clay-like substance.
10. Both starboard keel coolers were damaged beyond repair due to bottom contact.

NEW KEEL COOLER ON (DECK)
