PIPELINE INVESTIGATION REPORT

P01H0004

CRUDE OIL PIPELINE RUPTURE

ENBRIDGE PIPELINES INC.

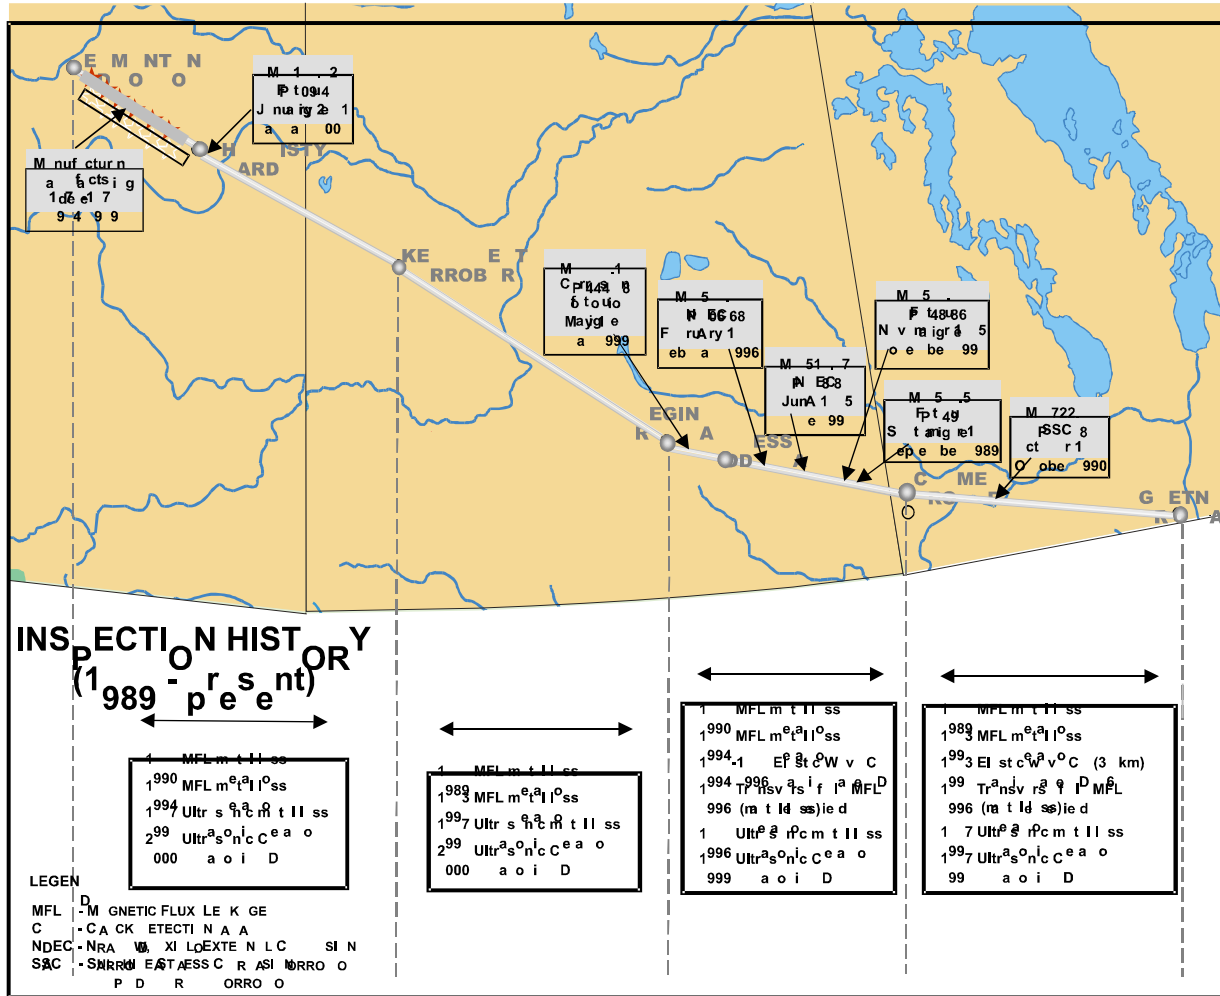
Appendix A - Long Seam Failures on Line 3/4 (864 mm)

The following long seam-related failures have occurred on the 864 mm line during its operating history:

- 1974-1979—5 ruptures between Edmonton and the Strome pump station due to manufacturing defects;
- 01 September 1989—rupture at MP 549.5 due to corrosion fatigue;
- 17 October 1990—leak at MP 722.8 due to sulphide stress cracking;
- 16 June 1995—rupture at MP 518.87 due to narrow, axial, external corrosion (NAEC) under disbonded coating (TSB report No. P95H0023);
- 13 November 1995—rupture at MP 548.86 due to fatigue cracking under disbonded coating (TSB report No. P95H0047);
- 27 February 1996—rupture at MP 506.68 due to NAEC under disbonded coating (TSB report No. P96H0008); and
- 20 May 1999—rupture at MP 444.18 due to corrosion fatigue under disbonded coating (TSB report No. P99H0021).
