**PIPELINE INVESTIGATION REPORT
P07H0014**

CRUDE OIL PIPELINE RUPTURE

**ENBRIDGE PIPELINES INC.
LINE 3, MILE POST 506.2217
NEAR GLENAVON, SASKATCHEWAN
15 APRIL 2007**

Report Number P07H0014

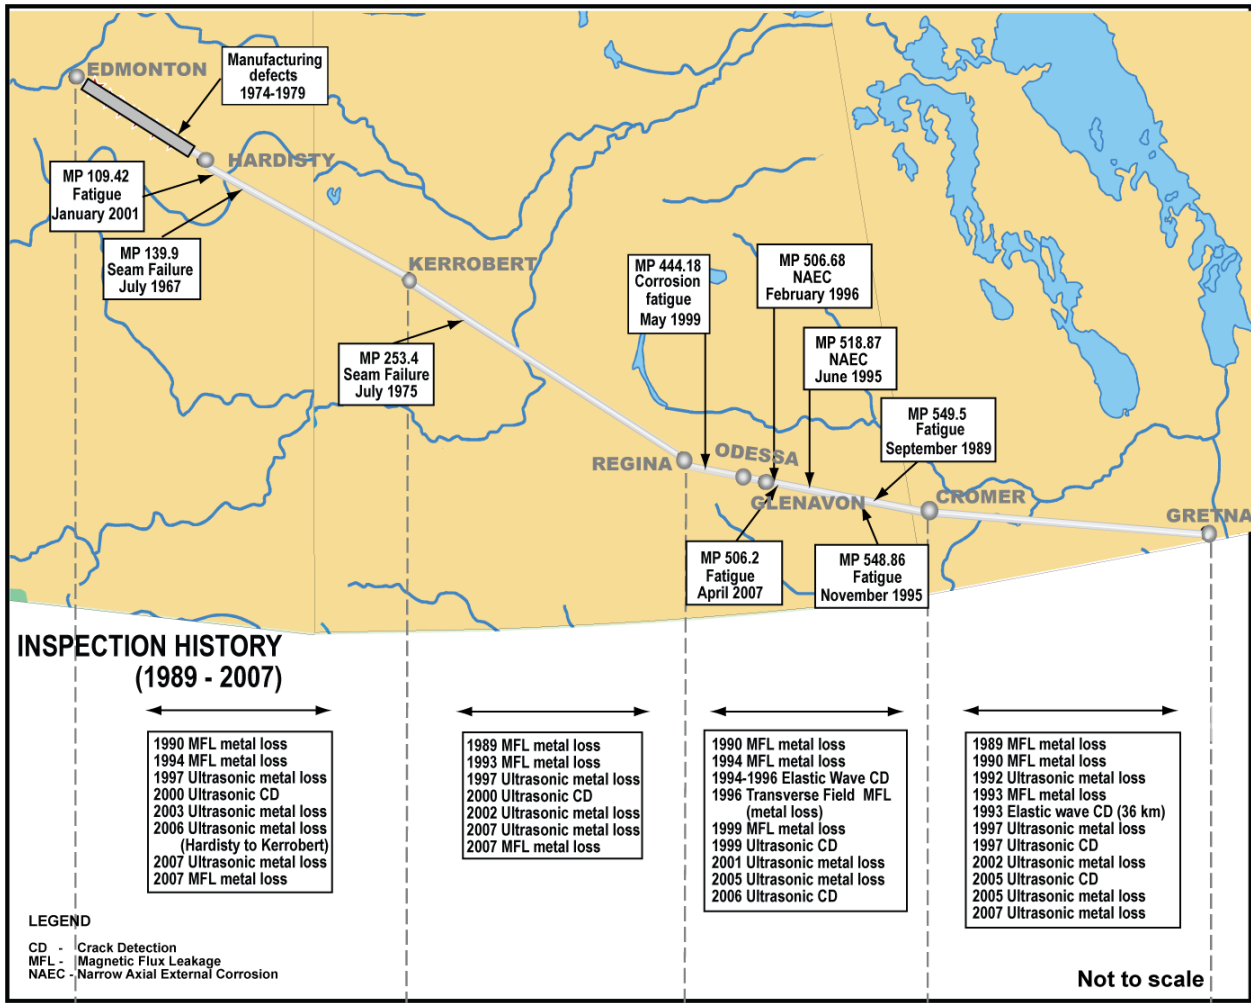
Appendix A – Long Seam Failures on Line 3

Between 1974 and 1979, five ruptures occurred due to pipe-related manufacturing defects. Two of the ruptures occurred downstream of the Edmonton terminal and three occurred downstream of the Strome pump station. Because these five failures occurred in pipe from the same pipe order (Canadian Phoenix DSAW pipe), Enbridge replaced all Canadian Phoenix DSAW pipe between 1979 and 1985 with IPSCO Inc. DSAW pipe.

In response to a rupture due to corrosion fatigue on Line 3 at Mile Post 549.5 in September 1989, Enbridge committed financial support to the development of an elastic wave tool – an internal inspection device designed to locate and size longitudinal planar defects, such as fatigue cracking, in the vicinity of the longitudinal weld. By 1996, Enbridge had internally inspected most of Line 3 between Regina and Cromer using the elastic wave tool.

Following three ruptures on Line 3 over an eight-month period, the National Energy Board (NEB) issued a directive to Enbridge in March 1996. In response, Enbridge prepared an operational reliability assessment of Line 3 between Edmonton and Gretna and implemented an action plan to address the integrity of the line. The action plan included a hydrostatic test of the line between Odessa and Cromer pump stations, operating pressure reductions, and in-line inspections (ILI) for cracking and narrow axial external corrosion.
