**PIPELINE INVESTIGATION REPORT
P12H0105**

GAS PIPELINE RUPTURE

**WESTCOAST ENERGY INC., CARRYING ON BUSINESS AS
SPECTRA ENERGY TRANSMISSION
NIG CREEK PIPELINE, KILOMETRE POST 1.93
NEAR BUICK, BRITISH COLUMBIA
28 JUNE 2012**

Report Number P12H0105

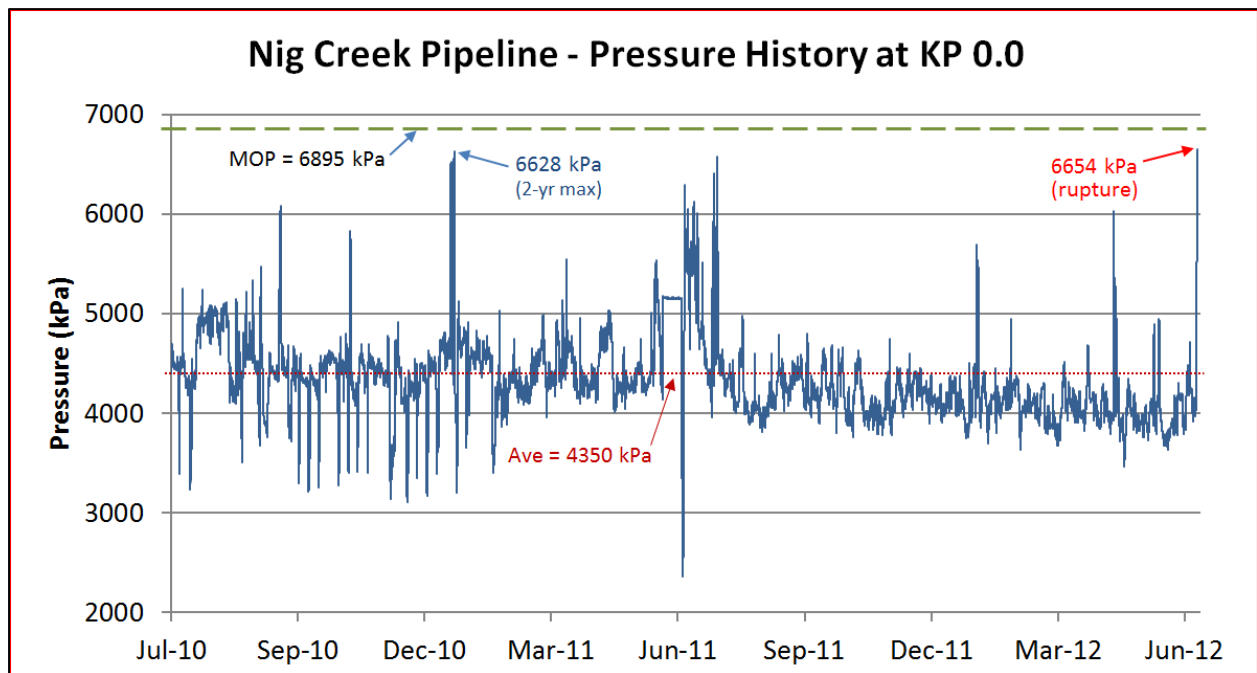
Figure 2. Nig Creek pipeline 2-year pressure history, measured at the pipeline's inlet

Over the 2 year period, the Nig Creek pipeline was operated at an average pressure of 4350 kPa. There were a few times over that period when the pipeline's operating pressure fluctuated for short periods of time, typically 24 to 48 hours. Before June 2012, the previous maximum operating pressure had been 6628 kPa, which occurred on 18 January 2011. Pressure fluctuations on this pipeline typically occur due to operating factors (for example, available supply of gas, maintenance activities and gas processing plant shutdowns).

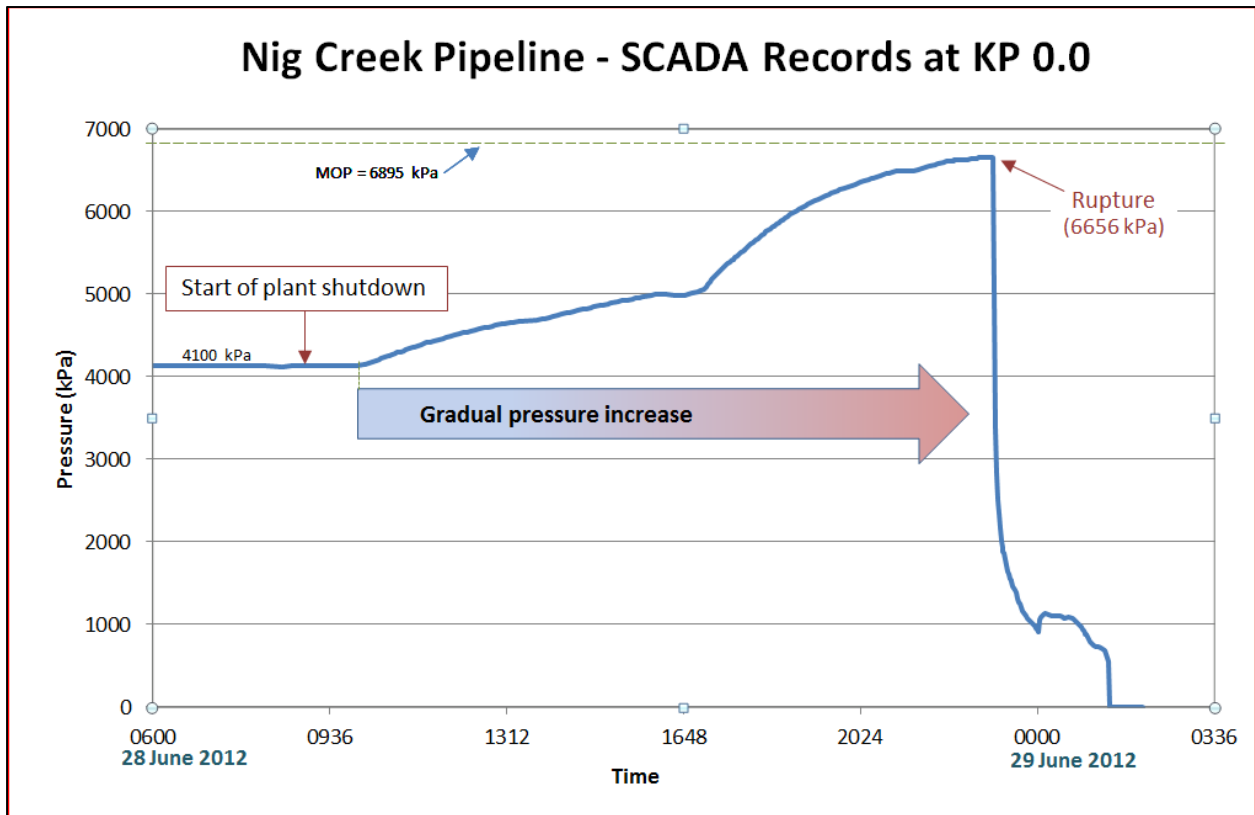
Figure 3. Pressure profile at the inlet of the Nig Creek pipeline on the day of the occurrence

On the day of the occurrence and starting from approximately 1000, there was a gradual pressure increase in the Nig Creek pipeline from 4100 kPa to 6656 kPa (see Figure 3).

The pressure increase was due to the accumulation of incoming sour gas in the Nig Creek pipeline as a consequence of the McMahon plant shutdown at approximately 0900 on 28 June 2012.

At 2305, at the time of the pipeline rupture, the pressure at KP 0.0 was 6656 kPa,⁶ which was followed by a rapid decompression to approximately 1000 kPa.

In the 14 hours (approx.) prior to the rupture, the pipeline experienced a gradual pressure increase from 4100 kPa to 6656 kPa. The pressure increase was due to the accumulating sour gas in the Nig Creek pipeline when the McMahon plant was temporarily shut down. Although the pressure increase stayed below the pipeline's authorized MOP of 6895 kPa, the elevated pressure was sufficient to rupture the pipe along the longitudinal seam starting at the location of the pre-existing hook crack. The pre-existing hook crack did not fail earlier because it had not reached a critical size in relation to the operating stresses it was subjected to during the past 5 decades of operation. While the crack growth mechanism could not be confirmed, it is likely that the hook crack was the initiating crack, which had been growing over an undetermined period of time.

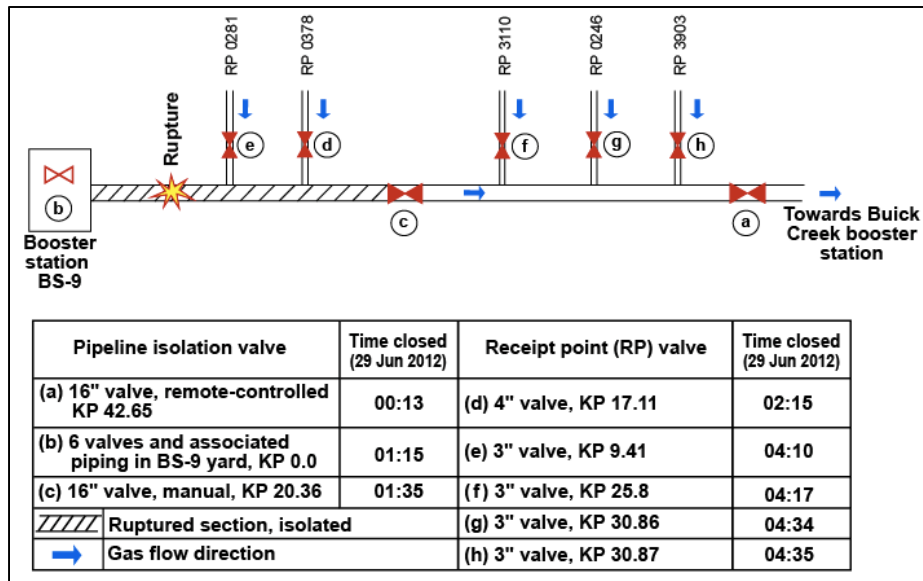
Figure 4. Westcoast's response to rupture on the Nig Creek pipeline

- At 0115, a series of gas isolation valves located at KP 0.0 in the Nig Creek Pipeline's BS-9 yard were closed by Westcoast personnel, isolating the Nig Creek pipeline upstream of the rupture (see (b) on Figure 4).

- At 0135, the manually operated pipeline isolation valve at KP 20.36 on the Nig Creek pipeline was closed by Westcoast personnel (see (c) on Figure 4). This further isolated the Nig Creek pipeline downstream of the rupture.

- At 0410, the isolation valve at the KP 9.41 receipt point on the Nig Creek pipeline was closed by Westcoast personnel (see (e) on Figure 4). This completed the isolation of the ruptured section of the Nig Creek pipeline.

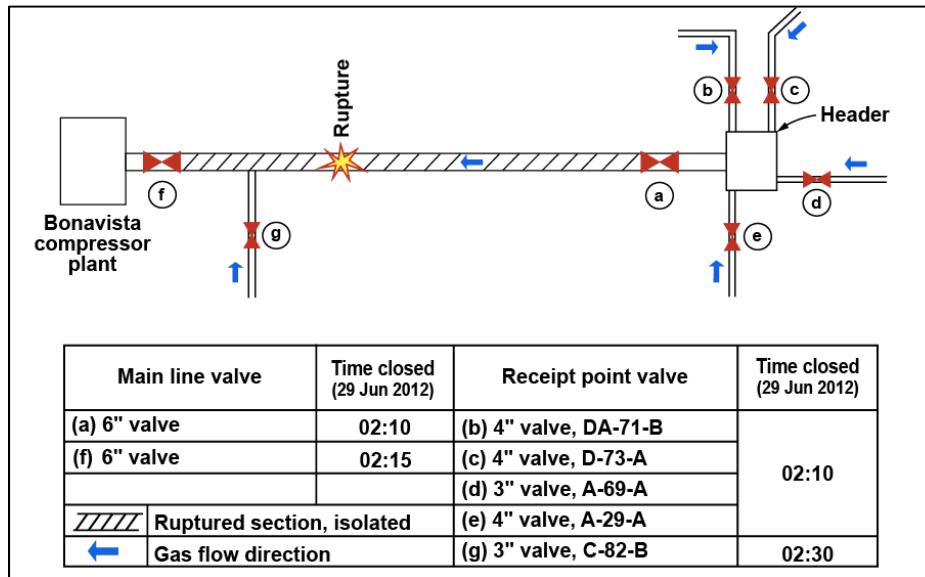
Figure 5. Bonavista's response to rupture on its pipeline

- At 0210, the Bonavista main line valve near the header at the upstream end of the Bonavista pipeline segment was closed by Bonavista personnel (see (a) on Figure 5). Furthermore, the 4 receipt points⁷ in the header area were closed (see (b), (c), (d) and (e) on Figure 5). This isolated the Bonavista pipeline upstream of the rupture.

- At 0230, the isolation valve at the Bonavista receipt point "C-82-B" was closed by Bonavista personnel (see (g) on Figure 5). This completed the isolation of the ruptured section of the Bonavista pipeline.

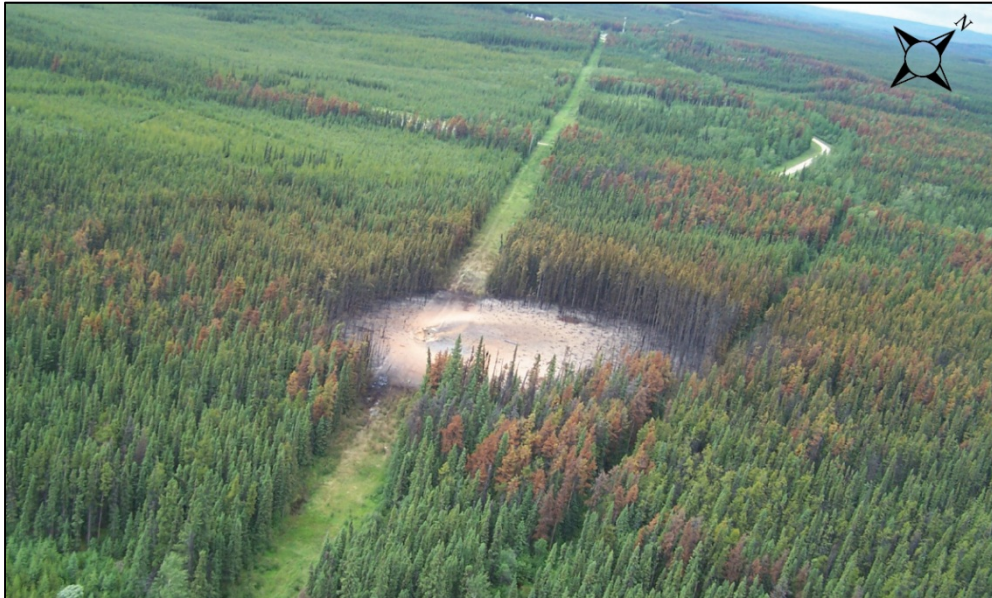
Photo 1. Aerial view of the occurrence site

- Approximately 1.6 hectares was burned (see Photo 1).

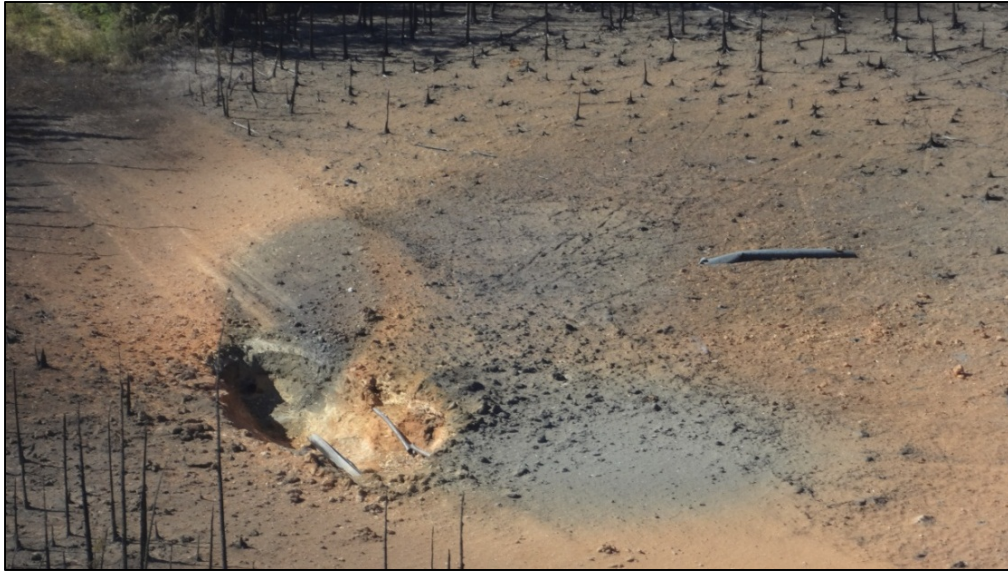
Photo 2. Crater and ejected section of pipe at occurrence site

- A large crater (that is, 17 m long, 7.6 m wide and 1.1 m deep) was formed. A 6 m-long piece of pipe had separated from the Nig Creek pipeline and was ejected approximately 20 m to the northeast along with other debris (see Photo 2).
- The remaining damaged section of the Nig Creek pipe, as well as the entire damaged section of the Bonavista pipe, was found within the crater.
- No ground water was present.

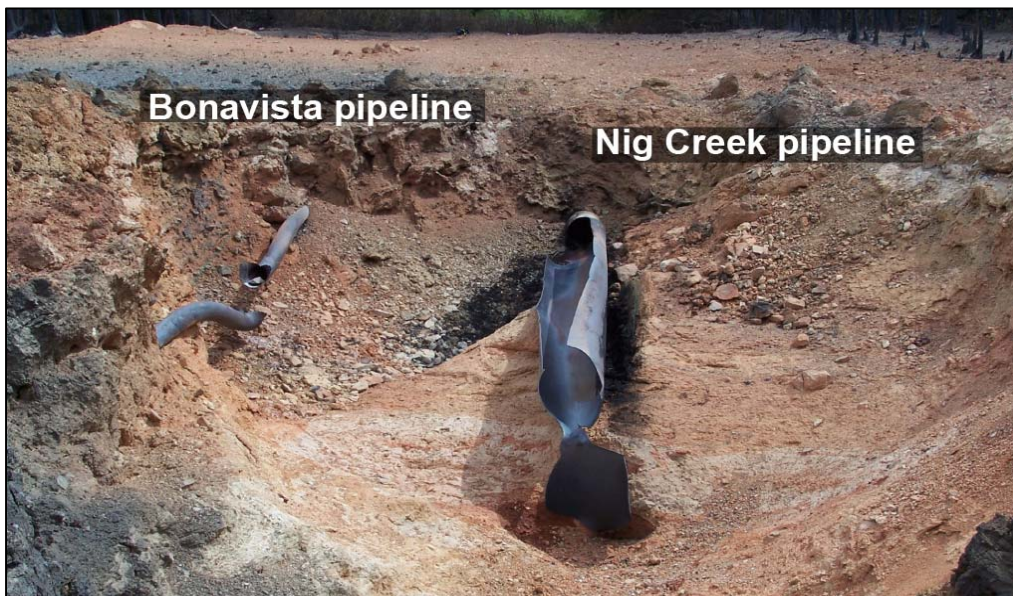
Photo 3. Bonavista pipeline and Nig Creek pipeline in the crater

Within the crater, the exterior coating of the Nig Creek pipeline (that is, asphalt enamel) and the exterior coating of the Bonavista pipeline (that is, extruded polyethylene) were completely destroyed by the fire (see Photo 3).

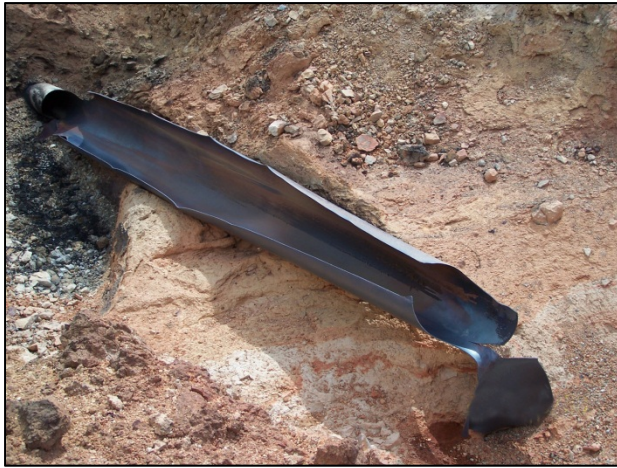
Photo 4. Failed section of the Westcoast Nig Creek pipeline

- Approximately 17 m of the Nig Creek pipeline and 9 m of the Bonavista pipeline were damaged during the pipeline ruptures and resulting fire.
- The Nig Creek pipeline had ruptured along its longitudinal seam weld (see Photo 4).

The Nig Creek pipeline ruptured at KP 1.93 when the load-bearing capacity of the pipe was reduced due to a pre-existing hook crack along the electric resistance welded longitudinal seam, which grew by a time-dependent mechanism and led to the explosion and fire.

- On 14 July 2012, the Nig Creek pipeline and the Bonavista pipeline were repaired by welding in place pre-tested sections of pipe. The crater at the site was then backfilled with soil.
- On 15 July 2012, the Bonavista pipeline was returned to normal service.
- On 21 September 2012, following a successful hydrostatic test of the entire pipeline at a minimum test pressure of 125% MOP, the Nig Creek pipeline was returned to normal service.

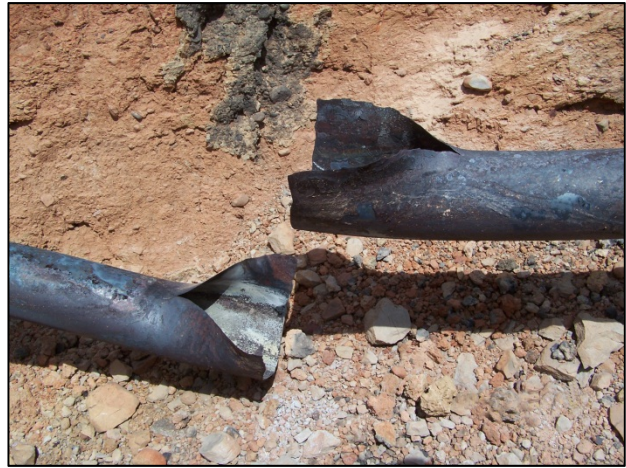
Photo 5. Failed Bonavista pipeline

- The Bonavista pipeline's rupture exhibited a thin-lipped "fish mouth" feature, which is characteristic of a pipe failure due to overheating (see Photo 5).

- The rupture of the Bonavista pipeline was the result of overheating due to fire impingement, which had lowered its yield strength, reducing its ability to withstand the internal pressure.

4. The Bonavista pipeline overheated locally due to the pipeline cover being removed by the explosion of the Nig Creek pipeline and the ensuing fire. The heat lowered the Bonavista pipe's strength and reduced its ability to withstand the internal pressure, leading to local swelling of the pipe and yielding of the steel until rupture.

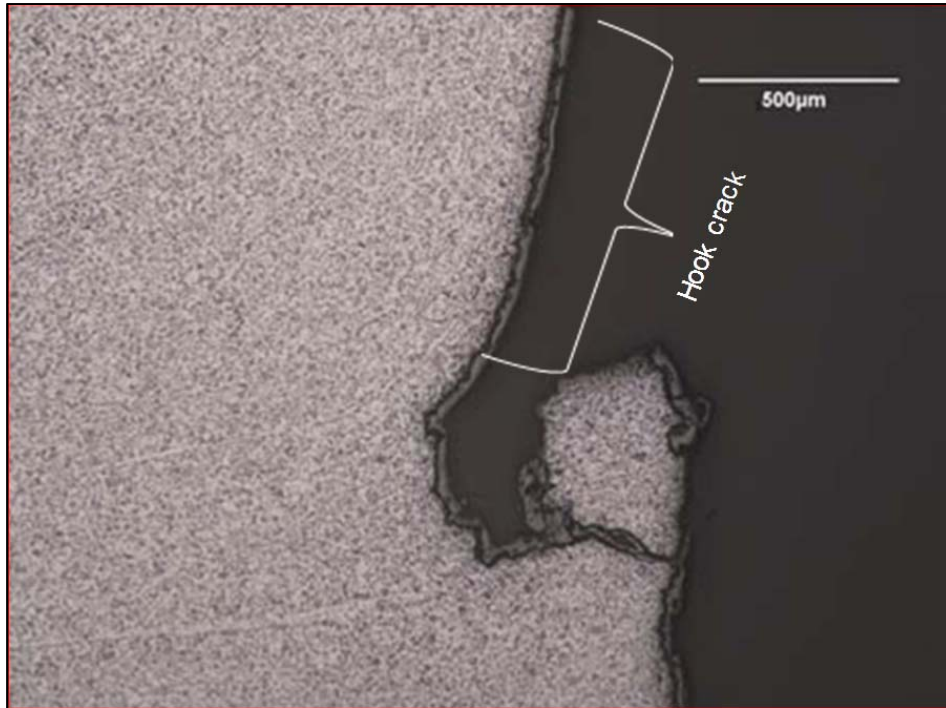
Photo 6. Hook crack

- The pipeline rupture was the result of a pre-existing hook crack ⁹ that caused a fracture along the electric resistance welded longitudinal seam of a pipe joint (see Photo 6).

- The rupture likely initiated in the downstream section and propagated to the ejected pipe section.
- The hook cracks had been created in the original electric resistance weld when the pipe was manufactured.
- It was not possible to identify a growth mechanism for the hook crack.
- The external coating on the ejected pipe was missing as a result of fire damage.
- The external coating on the upstream and downstream pipe sections, which were outside the fire zone, as well as some partially melted coating closer to the fire, exhibited good adhesion to the pipe.
- Visual examination and magnetic particle inspection of the pipe sections found no evidence of mechanical damage.
- There was no evidence of environmental or service-related degradation (for example, corrosion, thinning or environmental cracking).

In this occurrence, the pre-existing hook crack remained undetected after surviving a pneumatic test in 1960 and multiple hydrostatic tests in 1961. The successful hydrostatic tests in 1961 were not sufficient to address the development of a time-dependent growth mechanism associated with the original longitudinal seam defects that might later threaten the integrity of the pipeline while in operation.

1. A hydrostatic test at a minimum test pressure of 125% of maximum operating pressure was conducted in August 2012 on the entire Nig Creek pipeline. There were no pipe failures during the hydrostatic test.
2. In October 2012, the Nig Creek pipeline's ongoing monitoring and verification plan for the pipeline's fitness for service was filed with the NEB.
3. Additional metallurgical analysis of other pipe removed from the Nig Creek pipeline during the return-to-service hydrostatic test was commissioned.
4. An axial flaw detection in-line inspection of the Nig Creek pipeline is scheduled for May 2013.
