RAILWAY INVESTIGATION REPORT

R00C0159

ATHABASCA NORTHERN RAILWAY LTD.

MILE 138.07, WATERWAYS SUBDIVISION

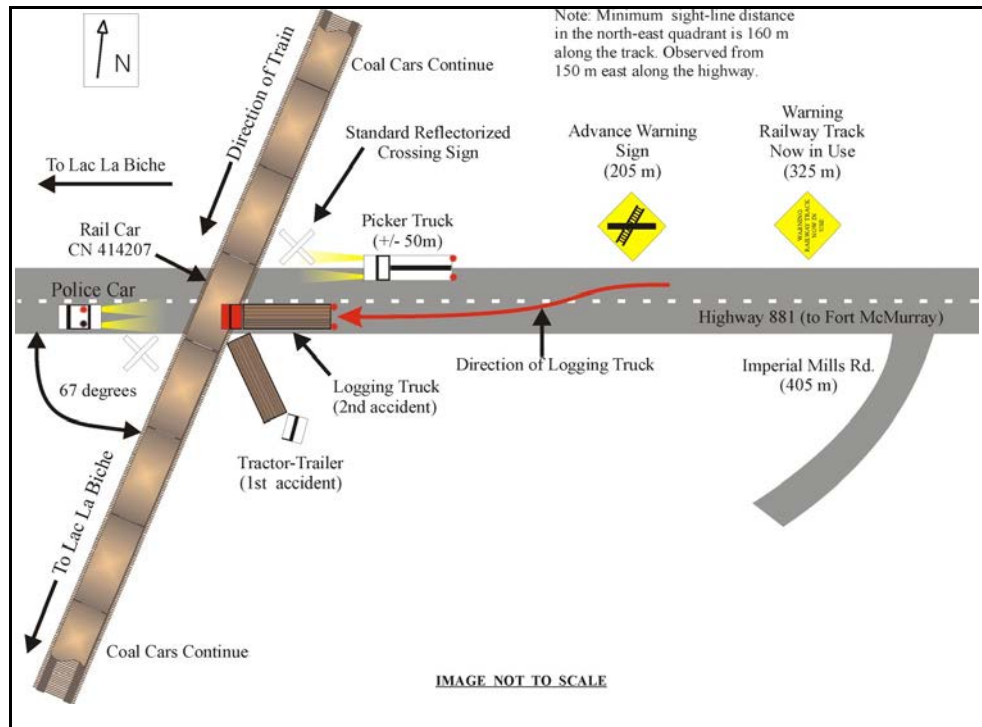
Sight-line distances for westward vehicles located 150 m from the crossing provided a view of approaching southward trains 160 m from the crossing. The view of the standard reflectorized crossing signs (crossbucks) was partially blocked by the position of the picker truck. The angle at which the crossing intersected the roadway was 67 degrees, and the track and highway are both tangent. The roadway approach grades to the crossing were level (see Figure 1).

The sight-line in the north-east quadrant of the crossing at Mile 138.07 would not meet the standards for trucks set out in Transport Canada's draft *Road/Railway Grade Crossings—Technical Standard and Inspection, Testing, and Maintenance Requirements*. The actual SSD was 149 m, compared to the recommended 210 m for trucks travelling up to 80 km/h. Further, the speed limit has now been increased on Highway 881 to 100 km/h, which corresponds to a recommended 330 m SSD for trucks in Transport Canada's draft *Road/Railway Grade Crossings—Technical Standard and Inspection, Testing, and Maintenance Requirements* and 200 m in Alberta Infrastructure's *Highway Geometric Design Guide*. The SSD standards contained in the *Highway Geometric Design Guide* adopted by Alberta in 1999 still do not differentiate between the varying stopping abilities of passenger vehicles and trucks and may lead to a lower level of safety at highway/railway interface points with passive warnings in that province.
