RAILWAY INVESTIGATION REPORT
R00M0007

COLLISION AND DERAILMENT

VIA RAIL CANADA INC.
PASSENGER TRAIN NO. 14
MILE 65.1, NEWCASTLE SUBDIVISION
MIRAMICHI, NEW BRUNSWICK
30 JANUARY 2000

Report Number R00M0007

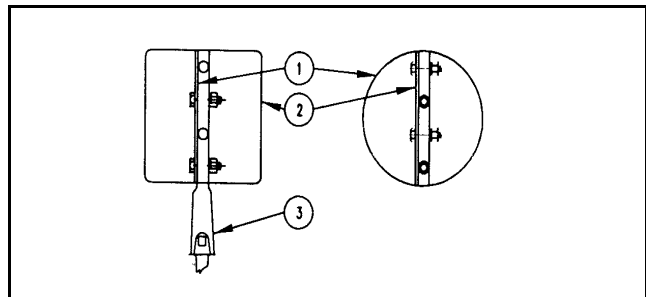
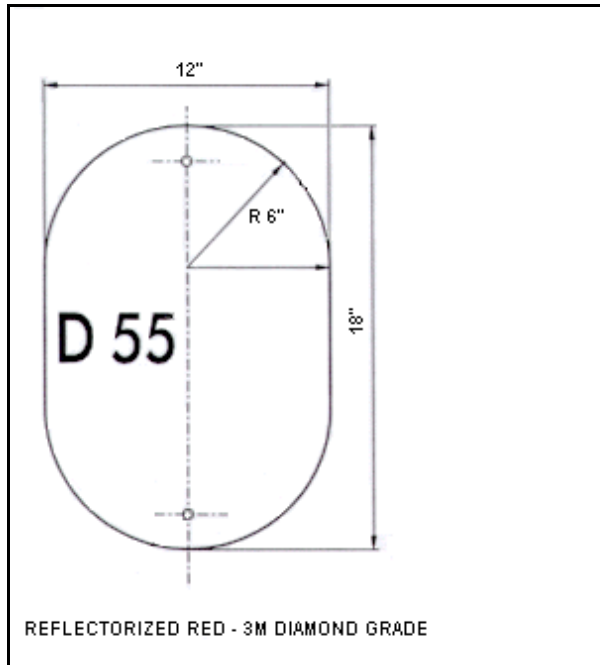
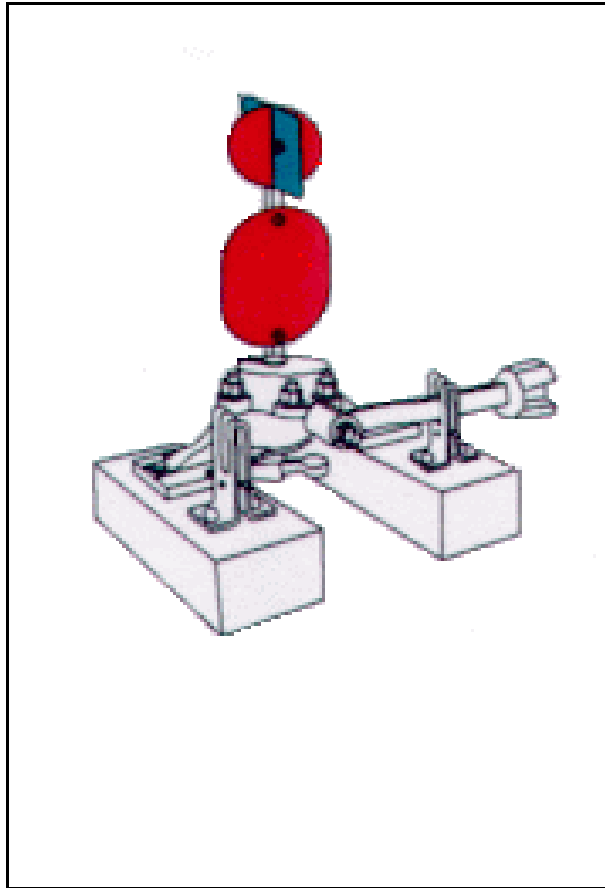
The switch stand for the main track crossover switch at Mile 65.1 was a 36-D low, rigid type that was patented in 1933 (see figures 4, 5, and 6). This type of lower profile switch stand is used in main track installations when it is necessary to place a switch stand between adjacent tracks where clearances are reduced. NBEC followed the CN Engineering (Maintenance-of-Way) *Manual of Standard Practice Circulars* (SPC) dated 1994, and

CN *Standard Plans*, dated 1996, as its maintenance standards for track-related activities. According to that standard, a 36-D low, rigid switch stand must be equipped with a mast extension approximately 25 inches high to which a D 55 switch target, 12 inches wide and 18 inches high, is attached. In Occupancy Control System (OCS) main track territory, it must be topped with a tip assembly consisting of a tip mast, approximately eight inches high, to which a red reflectorized eight-inch disk and a green reflectorized eight-inch square are attached.

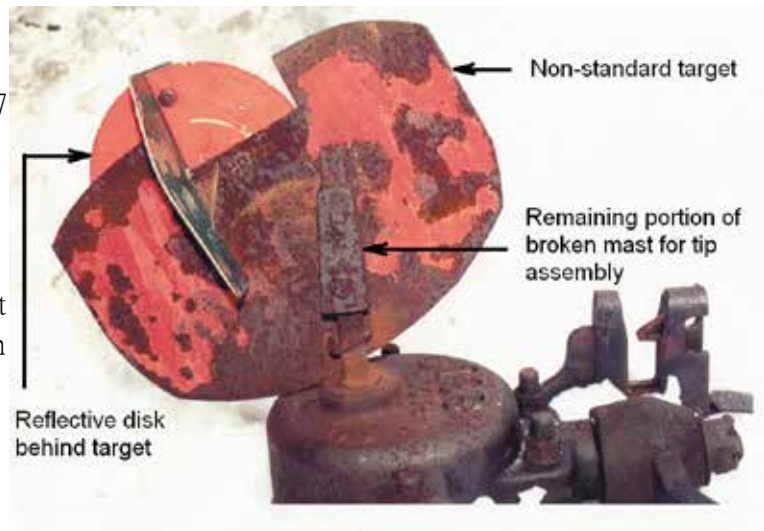
Photo 3 shows the condition of the target and tip assembly for the main track crossover switch at Mile 65.1 as found immediately after the accident. Examination of the mast extension, tip assembly, and target revealed the following:

The mast extension was 12 inches in length, not 25 inches as stipulated in the SPC. It was fractured in two pieces, one 7 inches long, the other 5 inches long. Construction was of forged steel with a cross-section measuring about $\frac{3}{4}$ inch square and about eight inches long with an integral one-inch-square socket and set screw. It conformed to a CN specification for a part to be used in a target tip assembly for forged switch masts, and was not designed for use with a large switch target. It was not painted black to SPC specifications, and was completely rusted, including the fracture surfaces. It was equipped with four bolt holes to permit the fastening of the tip targets directly to it by nuts and bolts.

The tip assembly was equipped with reflectorized material showing red on an eight-inch disk and green on an eight-inch square. Each piece was secured to the top of the mast extension by one bolt each, rather than by the standard CN specification of two each.

The red and green tip assembly attached to the larger broken piece of the mast extension was rotated 180 degrees and jammed down onto the red target, partially obscuring the red reflective surface of the upper tip assembly in the direction of travel of the approaching VIA train.

A red-painted sheet steel switch target, 10 inches high by 15 inches wide, was below the tip. It was of a slightly irregular shape and was loosely attached to the $\frac{7}{8}$ -inch-square vertical shaft (spindle) by a U-bolt. The set screw in the smaller broken mast fragment was used to hold the larger red target down on the spindle. Witness marks from rotational movement of the target against the tip mast were evident on the face of the painted red surface of the target.

- **Large Red Target:** This target was badly rusted to the point where only 20 per cent of the red paint remained on its rear face and about 25 per cent on its front face. This target also displayed numerous small, circular impact marks consistent with bullet impacts.

- **Red and Green Tip Assembly:** The top of this target was originally about 16 inches above the level of the adjacent track rail crown. After the fracture and temporary replacement, the top of the target was lowered another 3.5 inches over the circular red target.

- There were 13 small, circular-type spall impact marks on the rear face of the green plate, consistent with bullet impact marks. The front face of the target had also been hit once about one inch from the top by what appeared to be a large-calibre bullet which penetrated and tore out the plate to the edge. On penetrating, the bullet nicked the thread of the bolt beyond its penetration hole.

- It was concluded that the switch target and tip assembly provided were:
 - a) in a deteriorated and rusty condition for some time;
 - b) lower in height than desirable for optimum visibility in winter with banked snow alongside the tracks;

- c) broken off by a rifle shot, fracturing the support shaft, and temporarily repaired, thereby lowering the top targets 3.5 inches and partially obscuring the normal visibility of the circular, red target.

NBEC surveyed all main track switch targets and implemented a plan to repair and/or replace any that were in less-than-standard condition. All main track switches are now equipped with a regular-type switch stand mast with an elevated large target meeting the new CN specifications (diamond-grade material). Highly reflective material was added to all main track switch targets to increase their visibility, particularly in nighttime conditions. Improvements were also made to inspection procedures to ensure monthly focus on switch components on turnout inspection forms through the introduction of a switch inspection job aid (that is, switch stand mast, target, and tip assembly) to be used in addition to the standard turnout inspection forms.

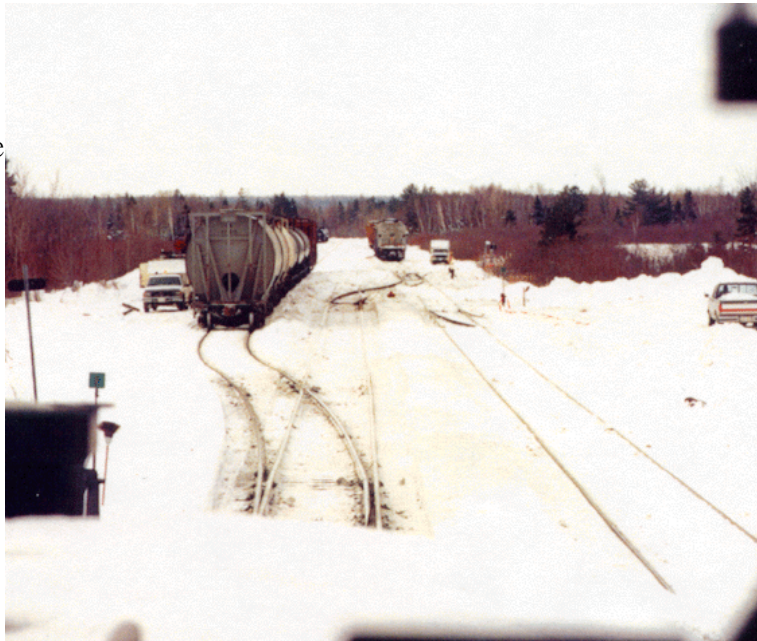
The colour and geometry of the non-standard target could first be seen from approximately 300 feet. At about 500 feet, the target was seen as black in colour and of no discernable geometry.

The colour and geometry of a standard switch arrangement in good condition could be seen from slightly less than 900 feet in the conditions that existed at the site.
