RAILWAY INVESTIGATION REPORT

R01M0061

CROSSING ACCIDENT AND DERAILMENT

MILE 178.67, NAPADOGAN SUBDIVISION

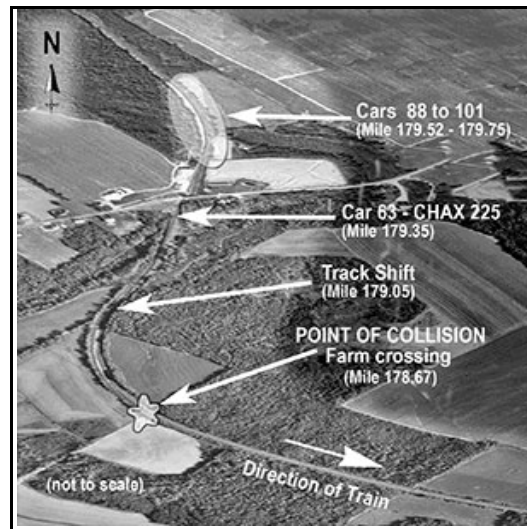
A subsequent inspection of train 306 determined that the 63rd car, and the 88th car to the 101st car from the head-end, derailed (see Photo 1). Fresh marks were visible on striker castings and coupler horns on many cars throughout the train.

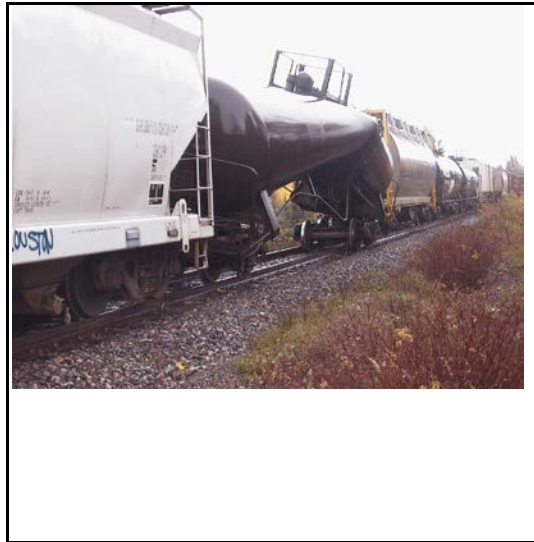
The 63rd car, CHAX 225, a class 111A tank car, buckled upwards and derailed the B-end⁴ at Mile 179.35 (see Photo 2). The tank car was empty and located between loaded hopper cars. Samples from the car were sent to the TSB Engineering Laboratory for analysis (report LP 102/01); the examination did not reveal any significant reduction in the car's strength. According to Association of American Railroads (AAR) design standards, tank cars must withstand a minimum longitudinal force of 1 000 000 pounds.⁵

For instance, train 306 was a long train marshalled with most of the weight in the tail-end. At the time of the accident, train 306 was negotiating an ascending grade, and was, therefore, fully-stretched; as the emergency brake was applied from the locomotive, a run-in occurred, and high buff forces were generated. Although the track met CN's *Standard Practice Circulars* and TC's *Railway Track Safety Rules*, the action of the buff forces on the 88th to the 101st cars, where several long/long, long/short car combinations were located on curved track, generated high lateral forces that exceeded the resistance of the track structure, causing gauge widening, rail rollover, and the derailment of the cars. Furthermore, the buff forces generated compressive stresses that exceeded the design specifications of the 63rd car, an empty tank car located between loaded cars, causing the tank car to derail and buckle.

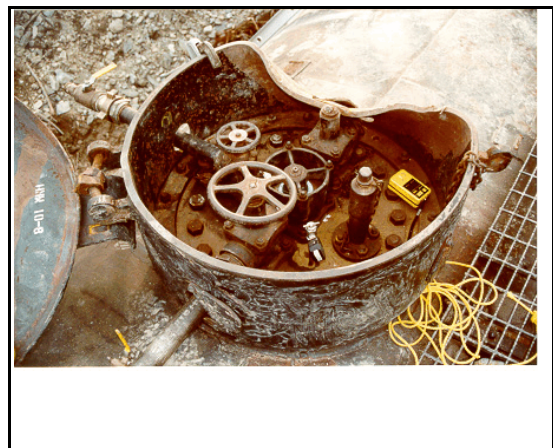
The 95th car, CITX 4240, a class 112 pressure tank car, came to rest on its side, striking the underframe of the 94th car. The protective housing was bent, damaging the liquid reduction valve (see Photo 3) and causing a release of butane.

In this occurrence, the liquid eduction valve was damaged, causing product to leak when tank car CITX 4240 overturned while train 306 was travelling at 27 mph. This type of damage also occurs in yard accidents where the speed is relatively low, as was observed on tank cars involved in the yard derailments at Macmillan Yard and Red Deer (TSB Report No. R98T0292 and Report No. R01E0009). Following these derailments, Transport Canada (TC) indicated that issues relating to design requirements applicable to top fitting protection would be examined when the standards were reviewed. In August 2002, new dangerous goods containment standards were issued; however, the requirement for rollover or skid protection for top fittings was not improved. Therefore, the shortcomings identified in the protection of top fittings remain unaddressed and will continue to present a risk to the public and the environment.

3. As there is no requirement for rollover or skid protection for top fittings on pressure tank cars, damage to the top protective housing and fittings will continue to occur even in accidents where the speed is relatively low.

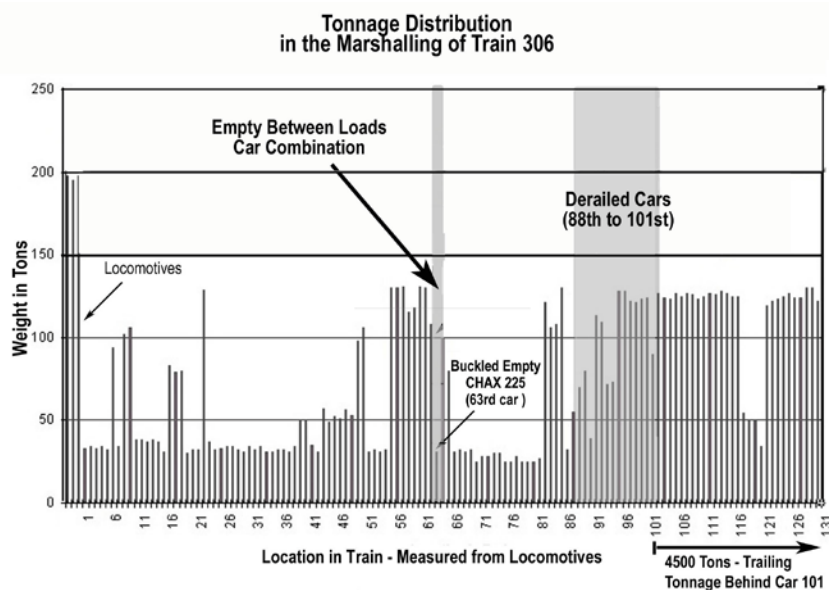
Most of the loaded cars on train 306 were located in the tail-end portion of the train (see Figure 2). There were several long-long and long-short car combinations in the consist (see Figure 3). Ten of the cars were equipped with EOCCDs. Train 306 passed by a wayside information system at Mile 200.5; no defects were noted.

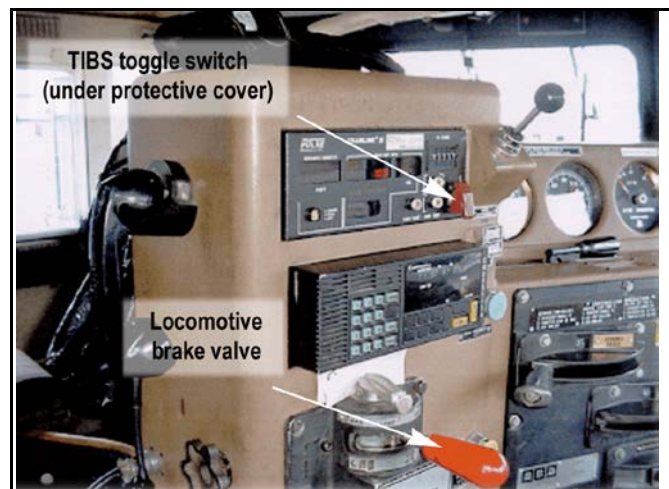
Even though CN has a directive requiring locomotive engineers to initiate end-of-train braking in emergencies by actuating the toggle switch on the control stand in order to reduce in-train forces, the toggle switch was not actuated in this occurrence. During emergency brake activation, a locomotive engineer must quickly respond and perform a sequence of actions under pressure. To ensure that all motor components of the emergency procedure are reliably triggered, the response sequence must be overlearned¹⁵ (i.e., it becomes, through repetitive practice, an automatic process, thereby requiring less attention and making emergency responses more resistant to stress and interference by other tasks). If the emergency braking procedure is not overlearned, it is not performed consistently from both ends of the train, resulting in higher in-train buff forces and a greater risk of derailment.

Canadian National (CN) has initiated a program to equip its operating fleet of approximately 1600 road locomotives with an end-of-train system that automatically initiates synchronous braking from both the locomotive and the tail-end during emergency and service applications.
