RAILWAY INVESTIGATION REPORT

R02C0050

DERAILMENT

CANADIAN NATIONAL

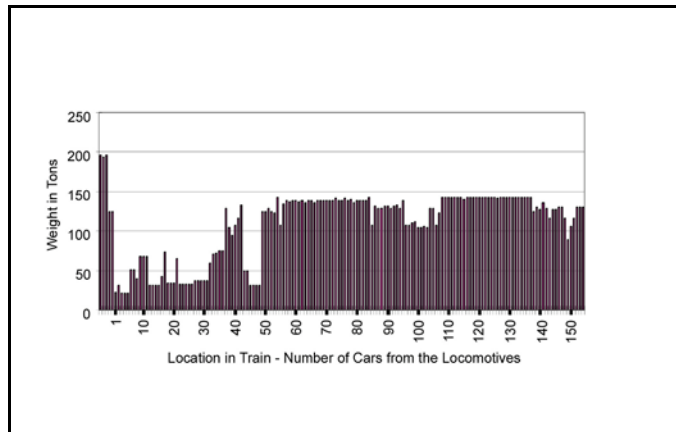
On 08 July 2003, train 442 had empty and lightly loaded cars totalling 2480 tons immediately behind the locomotive consist and ahead of loaded cars totalling 13 885 tons (see Figure 5).
