RAILWAY INVESTIGATION REPORT

R03T0026

YARD COLLISION

CANADIAN PACIFIC RAILWAY

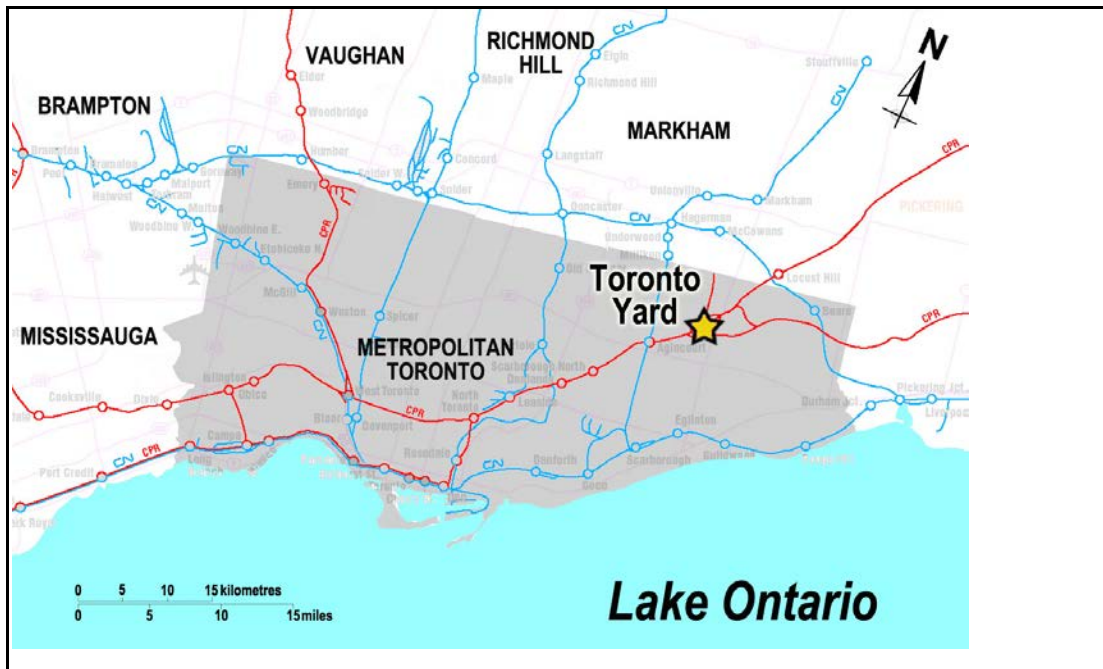
On 21 January 2003, at approximately 0717 eastern standard time (EST),¹ car HOKX 111044, a residue tank car last containing sodium hydroxide – caustic soda (UN 1824) – was released from the hump at Canadian Pacific Railway's (CPR's) Toronto Yard (see Figure 1). This tank car was to be marshalled with other rail cars in classification track C-34. The ambient air temperature was -19°C. The weather was clear and the winds were calm.

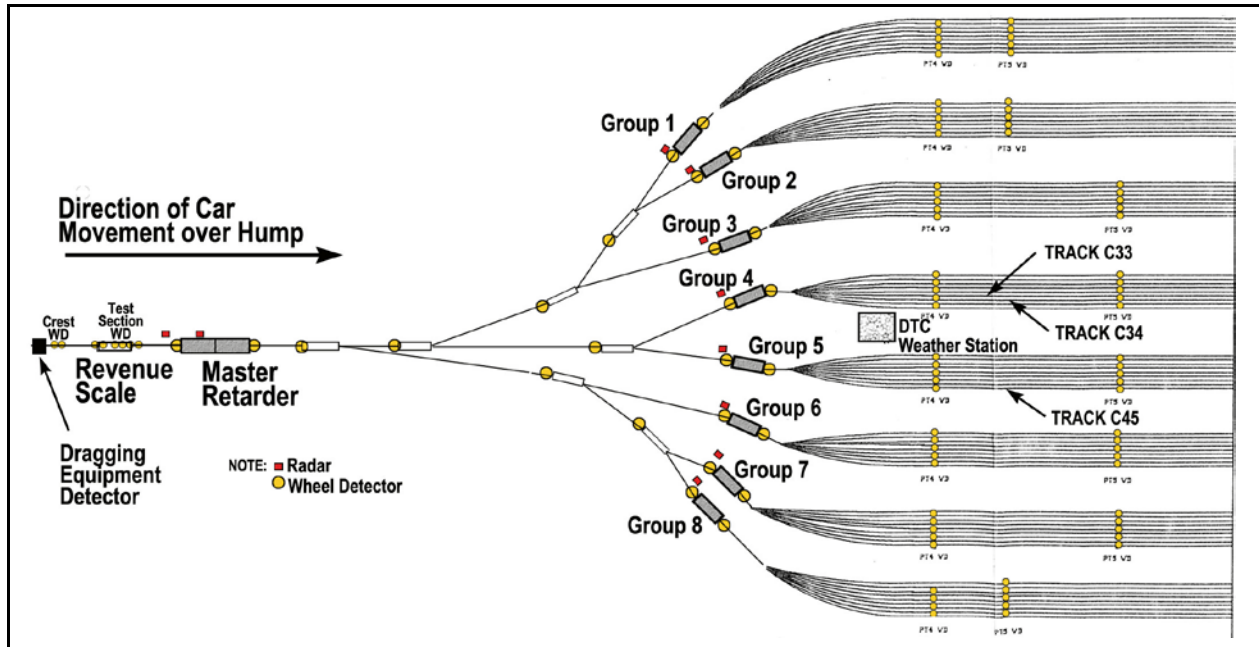
Arriving trains are routed into a receiving yard where locomotives are removed for servicing. Strings of inbound rail cars are then pulled from the receiving yard and uncoupled manually. To assist with assembling outbound trains in Toronto Yard, computer systems and specialized yard track equipment have been installed to allow the railway to automatically sort rail cars by their destination. Loaded and empty rail cars are sent over the hump and then routed to their designated classification track. The average daily capacity at Toronto Yard, which has a single hump, is approximately 1300 rail cars. Toronto Yard has 72 classification tracks that are divided into eight groups of nine tracks each (see Figure 2). Once the outbound rail cars have been humped, strings of sorted rail cars are pulled out of the classification tracks and are moved to the departure yard. At the departure yard, the outbound train is assembled with serviced locomotives.
