RAILWAY INVESTIGATION REPORT

R03T0064

DERAILMENT

Canadian Pacific Railway
Freight Train No. 938-12
Mile 39.5, Parry Sound Subdivision
Nobel, Ontario
13 February 2003

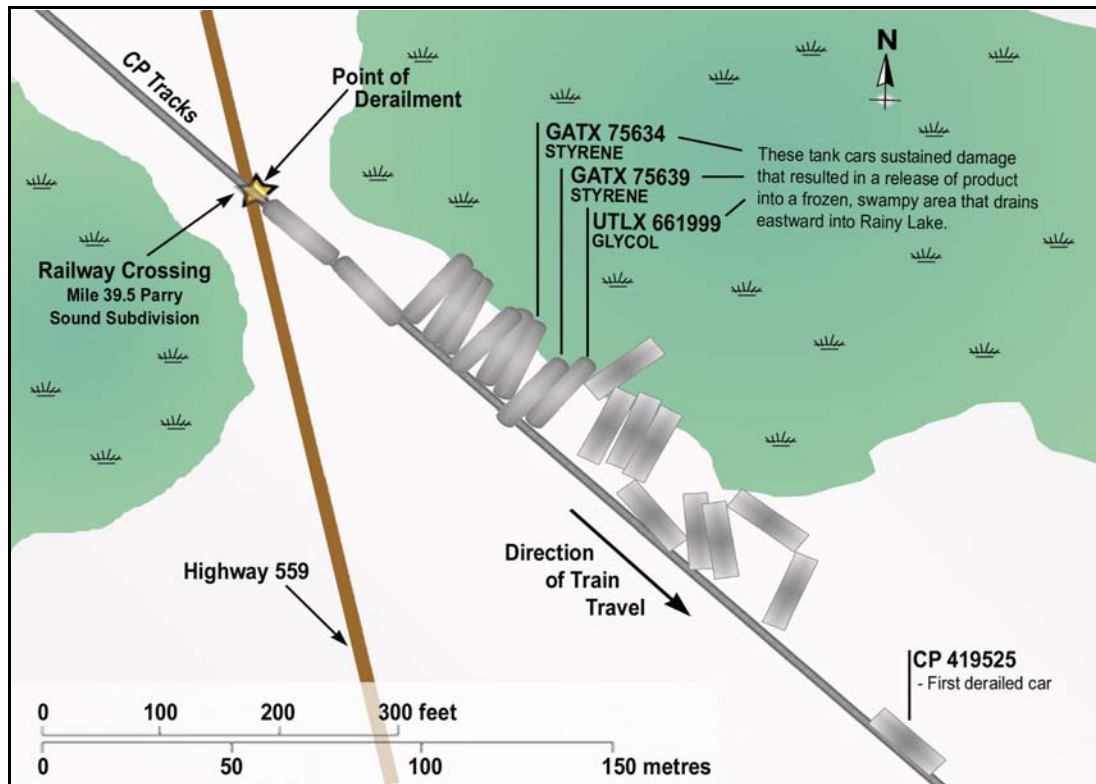
Figure 2. Derailment site sketch

The first derailed car was CP 419525, a flat car loaded with freight car wheel sets. This car, still attached to the front portion of the train, was upright with all wheels derailed. The following 20 derailed cars were separated from the front portion of the train by a gap of approximately 500 feet (150 m). Eighteen of these cars came to rest in various positions east of the track and immediately south of the Highway 559 public crossing at Mile 39.5 (see Figure 2). Approximately 430 feet (130 m) of track was damaged.

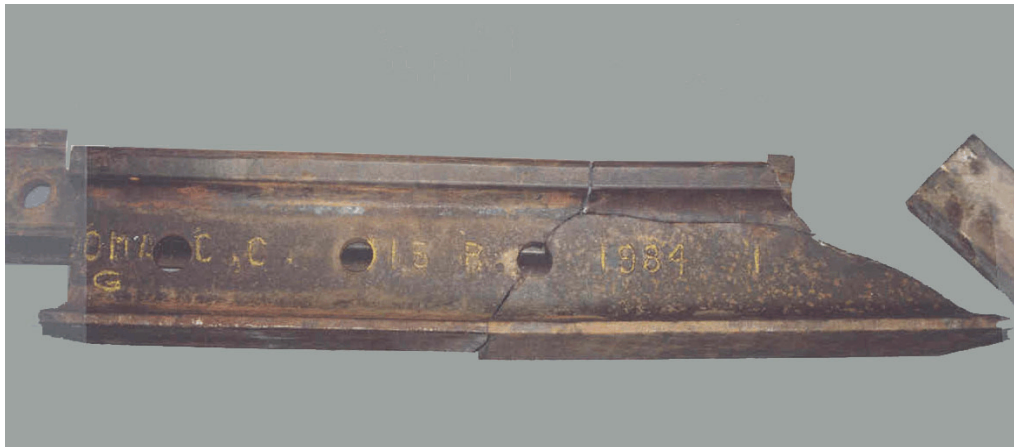
Photo 1. Reconstructed rail from suspected POD

1. The first rail piece contained the rail end, two complete bolt holes, and a portion of the third in its web. It measured 17 inches along the head and 14 inches along the base.
2. The second rail piece contained the remaining portion of the third bolt hole, measured 17 inches along the base, and was missing its rail head. The rail web fracture surface was damaged from wheel impacts resulting from wheel drop off.
3. The third piece was a seven-inch section of rail head that had separated from the web of the second piece and mated perfectly to the south-end rail head of the first piece. The third piece displayed fracture surfaces with brittle characteristics typical of catastrophic failure.

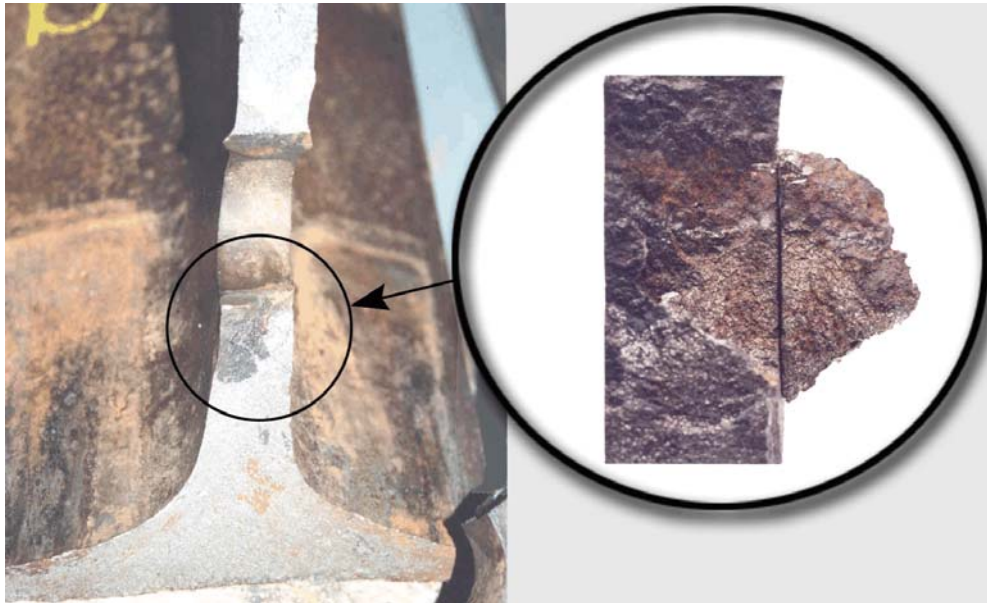
The observed dark oxidized area in the third bolt hole was determined to be a pre-crack (see Photo 2). It originated from the middle of the web in the hole's bore and extended through the entire thickness of the web downwards towards the base for 3/4 inch. From there, a secondary brittle fracture propagated down through the remainder of the rail base cross-section. Examination of a metallographic sample removed from near the pre-crack fracture origin revealed several corrosion pits and a secondary branch crack full of oxides extending from the surface of the hole bore. Two corrosion pits displayed microscopic cracks extending from their root. The examination determined that the pre-crack had been present for some time prior to the rail failure. Characteristics displayed by the pre-crack fracture surface were typical of brittle fracture with no evidence of fatigue.

Photo 2. Pre-crack in third bolt hole. Exploded view is a close-up of the full pre-crack fracture surface with the mating surface removed.

A corrosion test was performed by CPR using a broken rail from the site to determine the amount of time required to achieve the oxidized appearance observed on the pre-crack fracture surface. The test indicated that it would take longer than a month.

The train derailed just south of a public crossing when the east rail of the main track failed catastrophically in the location of a pre-existing rail joint bolt hole crack (pre-crack). A metallographic sample removed from near the pre-crack fracture origin revealed several corrosion pits and a secondary branch crack full of oxides extending from the surface of the hole bore. This suggests that at some time prior to the occurrence, a corrosion pit in the third bolt hole from the east rail end likely acted as a stress raiser and facilitated the development of the pre-crack. The lack of fatigue features on the pre-crack fracture surface suggests that it was generated by a single load some time prior to this occurrence. The amount of oxidation observed on the pre-crack, along with testing performed by CPR, confirmed that the pre-crack was likely present at the time of the ultrasonic inspection, one month prior to the accident, and had remained dormant until this occurrence.
