## RAILWAY INVESTIGATION REPORT

R03T0157

### MAIN-TRACK DERAILMENT

CANADIAN NATIONAL  
TRAIN NUMBER A-450-31-21  
MILE 68.9, BALA SUBDIVISION  
GAMEBRIDGE, ONTARIO  
21 MAY 2003

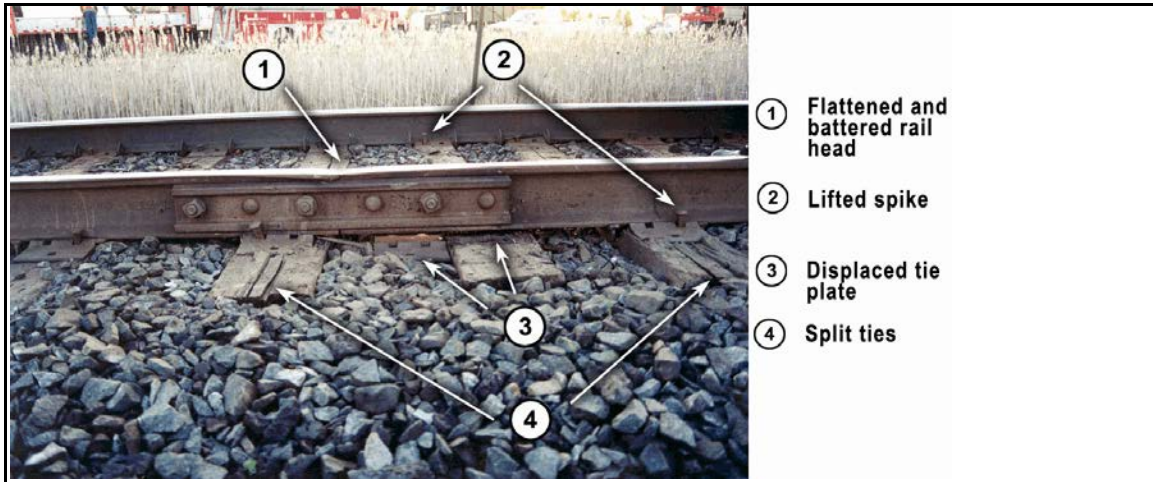
crossing, which were either crushed, split or missing spikes. The track was generally in good condition south of the Highway 12 crossing.

There were several joints on both rails just north of the crossing. One joint on the west rail was shimmed. An 18-foot rail plug was fully bolted in place on the east rail and both of the joints were battered. One joint was supported on two ties with only one tie plate (see Photo 2); the other had worked itself off the tie. A set of splice bars had also been applied to the east rail where the rail head was flattened and battered. Four bolts in the outer holes held the splice bars in place. There was also evidence of mud pumping and poor drainage, particularly at the joints north of the crossing (see Photo 3). An examination of several other road crossings within 10 miles of the derailment site revealed similar conditions.

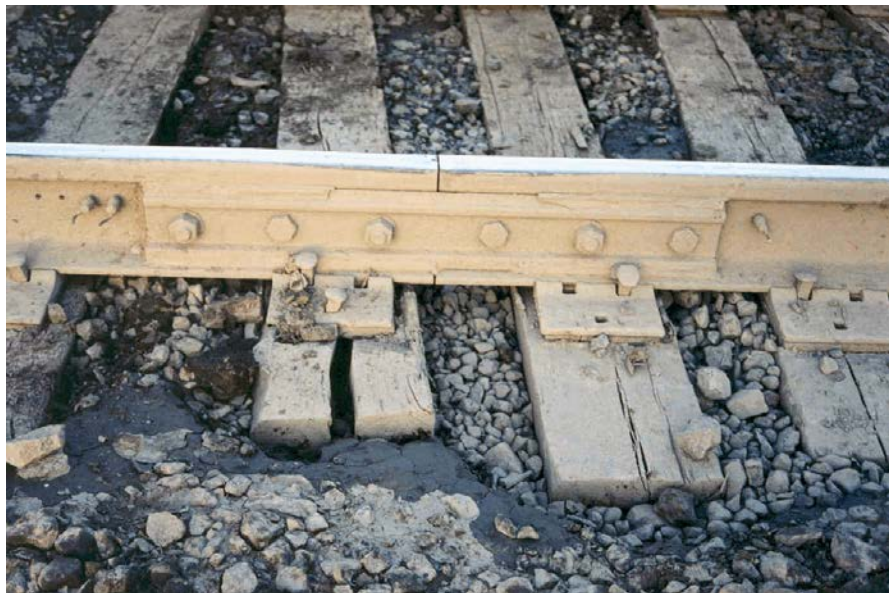
The Highway 12 crossing had an asphalt surface with rubber mud rails, and was protected with flashing lights, bell, and gates. It had been scheduled to be re-paved in June 2003. An examination shortly after the derailment indicated that there were no wheel or flange marks on the road surface in the crossing area. During the

post-accident assessment, track surface and gauge measurements were taken under a loaded rail car in the area north of the crossing. There were five near urgent (i.e. at least 70 per cent of the urgent limit) cross-level tangent defects, two near urgent warp62 defects, and two locations where the warp62 track geometry parameter was 1 7/16 inches, which exceeds the urgent limit of 1 1/4 inches prescribed for track surface in Part II, C.
