RAILWAY INVESTIGATION REPORT
R06T0022

MAIN-TRACK DERAILMENT

CANADIAN PACIFIC RAILWAY
FREIGHT TRAIN 230-30
MILE 114.65, MACTIER SUBDIVISION
BUCKSKIN, ONTARIO
31 JANUARY 2006

Report Number R06T0022

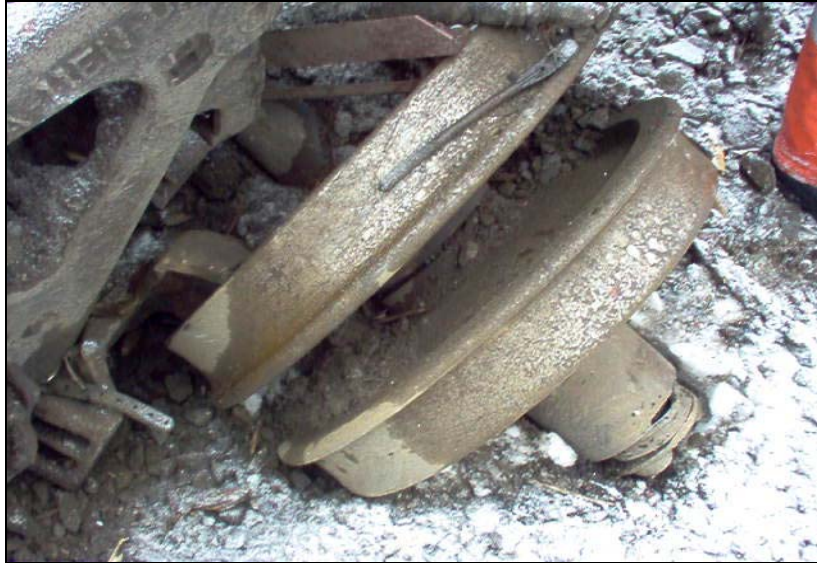
The 19th car from the head end, CP 346875, was the first derailed car. This car came to rest at Mile 103.6 in an upright position. Its No. 1 wheel set had dislodged from under the trailing truck and was on the right-of-way, west of the track near Mile 103.7. The L1 wheel from this wheel set had moved inboard off the axle wheel seat onto the axle body (see Photo 1). Score marks were observed on the wheel bore and axle body. The 20th to 30th cars came to rest in various positions along the right-of-way. The No. 1 wheel set from car CP 346875 was forwarded to the TSB Engineering Laboratory for examination.

Photo 1. No. 1 wheel set from car CP 346875 (Source: Canadian Pacific Railway)

The 19th car from the head end, CP 346875, was the first derailed car. It came to rest at Mile 103.60 in an upright position. The trailing 11 cars also derailed and came to rest in various positions along the right-of-way. The trailing No. 1 wheel set from car CP 346875 had dislodged from under the B-end truck and was located west of the main track about 500 feet north of the car. The L1 wheel from this wheel set had moved inboard off of the axle wheel seat onto the axle body. Score marks observed on the wheel bore and axle body indicate that the wheel had been unseated for some time.

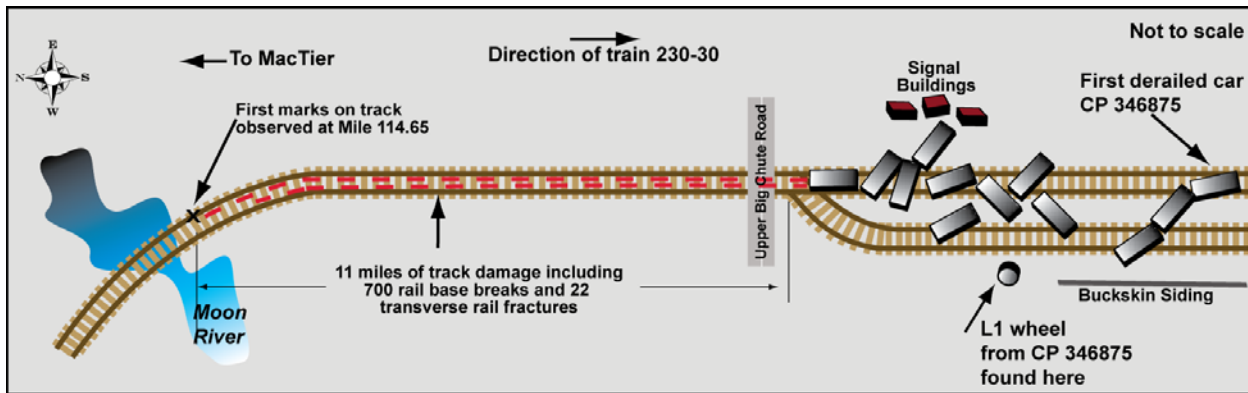
Figure 2. Derailment site

In the immediate derailment area, approximately 400 feet of track, including the Buckskin Siding north turnout and signal structures, was destroyed and a signal building was damaged. At the north end of the derailment site, heavy gauge side damage to rails, anchors, tie plates, and cross-ties was observed. From this location, track damage consistent with wheel impacts extended northward on the main line for approximately 11 miles to a series of short trestle bridges that traverse the Moon River. The first marks observed were at Mile 114.65, on the base of the east (high) rail of a three-degree, right-hand curve (in the direction of travel). Within the 11 miles of damaged track, approximately 700 rail base breaks and 22 transverse rail fractures were observed. Eight miles of continuous welded rail (CWR) had to be replaced (see Figure 2).

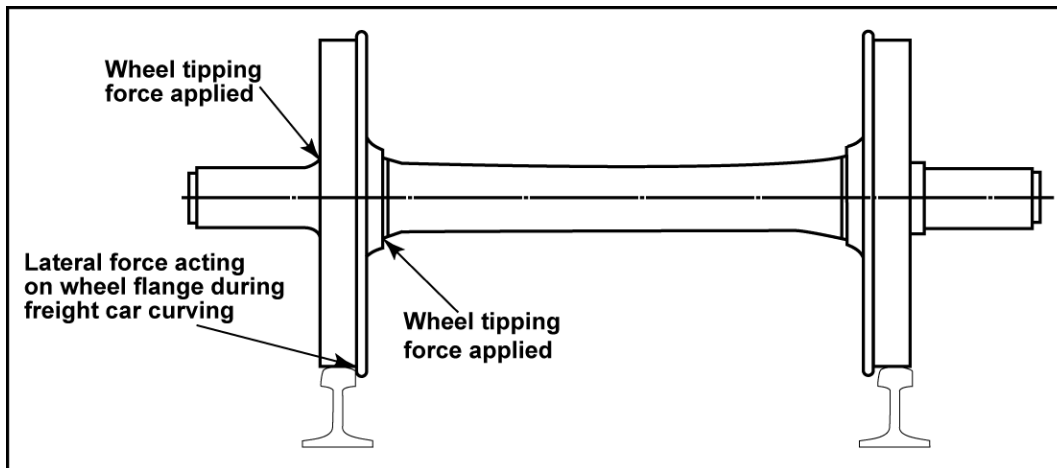
Figure 4. Forces acting on a wheel during curving

- With normal freight car curving, lateral forces acting on the wheel flange cause the wheel to tip slightly, which forces the tips of the harder bore spirals into the softer axle wheel seat material (see Figure 4).

- The tipping forces initiate brinell indentations on the axle wheel seat and progressively loosen the interference fit.⁸

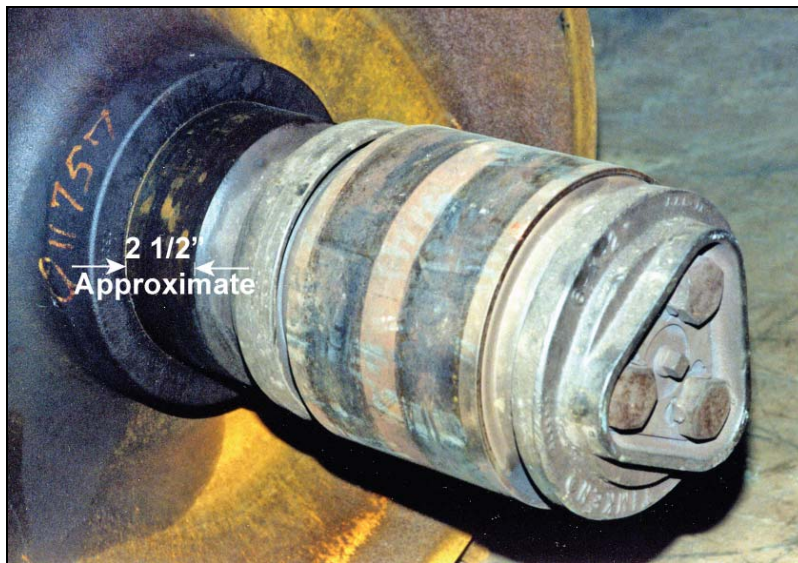
- The process continues to the point where only a small band of spirals near the centre of the wheel retained the interference fit. Under these conditions, these 36-inch wheels can rotate (screw) inboard, and occasionally outboard, off the axle wheel seat while in service, producing loose and out-of-gauge wheel conditions (see Photo 3).

Photo 3. Wheel movement on axle seat (2 ½ inches), typical of loose wheel-related occurrences

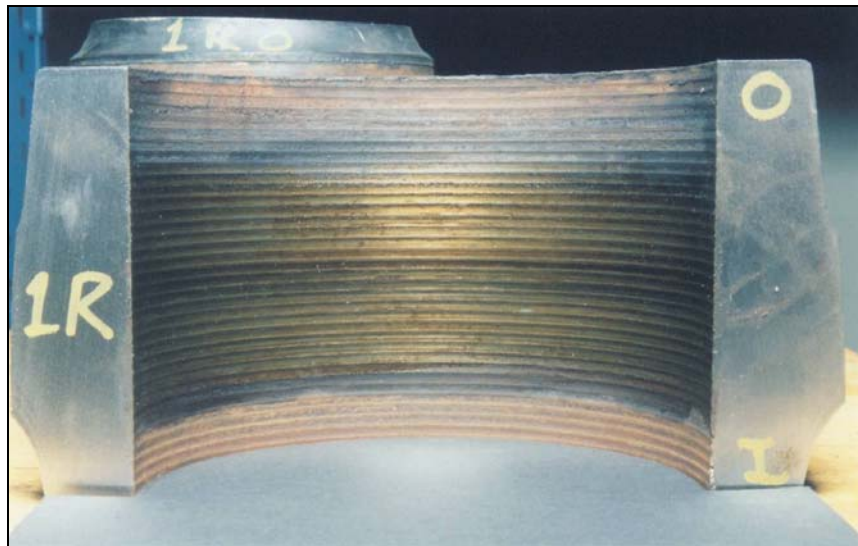
- Before sectioning of the subject wheel sets, each of the wheel bore/axle wheel seat interfaces displayed various stages of deterioration in the intended interference fit between wheel and axle.
- All of the wheel bore/axle wheel seat assemblies examined displayed fretting and produced red oxide indicating that there was slight flexure, due to wheel tipping forces, occurring between the wheel bore and the axle wheel seat. The greater the flexure, the greater the amount of oxide generated (see Photo 4).

Photo 4. Typical cross-section of wheel bores examined

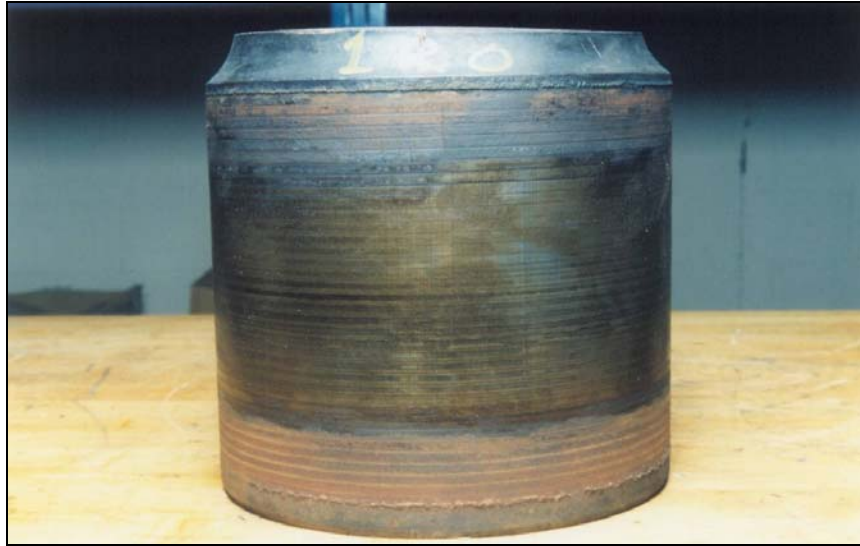
- All of the wheel seats, including those from the wheel set mounted outside the manufacturing window (February 1998), exhibited red oxide and surface brinelling⁹ at the wheel seat extremities, which was consistent with flexure at the wheel bore/axle wheel seat interface (see Photo 5).

Photo 5. Typical axle wheel seat examined

- The observed axle wheel seat brinelling indicates a slight difference in material hardness between the wheel bore and axle wheel seat. The axle wheel seat brinelling was more severe on the three laterally displaced wheels. It appears that the brinelling of the axle wheel seats initiates movement at the wheel bore/axle wheel seat interface.
