RAILWAY INVESTIGATION REPORT
R06V0136

RUNAWAY/DERAILMENT

CANADIAN NATIONAL
FREIGHT TRAIN L-567-51-29
MILE 184.8, LILLOOET SUBDIVISION
NEAR LILLOOET, BRITISH COLUMBIA
29 JUNE 2006

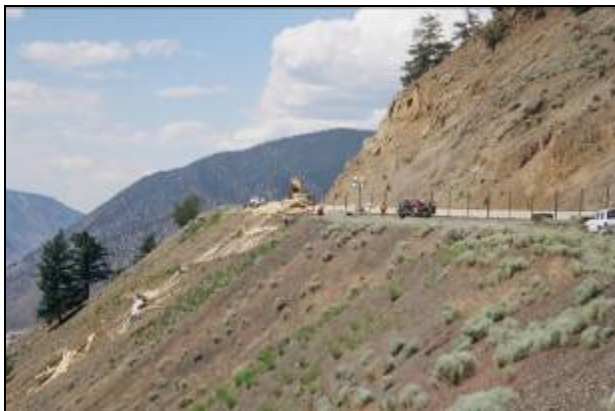
At Mile 184.8, having separated from the locomotive by about 200 feet, the car derailed to the outside of an 11-degree, left-hand curve (see photos 1 and 2). The conductor was thrown from the derailed car and sustained fatal injuries. The car came to rest about 1000 feet down the mountain.

Photo 1. Point of derailment of the centre beam flat car

The first markings were noted across the top of the outside rail of the curve at Mile 184.8 and were consistent with wheel climb. Near this location, there were also markings on the edge of the right-of-way to the outside of the curve. These markings continued along the right-of-way and down the mountain side to the derailed car. Fifty metres south of the markings on the rail, minor track damage was noted as both rails were slightly misaligned.

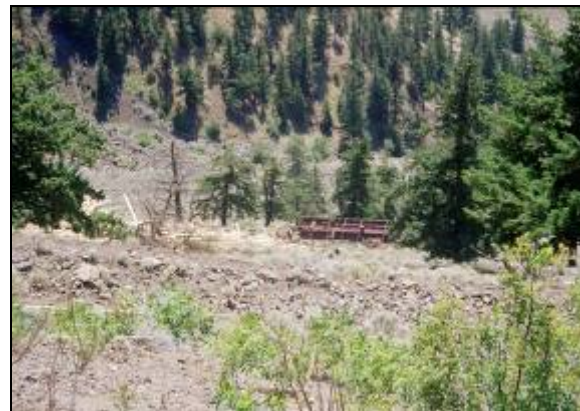
Photo 2. Derailed centre beam flat car

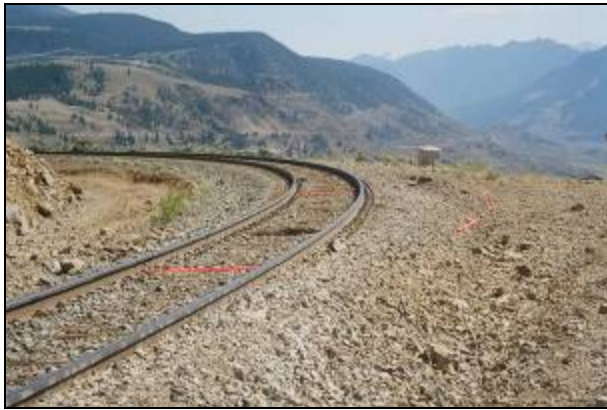
Photo 3. Point of derailment of the locomotive

At Mile 182.5, markings similar to those at Mile 184.8 were found on the edge of the right-of-way to the outside of the curve, leading down the mountain side to the locomotive. The derailed locomotive had come to rest on its side and burned in a post-accident fire. Its trucks had separated from the locomotive body and came to rest several hundreds of feet away. They were not exposed to the fire.

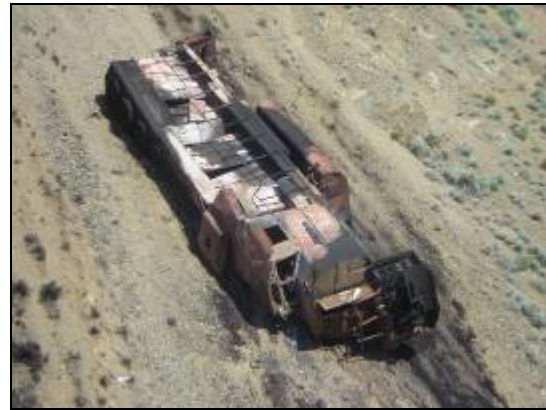
Photo 4. Derailed locomotive

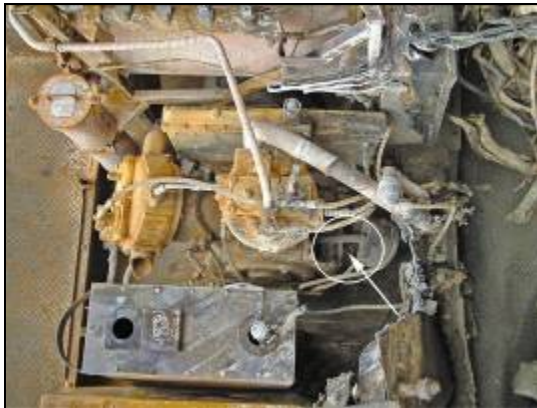
The two-stage air compressor had a broken pressure cylinder and the number two main reservoir one-way check valve was found to have the internal spring partially screwed around the check valve (see photos 5 and 6), impeding proper check valve operation. The main reservoir piping from the high-pressure cylinder of the locomotive air compressor to the number one main reservoir and the piping between the main reservoirs, including the automatic water drains, were intact. The derailment and fire damage precluded any further inspections and testing of the air brake components on site.

Photo 5. Broken pressure cylinder on the two-stage air compressor

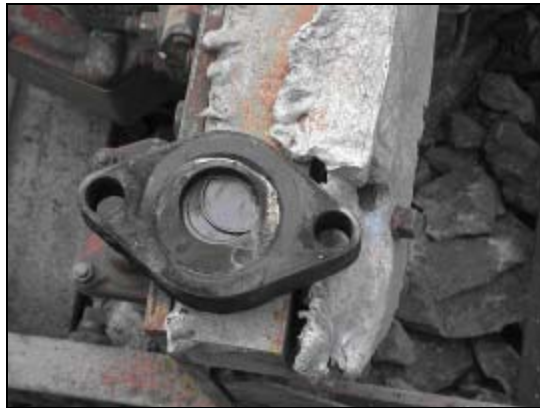
Photo 6. Defective locomotive one-way check valve

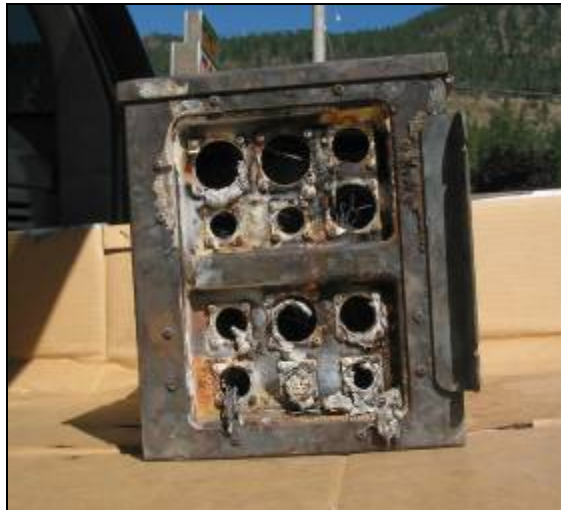
The fire and heat damage precluded the recovery of any useful data from the LER (see Photo 8). With the actual data unavailable, the investigation sought data for a comparable train trip. On 02 July 2006, a test train with a sister locomotive (CN 9574) and a sister loaded centre beam flat car was operated down the Lillooet Subdivision over the derailment location. The LER data from the resulting run was obtained by the TSB for analysis and comparison purposes.

Photo 8. Burnt locomotive event recorder

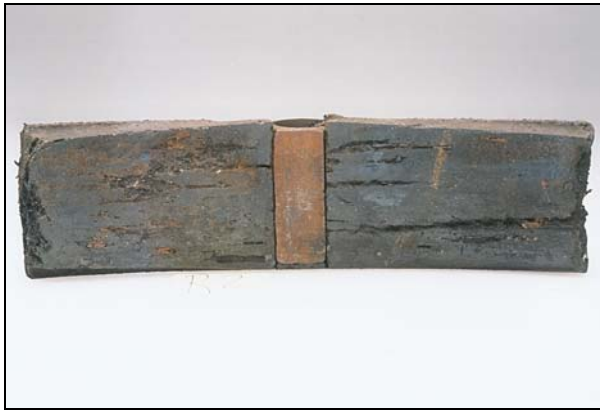
The eight car shoes were high-friction composition shoes. All shoes were worn but were within AAR²⁶ acceptable limit, which is that car brake shoes possess a minimum of 3/8 inch (1 cm) of wearable material, including lining and backing plate. Four of the eight shoes displayed areas where large chunks of the wearable material had separated from the assembly. This separation appeared to have been caused by secondary damage as a result of the derailment. Some small narrow regions of wearable material had also separated from some of the brake shoes, predominantly creating shallow trenches orientated along the longitudinal axis of the shoes (that is, along the circumferential direction of the mating wheel). In the remaining areas, the patterns observed appeared typical of normal wear, and no signs of excessive heat were apparent (see Photo 10).

Photo 10. Inboard face of the car brake shoe

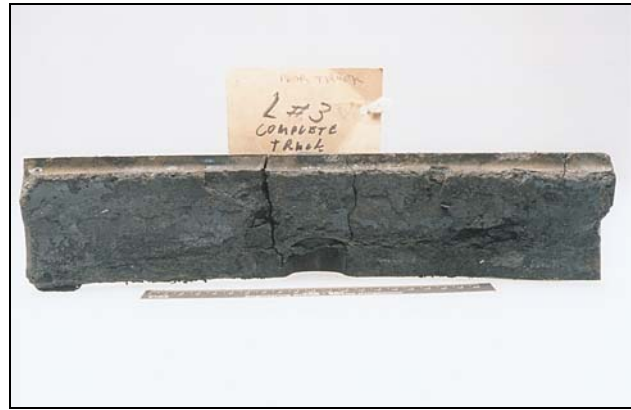
The seven recovered locomotive brake shoes were all high-friction composition brake shoes. The shoes were worn thin in some areas but were within the AAR acceptable wear limit of 3/8 inch.²⁷ In contrast to the car brake shoes, the locomotive brake shoes displayed characteristics of being significantly overheated. The lining of the shoes had delaminated and detached in many areas, creating rough, irregular contact surfaces that are indicative of overheating damage (see Photo 11). The heat damage had not been caused by the post-crash fire because the trucks and wheels, with brake shoes attached, had separated from the locomotive

during the derailment and were found a considerable distance from the post-crash fire area. The tread contact surface on the brake shoes displayed a shiny reflective appearance in most regions where the lining had not delaminated.

Photo 11. Inboard face of the locomotive brake shoe

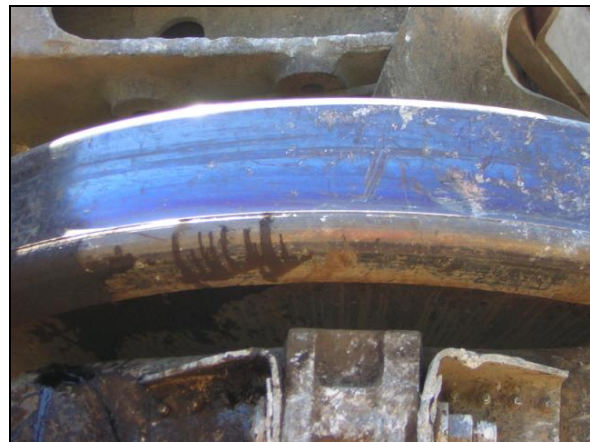
Markings indicated that the locomotive wheels were type T40A 40-inch wheels manufactured by Griffin Wheel Company. In contrast to the car wheels, all of the locomotive wheel treads showed blue discoloration due to high-temperature surface oxidation (see Photo 12). Laboratory analysis showed that, when the tread was lightly buffed, the blue discoloration could be readily removed, which indicated that it was only a superficial layer. There were no thermal crack patterns or heat checks visually apparent in the treads or flanges.

Photo 12. Locomotive wheels after the derailment

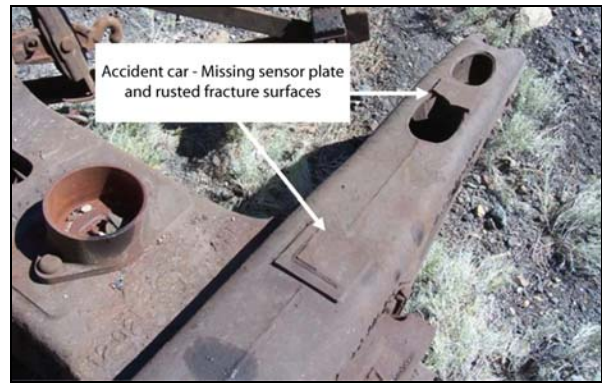
During examination of the accident car and several other cars (at Joffre, Quebec), as well as subsequent air brake testing of similar centre beam cars (at Winnipeg and Prince George), TSB personnel noted that many of the cars were missing the sensor plate (see Photo 13). Of the nine cars that the TSB examined, five had missing sensor plates: the accident car, the car examined at Winnipeg, one at Prince George, and two at Joffre. Of the four remaining cars, one had a sensor plate that was replaced in the field. It was not as per the original manufacturer in size and shape.

The manufacturer of the empty/load device (model ELX-B 60 supplied by Wabtec Canada Inc.) states that the contact ball of the adjustment screw on the sensor arm must contact a flat and level surface throughout the appropriate amount of truck swing the car would encounter, including lateral and vertical displacement. Later versions of the sensor plate specified an increase in thickness to 1/2-inch material and the use of “plug welds” for enhanced securement to the top of the truck sides.

Photo 13. Accident car with missing sensor plate
(Source: Canadian National)
