**RAILWAY INVESTIGATION REPORT**  
**R06V0183**

**RUNAWAY AND DERAILMENT**  
**WHITE PASS AND YUKON ROUTE**  
**WORK TRAIN 114**  
**MILE 36.5, CANADIAN SUBDIVISION**  
**LOG CABIN, BRITISH COLUMBIA**  
**03 SEPTEMBER 2006**

Report Number R06V0183

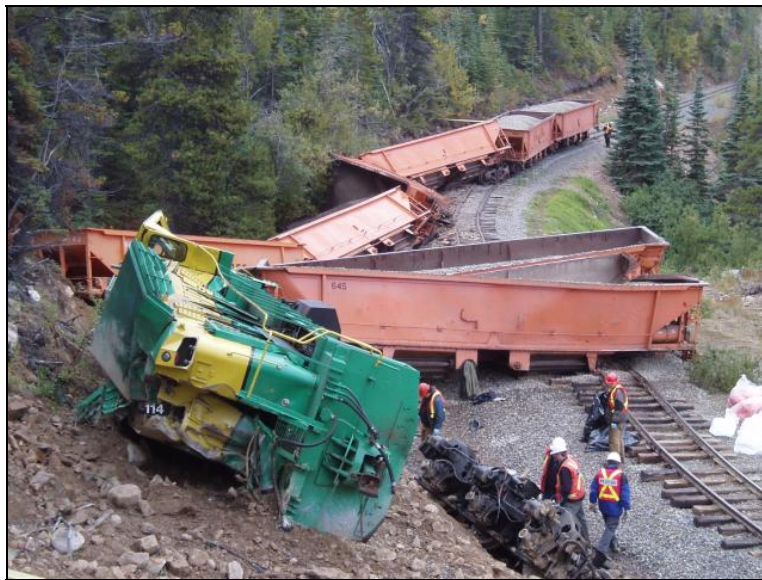
As the train was negotiating the 16-degree, left-hand curve at Mile 36.5, the conductor jumped to the east and landed in a small stream. The train then derailed to the outside of the curve, the east side (see Photo 1). The locomotive engineer and the two heavy equipment operators were trapped inside the cab.

**Photo 1.** Derailment of work train

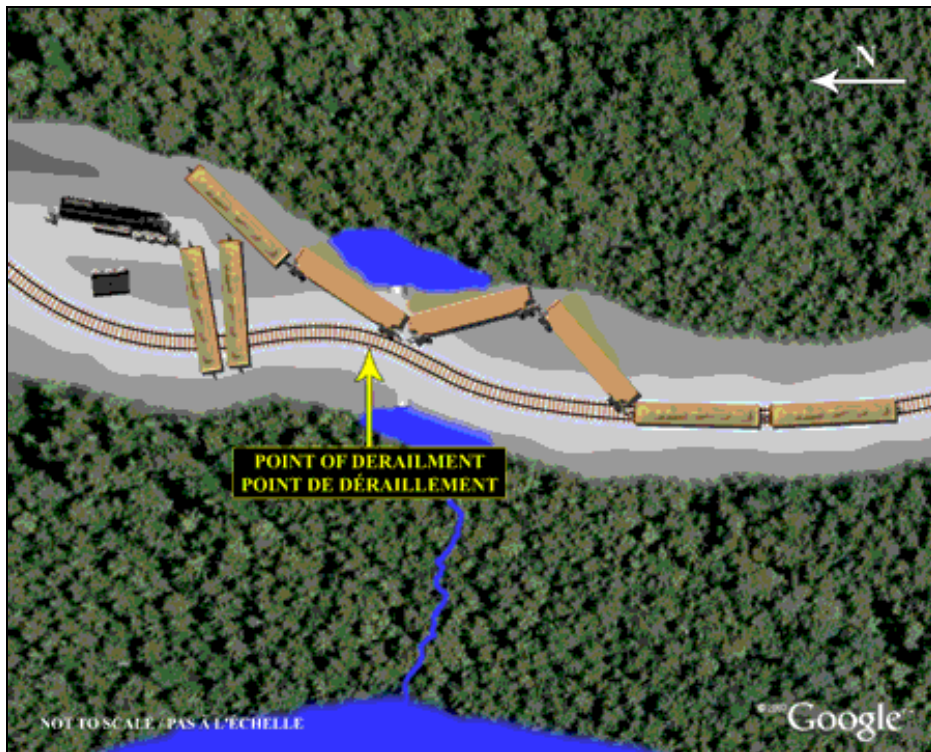
The locomotive and the first six cars derailed to the east side of the track (see Figure 2). The locomotive came to rest on its side, parallel to the track, after sliding about 135 feet along the right-of-way. The conductor's side of the cab and the short hood nose had collapsed and were partially filled with rock and debris, burying the crew members. The interior of the cab had sustained heavy damage.

**Figure 2.** Location of derailed rolling stock

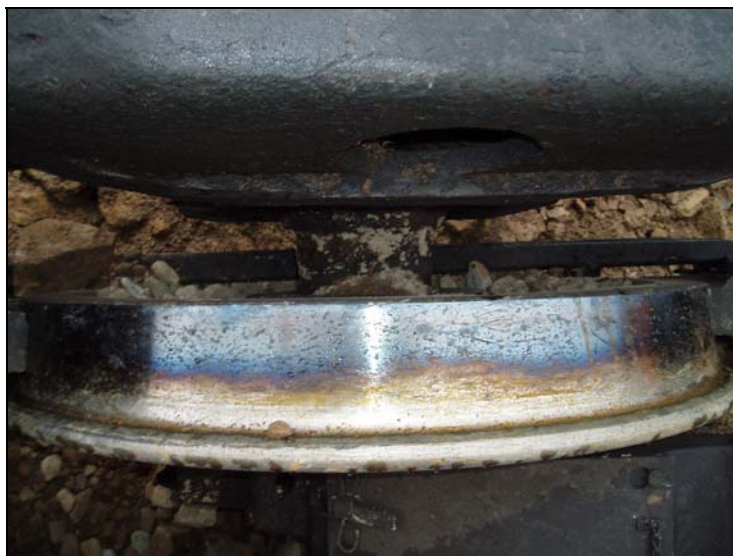
An examination of the locomotive showed that the wheel rims were blued<sup>9</sup> (see Photo 2), with some showing signs of skidding. The brake shoes were thermally damaged.

**Photo 2.** Locomotive wheel

<sup>9</sup> Blueing is a term that refers to the appearance of the wheel tread surface that results from subjecting the tread to excessive heat, usually from prolonged or heavy brake applications.

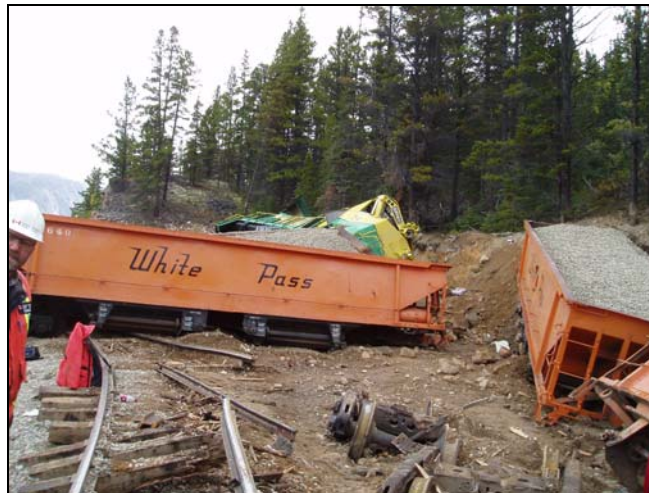
The roadmaster expected the cars to be loaded to the top with ballast in accordance with regular practice (see Photo 3). Accordingly, the heavy equipment operators would typically place between 17 to 21 buckets of ballast in each car. Each bucket had a capacity of 3.0 cubic yards when level and 3.5 cubic yards heaped; all buckets were heaped.

**Photo 3.** Ballast cars

As the roadmaster expected the cars to be loaded as full as possible for operational reasons, the cars typically would be completely filled with ballast. Because the load appeared reasonable for the size of the car and because cars had been handled while overloaded north from Log Cabin many times before without incident, WP&YR employees believed that fully loaded cars could be safely handled. However, based on the AAR-recommended maximum gross rail load of 71 tons for cars equipped with 5-inch-by-9-inch axle journals, each car was overloaded as indicated in Figure 3.
