**RAILWAY INVESTIGATION REPORT
R07C0040**

MAIN-TRACK COLLISION

**BETWEEN
CANADIAN PACIFIC RAILWAY FREIGHT TRAIN 375-237
AND
CANADIAN PACIFIC RAILWAY FREIGHT TRAIN 862-012
MILE 42.55, TABER SUBDIVISION
BOW ISLAND, ALBERTA
22 APRIL 2007**

Report Number R07C0040

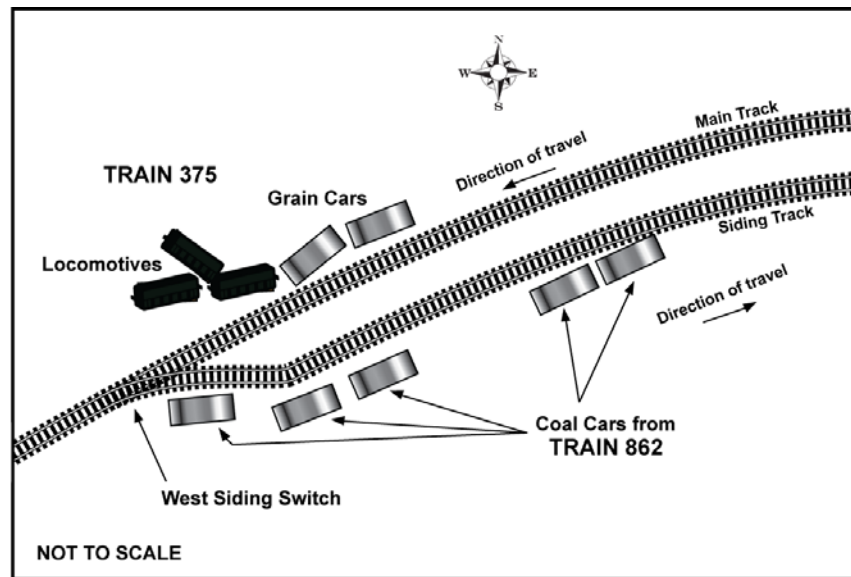
Figure 2. Site diagram

The five derailed coal cars of train 862 came to rest south of, and parallel to, the siding track east of the west siding switch; the first and fifth cars remained upright, while the other three cars rolled onto their sides and spilled their product (see Figure 2).

The lead locomotive of train 375 came to rest approximately 30 feet north of the main track near the west siding switch; the two following locomotives and first two cars also derailed to the north side. The third locomotive was immediately behind the second locomotive while the first had been pushed north. All three locomotives were leaning and had sustained heavy damage. The first derailed grain car had overturned and spilled its product; the second car remained upright.

The main track and the siding track, east of the west siding switch, were damaged for a distance of approximately 400 feet. An inspection of the track and the derailed equipment did not reveal any pre-derailment defects.
