RAILWAY INVESTIGATION REPORT
R07D0030

MAIN-TRACK DERAILMENT

CANADIAN NATIONAL
FREIGHT TRAIN M-32721-28
MILE 202.51, CSX MONTRÉAL SUBDIVISION
HUNTINGDON, QUEBEC
29 MARCH 2007

Report Number R07D0030

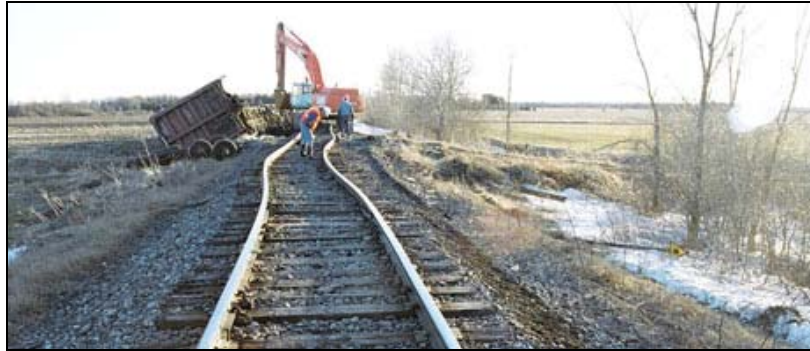
At the north end of the derailment site, the track had buckled and shifted laterally, up to 24 inches, to the east. The buckle began 72 feet north of the farm crossing and extended southward in an “S” shape, up to the crossing surface (see Photo 1).

Photo 1. Southward view showing the track buckle and derailment

The diagonal mark on the rail head and track damage observed on the field side of the east rail as well as wheel drop-in marks on the gauge side of the west rail identified that the initial point of derailment was located near the middle of the track buckle at Mile 202.51. From this point, the track damage extended southward and terminated at the trailing truck of the 68th car from the head end, GATX 6545, which indicated that this was the first car to derail. The rail creep marks and the condition of the rail joints, which were open near Rankin Road and tight near the farm crossing, show that the rail had moved southward and was in compression at the north end of the farm crossing. These compressive stresses in the rail likely contributed to the development of the progressive alignment deviations recorded at that location before the accident. As the train passed over the alignment deviations, the wheel action exerted lateral forces that increased the track misalignment and led to the derailment of the 68th car. Under the passage of the following five cars, which did not derail, the track shifted further and caused the derailment of the seven tail-end cars of the train.

In the two years before the accident, the rail creep had contributed to seven pull-aparts and a track buckle in the area. The addition of nine inches of rail in January 2007 to repair a pull-apart just north of the farm crossing further exacerbated the problem and created even higher compressive forces in the rail. Since the rail within 70 feet north of the farm crossing had been securely box anchored while repairing a previous track buckle in March 2006, this area acted as a focal point for longitudinal compressive stresses in the rail. The addition of nine inches of rail, the rail creep resulting from mostly southward traffic tonnage, and the influence of train braking through this area increased the compressive stresses in the vicinity of the farm crossing and led to the track buckling under the passing train.

In 2007, CSX performed track rehabilitation on the Montréal Subdivision from the Canadian border (Mile 183.2) to Beauharnois (Mile 225.2), which is the end of CSX operation in Canada. The rehabilitation included track surfacing as well as the installation of approximately 3800 feet of continuous welded rail, 7000 tons of ballast, 13 000 ties and 10 000 rail anchors. Additional anchors were installed on the north approach to Huntingdon yard limits, where trains reduce speed. Two track geometry inspections were performed, one of which also tested the lateral strength of the track using a gauge restraint measuring system (GRMS).

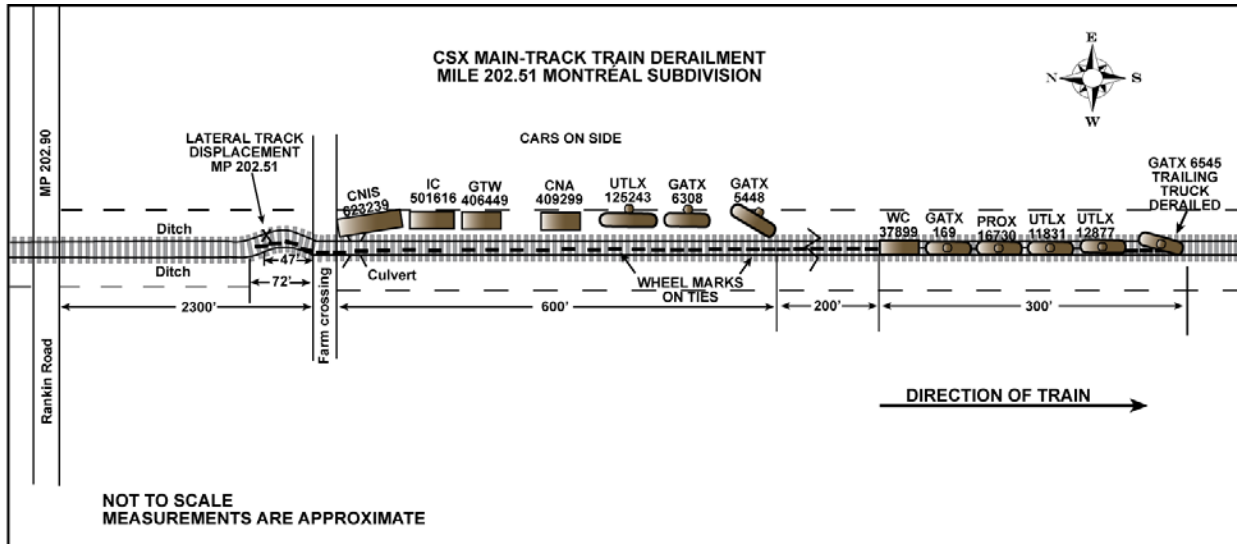
Near the middle of the track buckle, a diagonal wheel flange mark was observed on the head of the east rail, extending southward from the gauge side. Two feet from the mark and extending southward, the field side spikes, tie plates and ties exhibited impact marks. Corresponding marks were observed on the ties on the gauge side of the west rail. Track damage extended for about 1200 feet up to the trailing truck of the first derailed car, GATX 6545 (the 68th car from the head end). The 69th to 73rd cars did not derail; the 74th to 80th cars, including the three tank cars loaded with sulphuric acid, derailed and came to rest on their sides, down the embankment on the east side of the track (see Figure 2).

Figure 2. Derailment site diagram

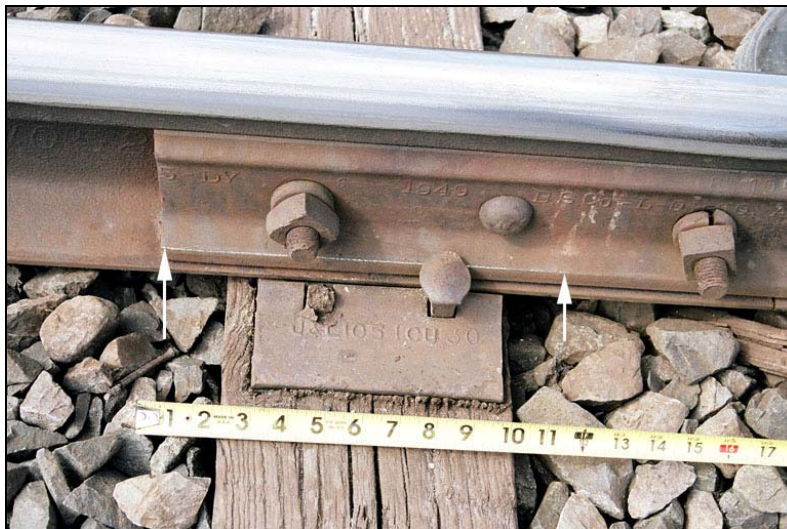
In the immediate vicinity of the farm crossing, every tie was box anchored. North of the track buckle, and extending up to the public crossing at Rankin Road (Mile 202.90), rail anchors were scarcely applied, were not in contact with the ties, and had moved southward. There were multiple clusters of up to 32 consecutive ties with no rail anchors. Rail creep marks were observed on either side of track spikes along the base of a joint bar and the toe of the east rail base in several locations. The marks extended up to nine inches southward and three inches northward (see Photo 2). The rail joints were tight near the track buckle, but displayed gaps of up to 7/8 inch near Rankin Road.

Photo 2. Rail creep marks observed along the base of a joint bar

The function of a rail anchor is to secure the rail longitudinally and prevent creep. When rail is not secured properly, longitudinal rail movement and bunching of the rail can occur at certain locations, leading to a build-up of compressive stresses in the rail. The anchoring of the jointed rail in the area between Rankin Road and the farm crossing did not comply with either the Transport Canada-approved TSR or CSX standards. The rail was sporadically anchored and multiple clusters of ties had no anchors. In addition, the anchors that were present were not effective and had moved away from the ties. Consequently, the rail was not restrained longitudinally and was free to move.
