**RAILWAY INVESTIGATION REPORT
R07E0129**

MAIN-TRACK COLLISION BETWEEN:

MILE 112.1, EDSON SUBDIVISION

Report Number R07E0129

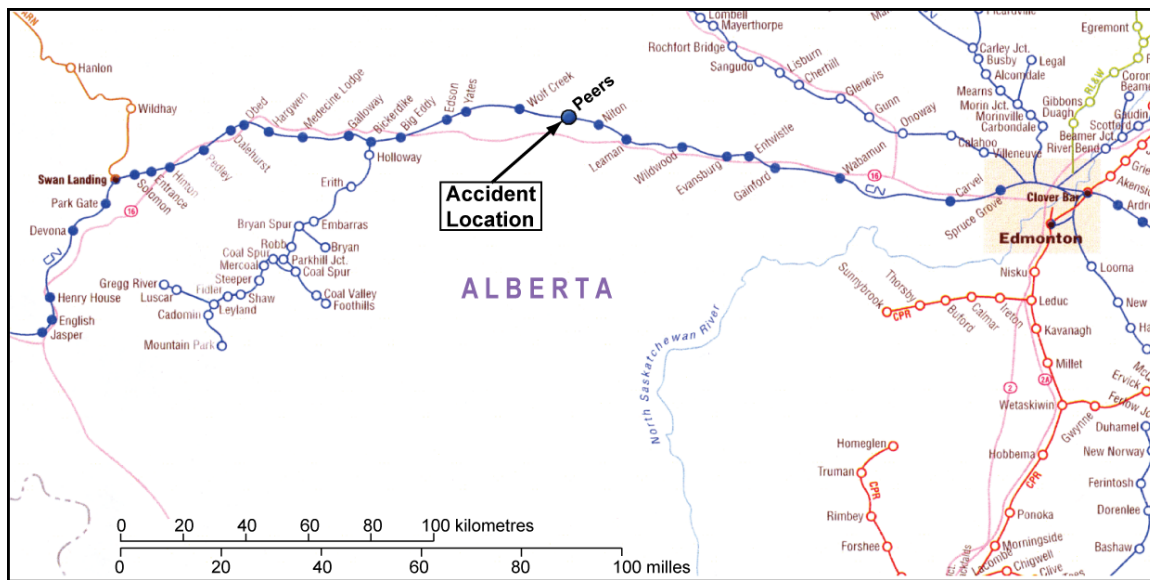
Figure 1. Accident location on the Edson Subdivision

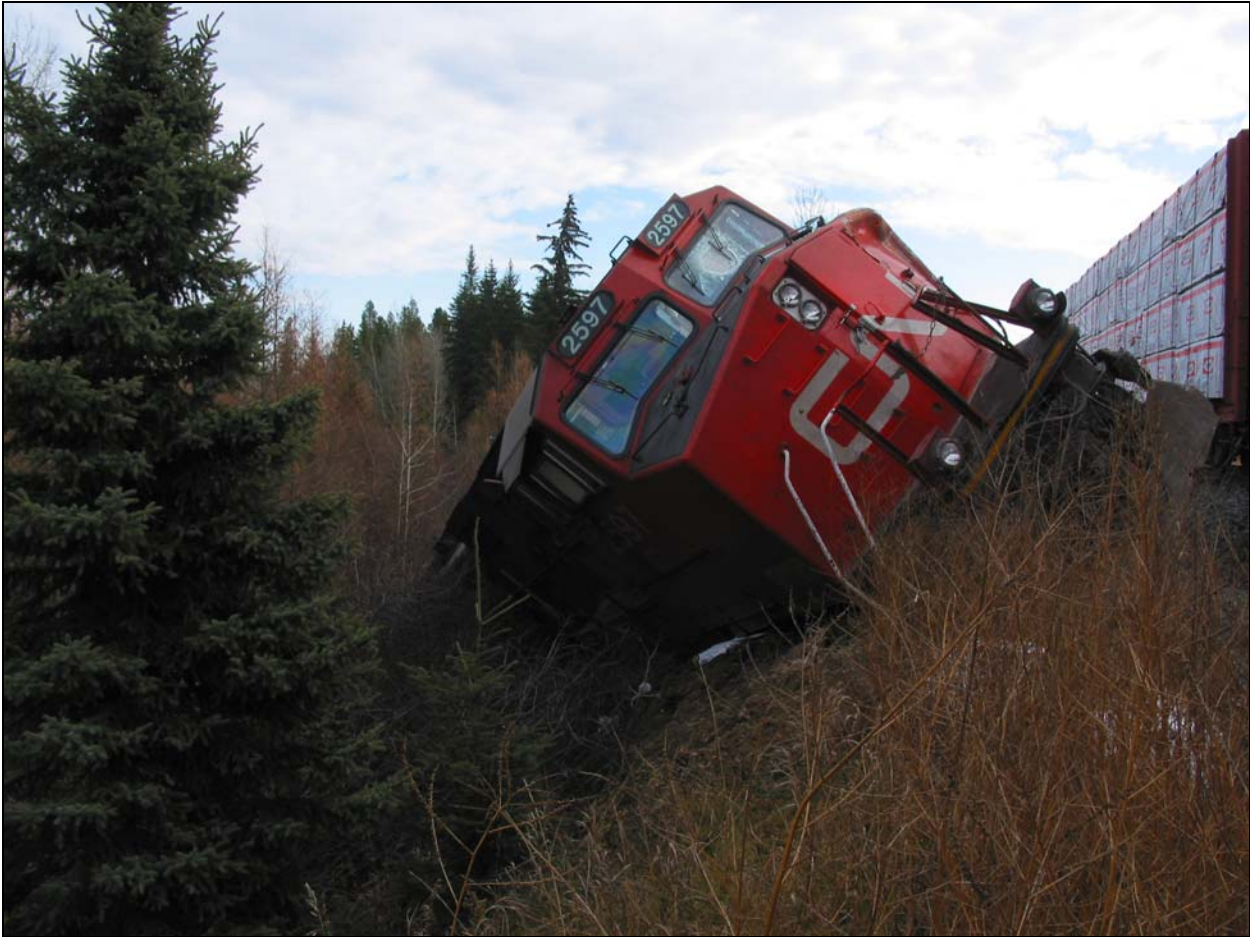
Train 417's locomotives (CN 2597 and CN 5244) came to rest upright but leaning at approximately 45 degrees in a ditch north of the track. (Photo 1 shows the position of the derailed lead locomotive after it came to rest.) Twenty-two cars, the 3rd to 5th, the 13th to 18th, and the 22nd to 34th, derailed. Ten cars, the 6th to 12th and 19th to 21st, also sustained damage.

Photo 1. Derailed lead locomotive number 2597

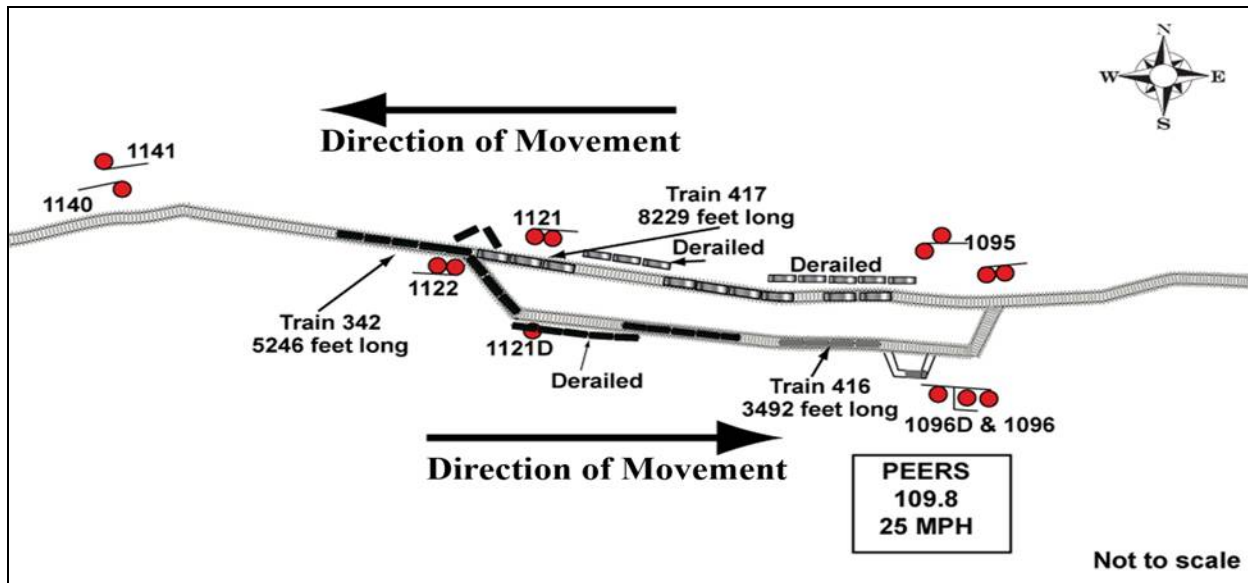
Four cars from Train 342 (the 35th and the 45th to 47th cars) sustained damage in the initial collision. Train 417's abrupt stop caused an additional collision between the two trains further east as derailed cars from Train 417 contacted Train 342, derailing 5 cars (the 26th to 30th cars). Figure 2 shows the track layout and location of derailed equipment.

Figure 2. Track layout in the vicinity of the collision site and derailed rolling stock location

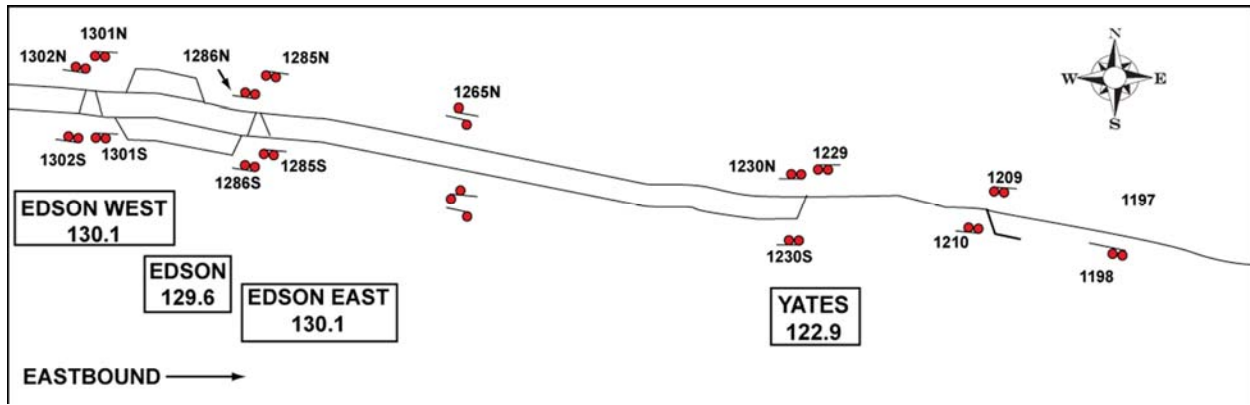
Just prior to the accident, the locomotive engineer formed a mental model that he was actually two stations away, in Yates, about 13 miles further to the west, where there are also two tracks (see Figure 3). The double track that commences at Yates continues for 12.8 miles, whereas the siding that commences at Peers extends for 2.6 miles. The distance between the first two signals encountered for westbound trains is 3.6 miles at Yates as compared to 2.6 miles at Peers.

Figure 3. Yates is the location on the Edson Subdivision where the locomotive engineer thought he was operating just before the accident

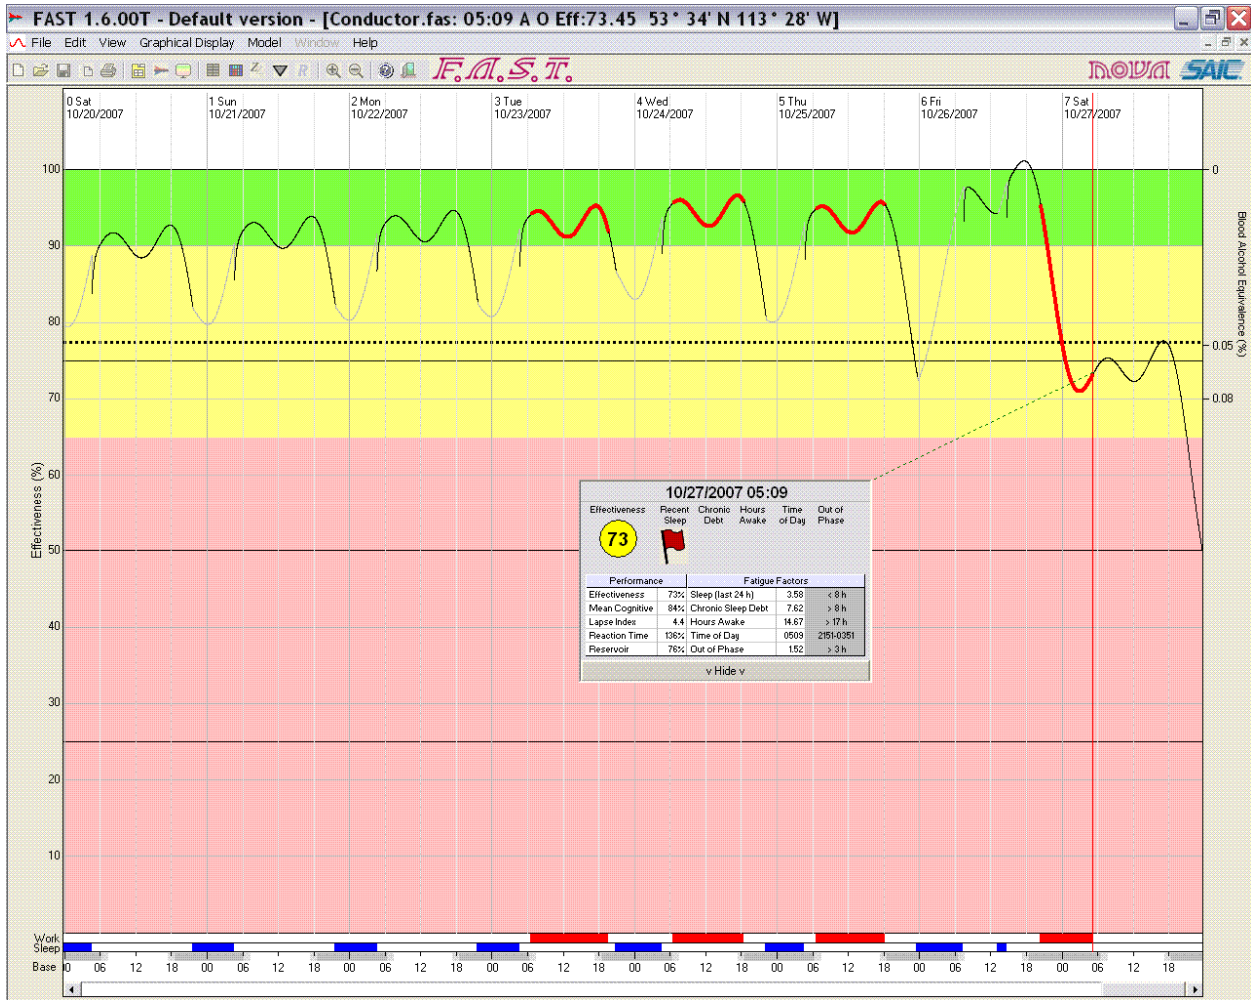
FAST Table for Conductor – Train 417

The results of the fatigue analysis indicate that Train 417's crew was insufficiently rested to be engaged in safety-critical tasks. While the railway's *General Fatigue Management Plan for Rail Operating Employees* lists a number of suggested strategies to deal with fatigue, opportunities to enact several of these countermeasures were not taken.
