RAILWAY INVESTIGATION REPORT
R07Q0001

MAIN-TRACK TRAIN DERAILMENT

CANADIAN NATIONAL
FREIGHT TRAIN M-308-31-06
MILE 78.13, MONTMAGNY SUBDIVISION
MONTMAGNY, QUEBEC
07 JANUARY 2007

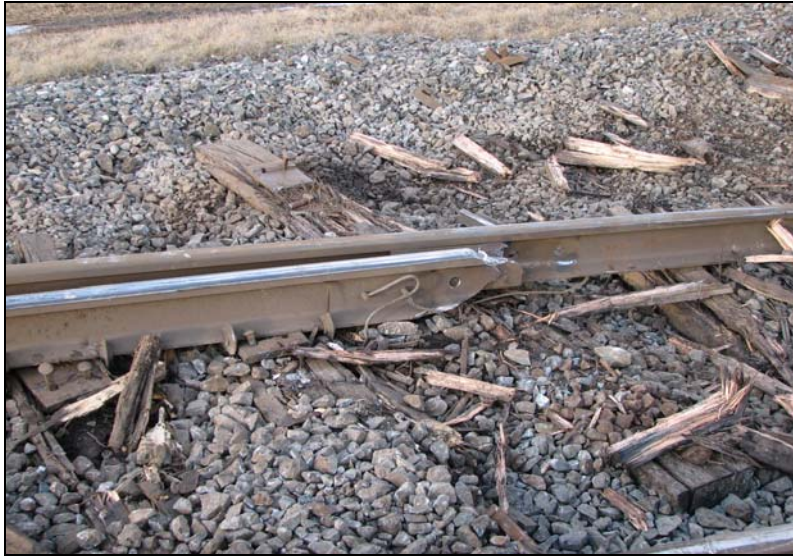
The tie immediately beneath the heel block joint was severely damaged during the derailment; however, it showed signs of previous degradation and had several old longitudinal splits (see Photo 1). This tie was the only switch tie that did not shift laterally during the derailment.

Photo 1. Track ties beneath the heel block joint

The condition of the switch plates, the plastic deformation of the bolt holes, and the degradation of the switch tie located immediately under the heel block were indicative of inadequate track support and pumping under traffic. The repetitive movement under each passing truck led to the looseness and the fracture of the bolts of the north heel block joint and increased the risk of crack development. Once initiated on the north switch point rail, the cracks propagated horizontally between the bolt holes and then vertically at the bond wire hole, breaking the rail and causing the derailment of the train.

The pumping in the north heel block area due to the degradation of the switch tie and the looseness of different components exacerbated load impact and contributed to the development of fatigue cracks.

A temporary slow order at 40 mph was set after the derailment and is still in force. The entire turnout was removed and replaced by standard track and all rail joints were eliminated in the Montmagny area to reduce track discontinuities and improve track quality. The frequency of inspection has been increased; the track will be inspected twice per month on foot and will be ultrasonically rail tested 12 times a year. Canadian National (CN) has amended switch designs and removed heel blocks.

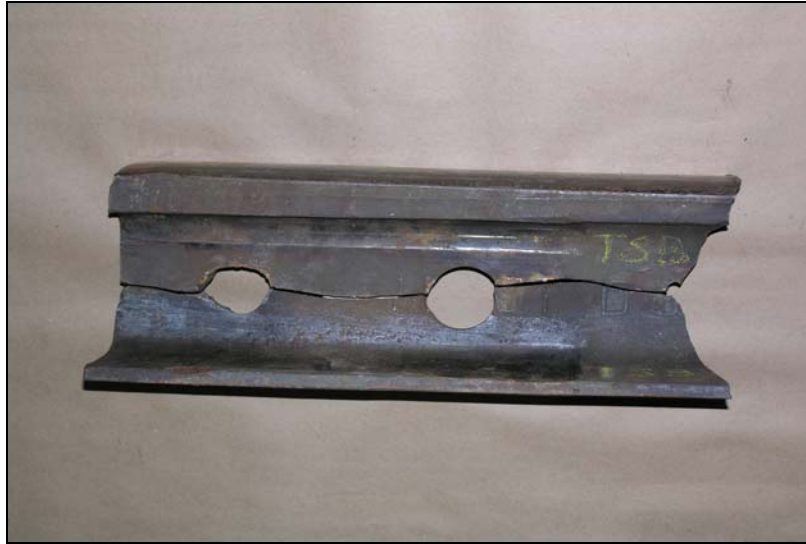
There was a fracture at the end of the north switch point rail at the connecting joint with the closure rail. The fracture extended horizontally through the two bolt holes, then propagated vertically at the bond wire hole (see Photo 2).

Photo 2. Fracture through the bolt holes

The holes were plastically deformed but there were no burrs around them. Although the fine surface details on the rail fracture surfaces had been obliterated, the smooth, polished appearance of the fracture surfaces was indicative of pre-existing fatigue cracks, whose surfaces were rubbing over an extended period. The base of the fractured north switch point rail and the south switch point rail were compared; the indications of long-term rubbing wear were more severe on the north switch point rail.

The laboratory examination of the fractured components recovered in the north heel block joint area revealed that pre-existing fatigue cracks were present. The fracture surface on the north heel block contained a pre-existing crack with a dark surface due to long-term oxidation. Although the fine surface details on the fracture surfaces of the switch point rail had been obliterated, the smooth, polished appearance of the fracture surfaces was indicative of pre-existing fatigue cracks, whose surfaces were rubbing over an extended period.

There were no manufacturing defects or anomalies such as inclusions or porosities that could have caused the metal fatigue. However, the metallurgical and mechanical properties of the north switch point rail and the closure rail were very dissimilar in terms of grain size and Brinell hardness. The north switch point rail, being a carbon steel rail, had a coarser grain and a lower internal Brinell hardness. Therefore, its tensile strength and fracture toughness were lower, which made it more susceptible to crack propagation.

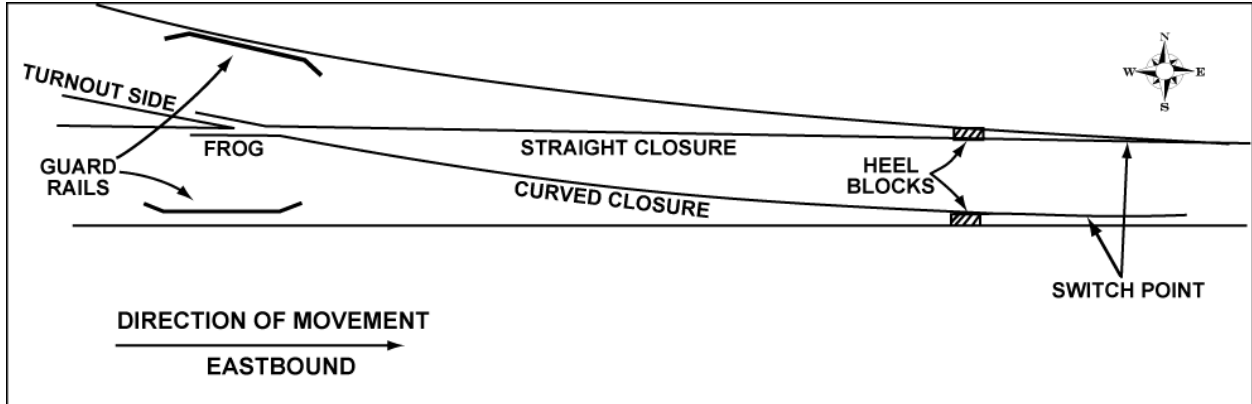
Appendix A - Turnout Diagram

The turnout located at Mile 78.13 was a CN No. 12, 115-pound, hand-operated (CN Standard Plan Drawing TS-012) with the switch points facing east (see Appendix A). There were no records on the origin and history of the north switch point rail. It was rolled in 1965 but was probably never installed in track before its installation at the accident site in 2004. It had less than 2 mm of wear.
