RAILWAY INVESTIGATION REPORT

R07T0323

MAIN TRACK DERAILMENT

**CANADIAN NATIONAL
TRAIN NUMBER M-38461-29
MILE 9.30, HALTON SUBDIVISION
MALPORT, ONTARIO
30 OCTOBER 2007**

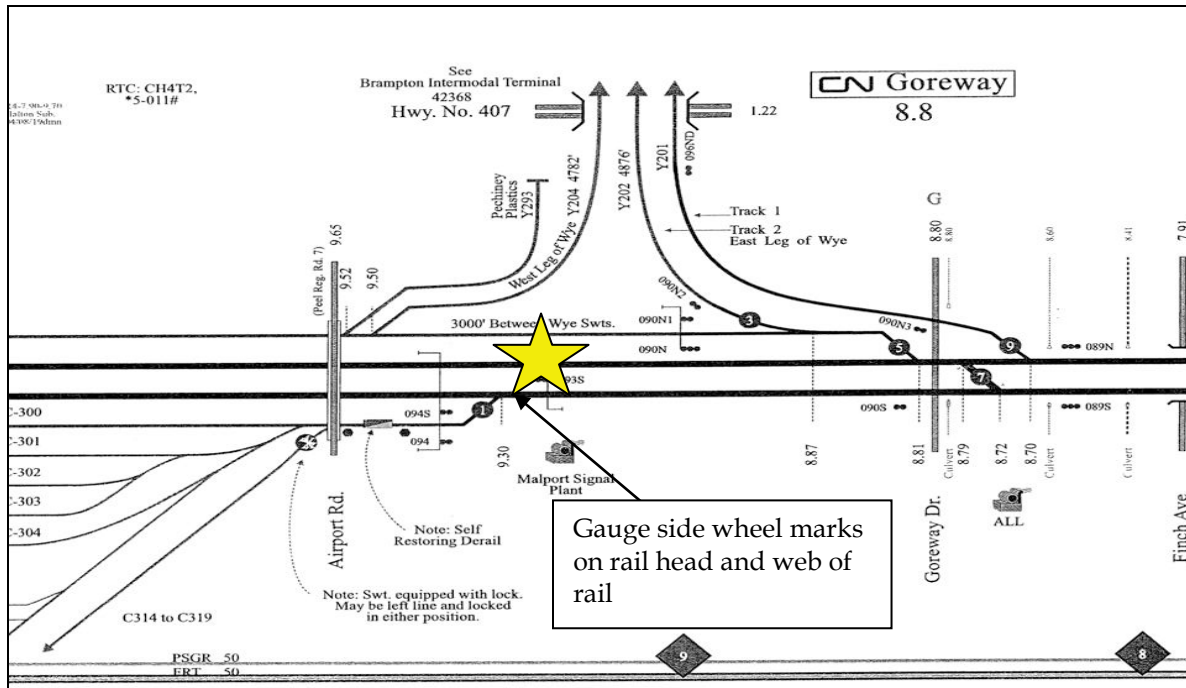
Figure 2. Derailment site at entrance to BIT

On the day of the occurrence, the train was travelling east on the north main track of the Halton Subdivision. The train was slowed using dynamic braking to allow the conductor to detrain in the vicinity of Mile 9.0. The train then pulled forward approximately 3000 feet and was brought to a stop using the train air brakes. The locomotive's independent brake was not bailed off.³ The conductor made the cut, entrained, and the cars were shoved in to BIT (see Figure 2).

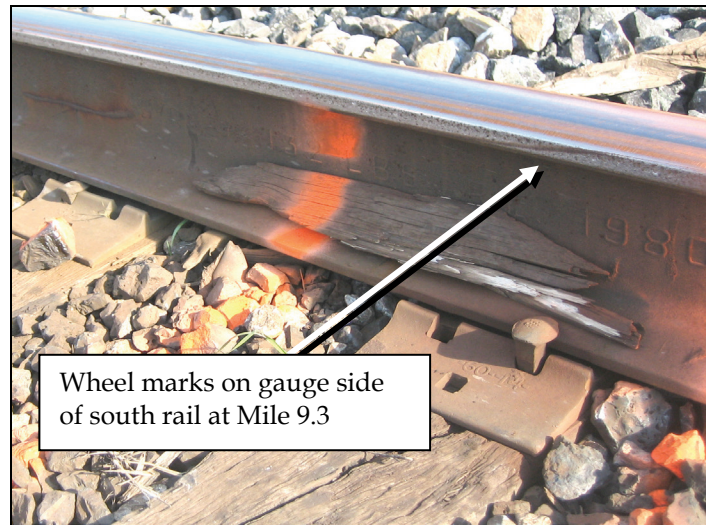
Photo 1. Mile 9.3 of the north track of the Halton Subdivision

Examination of the rail revealed multiple wheel flange marks on the gauge side of the north and south rail. Some wheelsets were straddling the south rail, east of where the rail had fractured at thermite welds. Damage to cross-ties, anchors, and spikes was predominantly to the gauge side of both rails. The wheel marks were traced back to the vicinity of Mile 9.3, where there were marks on the head and gauge side of the south rail (see Photo 1). Approximately 20 feet to the east, there were similar wheel marks on the north rail. In the vicinity of these wheel marks, spikes on the gauge side were lifted, consistent with the rail having canted out.

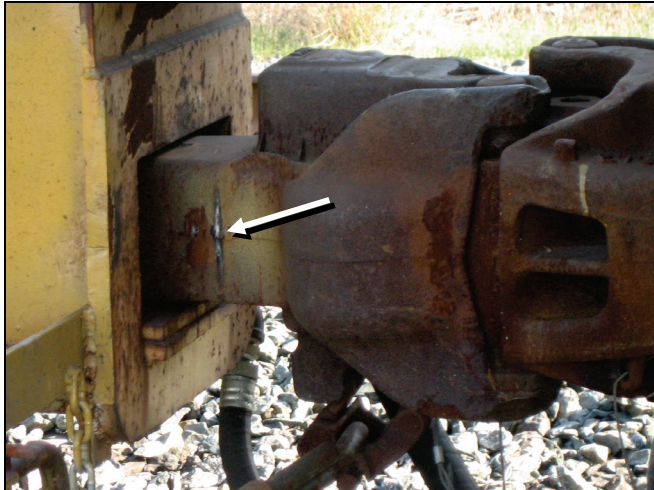
Many of the derailed cars showed recent impact marks on the centre of the car end sill draft opening and the coupler horn. Examination of a group of 10 air dump cars revealed that 7 of these cars ⁴ had severe gouging on the sides of their coupler shanks and impact marks on the side of the car end sill openings (see Photos 2a and 2b). These gouge marks were most prominent between cars BGSX 122226 (the 23rd car) and BGSX 122227 (the 24th car). In addition, the wheel treads on these two cars were battered and scored.

Photo 2a. Severe gouging on the side of the coupler shank of car BGSX 122226

Impact marks on the coupler shank and end sill opening in a group of derailed air dump cars were consistent with a train slack run-in event. Track damage was consistent with rail roll out and wheel drop in. A dynamic analysis was conducted, focusing on the two air dump cars with the most damage: BGSX 122226 and BGSX 122227 (the 39th and 40th cars in the train consist, prior to the setoff of cars at BIT). Based on analysis of detailed track, equipment, and event recorder data, it appears that an elevated buff force event occurred when the train originally came to a stop on the Halton Subdivision. The timing of the buff force event placed the two air

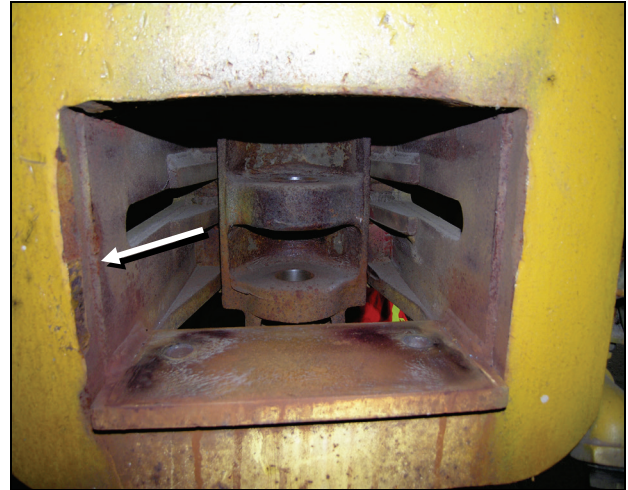
Photo 2b. Impact marks on the end sill opening

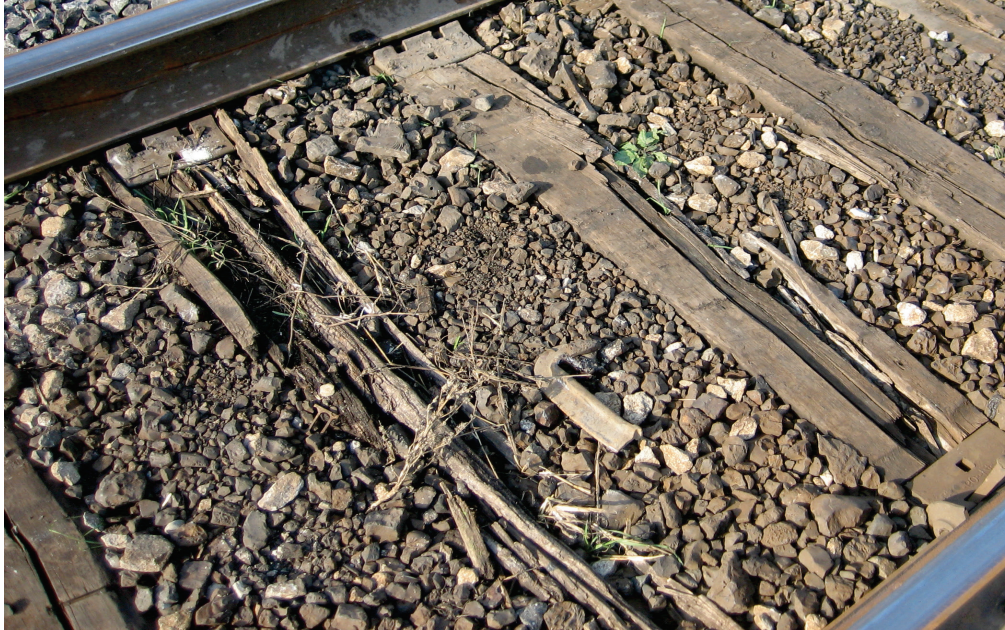
Photo 3. Tie condition in the vicinity of the derailment

Tie condition in the vicinity of the derailment area was marginal (see Photo 3). Prior to the derailment, CN's most recent documented tie count (conducted in April 2007 - see Appendix A), identified 41 defective ties out of the 100 ties just west of the point of derailment (POD), and 1056 defective ties between Mile 9.0 and Mile 10.0. The last major tie program in the area was completed when the rail was installed in 1987.

However, the track structure was weakened by a deteriorated tie condition, resulting in a reduced resistance to lateral forces.

2. The tangent track structure was weakened by a deteriorated tie condition resulting in a reduced resistance to lateral forces.
3. Elevated longitudinal forces were produced when the locomotive independent brake was not bailed-off, leading to a rapid and heavy application of locomotive independent brake at the head-end of the train.

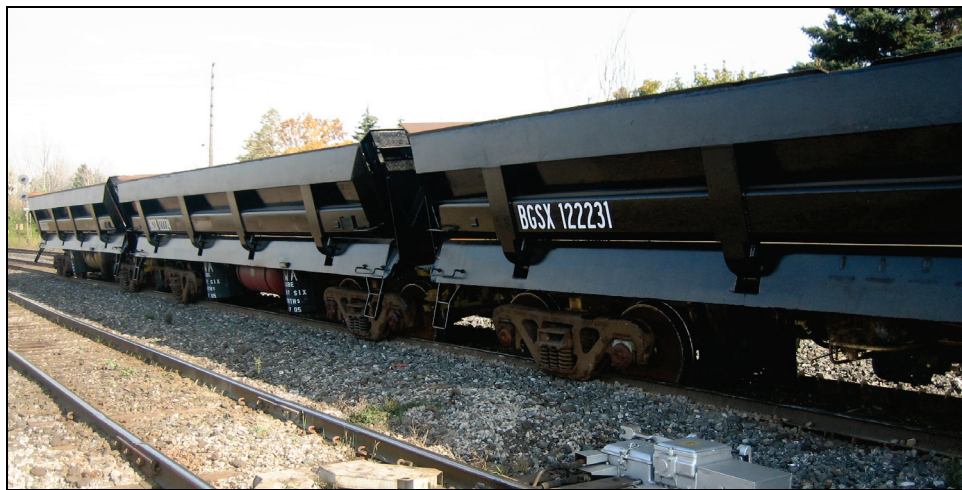
Photo 4. BGSX series air dump cars

Air dump cars (see Photo 4) are used for carrying bulk materials such as iron ore and ballast. The typical air dump car is comprised of a steel frame on trucks and a pivotally-connected hopper body. The hopper body consists of side doors that open when the body is tilted at an angle sufficient to discharge the bulk material. Once activated, pneumatic rams attached to the frame of the car will initiate the dumping function. A piston raises the bed on one side, discharging the material over the other side of the car through the opened side door.

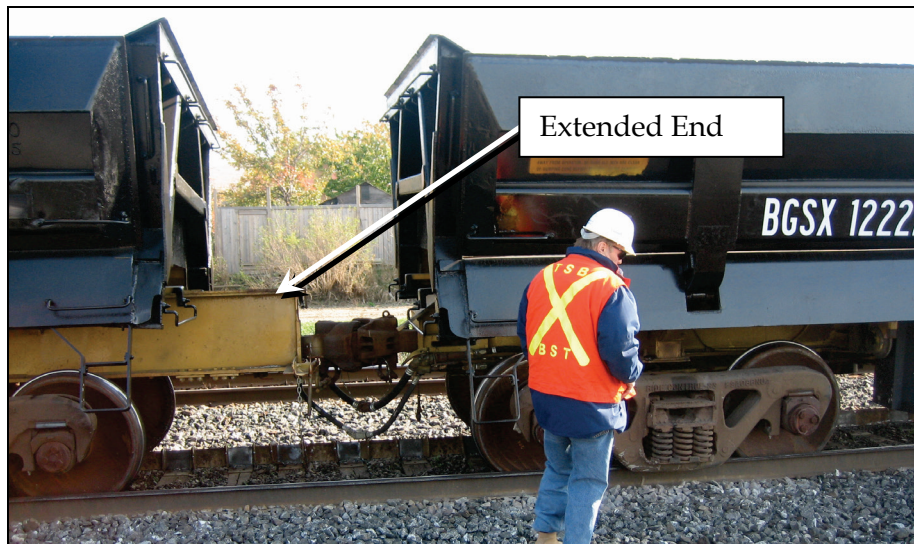
Photo 5. Side view of BGSX 122226 (extended end sill) and BGSX 122227

Some of the air dump cars involved in this occurrence were designed to carry a cab unit for controlling car dumping activities. However, the cab unit on these cars had either been removed or had not been installed. These cars, such as BGSX 122226 had an extended end sill (see Photo 5).

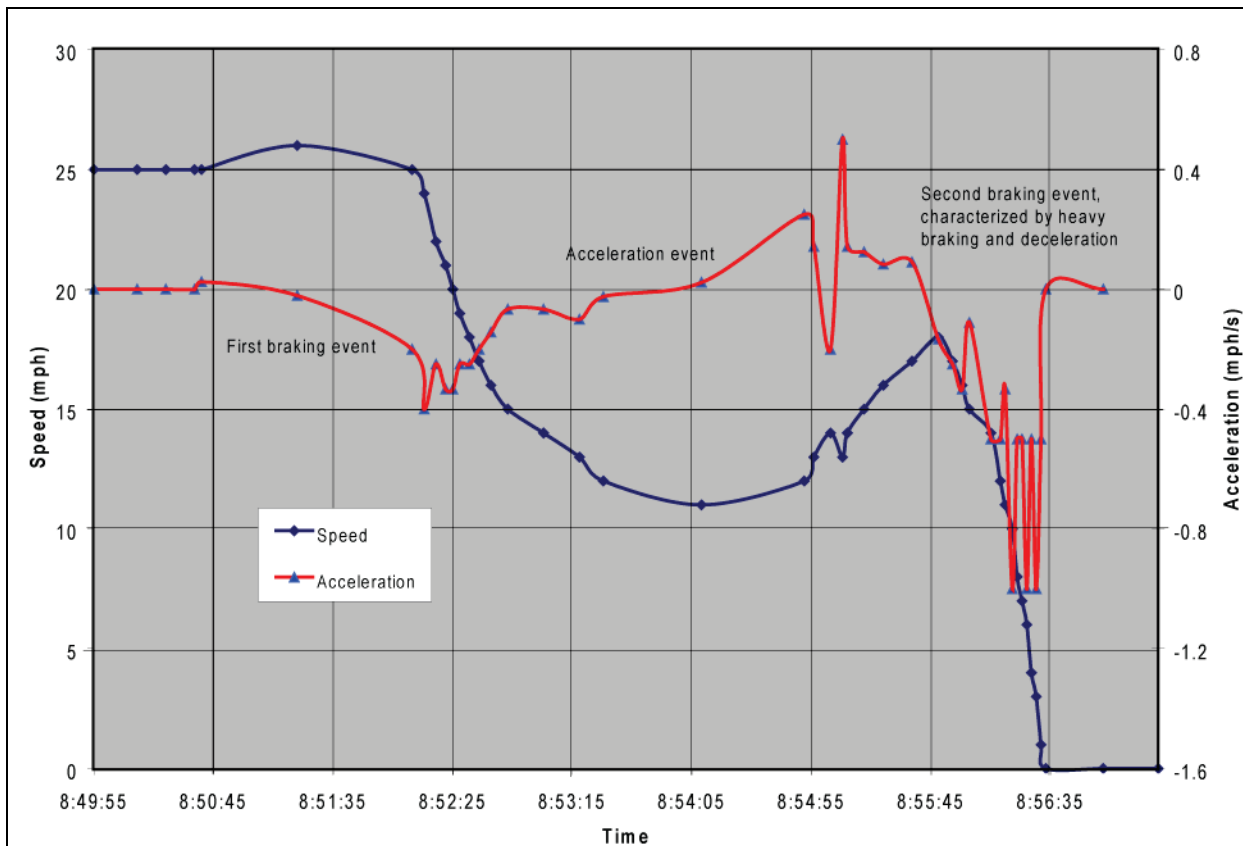
Figure 3. Speed and acceleration versus time

Based on the Locomotive Event Recorder (LER) data, train acceleration/deceleration was calculated from the recorded speed, mileage, and time data, and then plotted against time (see Figure 3).

Based on the deceleration graph and LER data, the following observations were noted:

- Just prior to the derailment, the train experienced two braking (deceleration) events and one acceleration event.
- The first braking event was carried out through a combination of a light, short automatic braking reduction and a sustained dynamic brake (DB) application.
- At 0851:47, the automatic braking reduction and release caused a local, but not significant, disturbance of the deceleration. The train deceleration was within a safe range (-0.4 mph/second).
- The train decelerated smoothly throughout the sustained DB application.
- Once the conductor detrained, the throttle was advanced.
- The surge oscillation at 0855:04 correlates with a rapid change of throttle positions.

- The second braking event was characterized by heavy braking and deceleration. The locomotive independent brake was not bailed off, allowing a rapid build-up of the locomotive independent brake. As brake cylinder pressure approached a full nominal application of 80 pounds per square inch just before the final stop, three deceleration peaks of approximately 1 mph/s occurred.
