**RAILWAY INVESTIGATION REPORT  
R07V0109**

**NON-MAIN-TRACK TRAIN DERAILMENT**

**KOOTENAY VALLEY RAILWAY (KVR)  
0700 TRAIL YARD ASSIGNMENT  
MILE 19.0, ROSSLAND SUBDIVISION  
TRAIL, BRITISH COLUMBIA  
23 APRIL 2007**

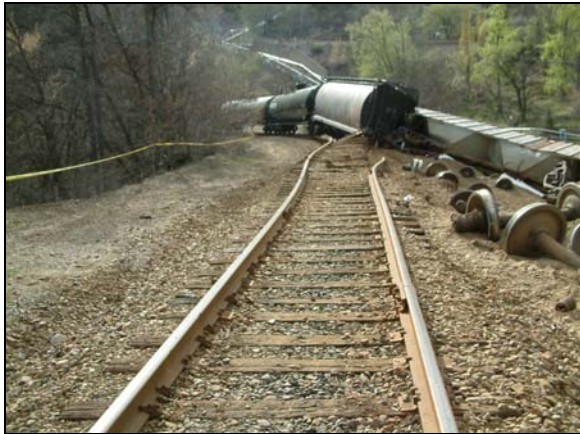
Photo 1. Derailment at Mile 19.2

The three residue tank cars did not derail. They came to rest at Mile 19.2 (see Figure 2 and Photo 1).

Immediately ahead of the tank cars, a loaded covered hopper car (CP 385119) came to rest with its trailing truck still on the rails and coupled to the residue tank cars. Its leading truck was derailed. The next six covered hopper cars ahead were derailed to the outside of the curve.

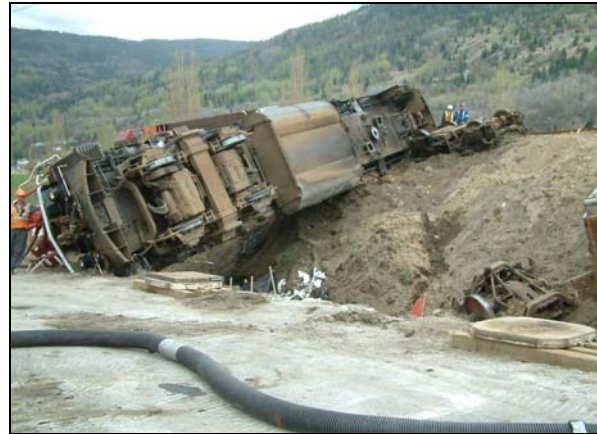
Photo 2. Derailment at Mile 19.038

The two locomotives and the remaining covered hopper car came to rest derailed to the outside of the curve at Mile 19.038 (see Photo 2).
