RAILWAY INVESTIGATION REPORT

R09T0057

RUNAWAY AND NON – MAIN-TRACK DERAILMENT

**SOUTHERN ONTARIO RAILWAY
0900 HAGERSVILLE SWITCHER
MILE 0.10 AND MILE 1.9 HYDRO SPUR
NANTICOKE, ONTARIO
11 FEBRUARY 2009**

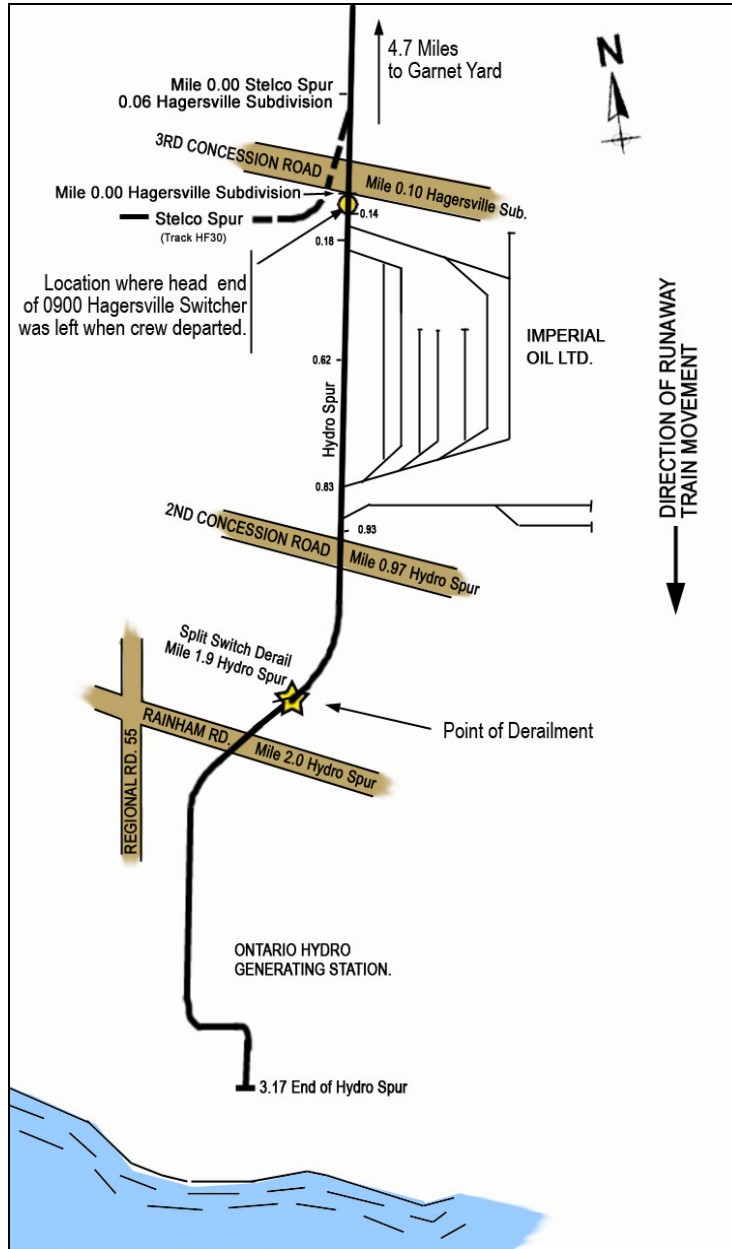
Figure 2. Hydro Spur diagram (not to scale)

At 2114, the assistant conductor brought the train to a controlled stop just south of the crossing (see Figure 2) with the locomotives coupled, the brake pipe connected, and the engines running. The plan was to secure the train and to change locomotives by setting lead locomotive RLK 4057 into the controlling position³. In preparing for the change of control, the assistant conductor set the MU2A valve on the control stand of RLK 3873 to the "Trail" position and the automatic brake cut-off valve to the "Cutout" position. The assistant conductor then detrained and departed the site without placing lead locomotive RLK 4057 in the controlling position. It is not known whether, or how many, handbrakes were set.
