**RAILWAY INVESTIGATION REPORT  
R10T0020**

**NON-MAINTRACK TRAIN DERAILMENT**

**CANADIAN NATIONAL RAILWAY  
YARD SWITCHING MOVEMENT  
MILE 0.0, HALTON SUBDIVISION  
MACMILLAN YARD, TORONTO (ONTARIO)  
09 FEBRUARY 2010**

Report Number R10T0020

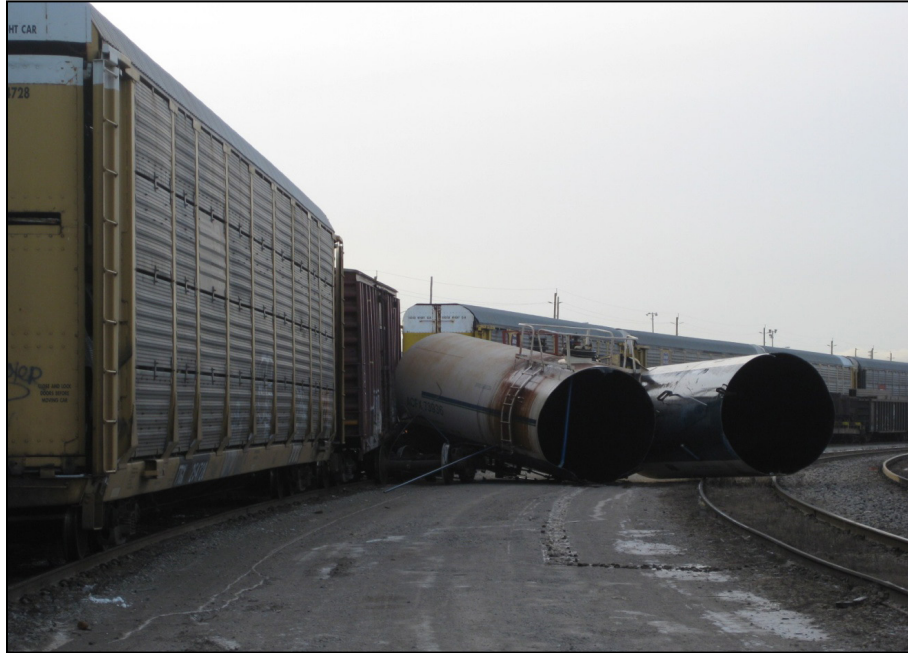
Subsequent inspection determined that the 16<sup>th</sup> and 17<sup>th</sup> cars from the locomotives had derailed near the north switch of track R-011. The A-end of the 18<sup>th</sup> car and 2 cars on an adjacent track sustained impact damage. The 17<sup>th</sup> car, dangerous goods (DG) tank car ACFX 73936, had failed catastrophically near the middle of the car and had broken into 2 sections (see Photo 1).

**Photo 1.** ACFX 73936 fractured and derailed

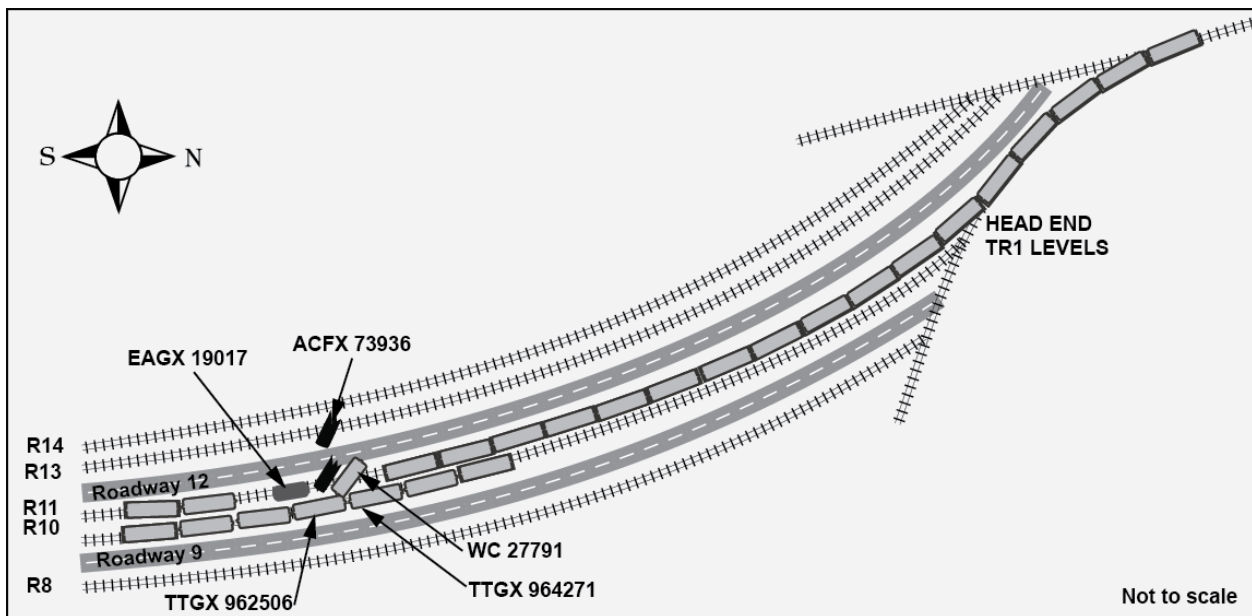
**Figure 3.** Site diagram

From the north switch, tank car ACFX 73936 had been shoved southward for about 600 feet. In the process, it released its entire load of approximately 57 000 litres (15000 US gallons) of ferric sulphate (UN 3264) along roadway 12 and the adjacent tracks. One half of the tank car came to rest on roadway 12 between tracks R-011 and R-013. The other half came to rest fouling roadway 12 and track R-013 (see Figure 3). Aside from product contamination, only sporadic tie damage was observed along track R-011 for about 600 feet.

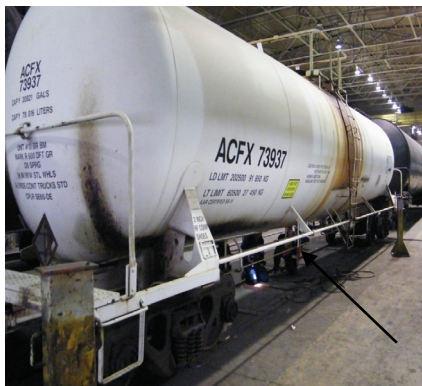
**Photo 2.** Sister tank car ACFX 73937

A sister tank car (ACFX 73937) was also examined at a certified tank car repair facility. Three sets of bracket welds, including the center bracket where the occurrence tank car cracking had initiated, were examined by a certified Non Destructive Evaluation (NDE) technician. The paint was removed from all six welds and both liquid penetrant and MPI inspection techniques were used. No cracking was found at any of the welds. However, the bracket leg weld sizes were also oversized measuring from 5/16 inch to over 1/2 inch.

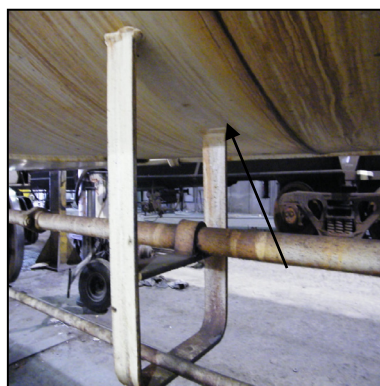
The fracture origin (crack #1) was located at the toe of a longitudinally oriented fillet weld which secured the inboard leg of the bracket to the tank shell (see Photos 2 and 3). The fracture origin was oxidized and displayed beachmarks and ratchet marks typical of fatigue cracking. The fracture features indicate that multiple cracks initiated on the exterior of the tank shell and propagated into the shell material. The cracks combined into a single fatigue crack about 2 inches long and 5/16 inches deep (see Photo 4).

**Photo 3.** Location of fracture origin (ACFX 73937)

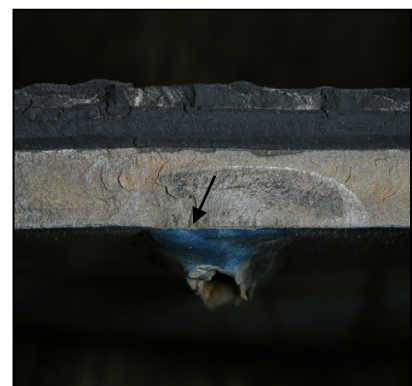
**Photo 4.** Close-up of fracture origin (crack #1) on ACFX 73936

- The inboard leg of the bracket was located near the bottom center line of the tank shell in an area that was not reinforced. In the absence of any reinforcing pad, the weld which secured the inboard leg of the bracket to the tank shell was subjected to higher in-service bending loads. These bending loads applied tensile stresses at the toe of the inboard bracket leg weld and initiated the fatigue crack (crack #1).
