RAILWAY INVESTIGATION REPORT
R10T0056

MAIN-TRACK DERAILMENT

CANADIAN NATIONAL
TRAIN M37631-30
MILE 1.40, YORK SUBDIVISION
PICKERING, ONTARIO
30 MARCH 2010

Report Number R10T0056

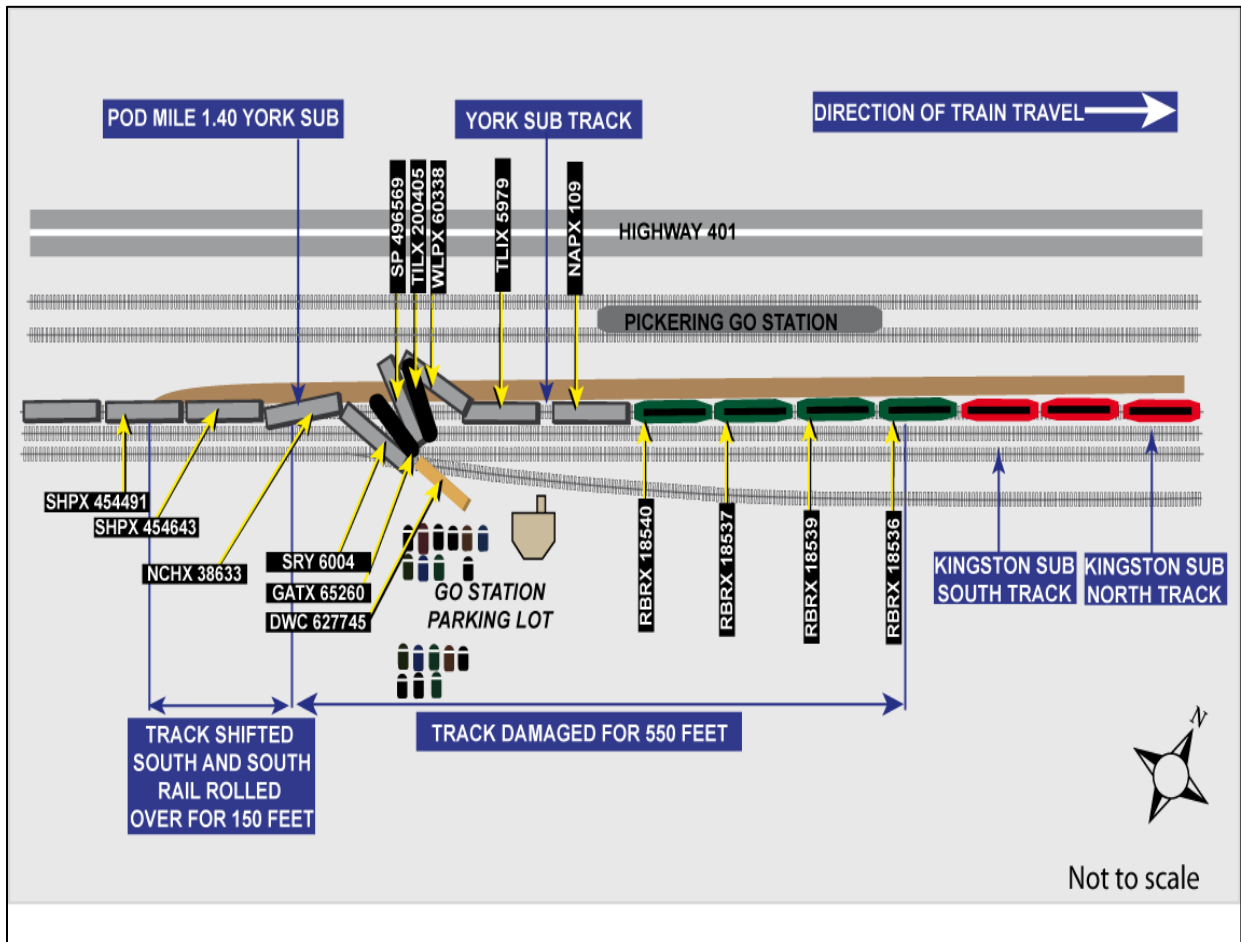
Figure 2 – Site Diagram

Approximately 125 feet east of the Liverpool Road overpass, the York Subdivision track had shifted about 8 inches to the south. The track shift extended for 150 feet up to Mile 1.40. Within this area, the south rail had lifted out of the tie plates, was canted and rolled. Wheel flange marks were observed on the ties extending eastward from Mile 1.40 for a further 550 feet up to the trailing truck of the first isolated locomotive, RBRX 18536. About 700 feet of track on the York Subdivision and 180 feet of parallel track on the Kingston Subdivision north track were damaged.

All locomotives and the first freight car (loaded covered hopper) had separated from the remainder of CN 376. The lead locomotive came to rest approximately 1000 feet east of the Liverpool Road overpass. The trailing truck of the first isolated locomotive, RBRX 18536, and all wheels of the following 3 isolated locomotives and the freight car were derailed. There was a short separation followed by the 2nd to the 11th cars which had also derailed. Five of the cars had jackknifed and were foul of both Kingston Subdivision tracks. A centre beam flat car, loaded with lumber, came to rest in the Pickering GO station parking lot (see Figure 2).

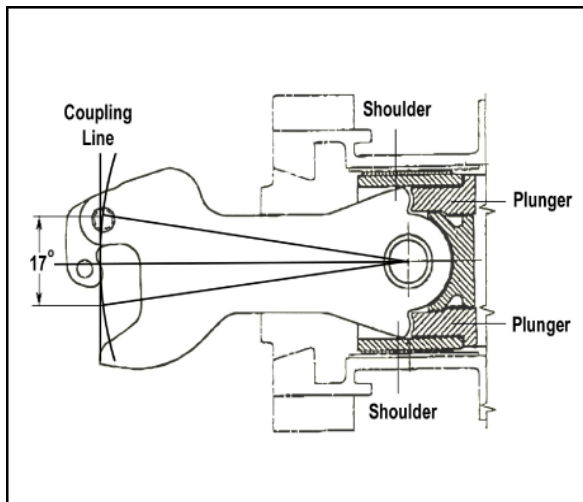
Figure 3 - Alignment control coupler

Most freight locomotives are equipped with alignment control couplers (see Figures 3 and 4) and bolster stops that limit coupler swing. Alignment control couplers limit the coupler angle under buff conditions, to within 8° from centreline. This limits the lateral force imparted on the track due to high in-train longitudinal compressive buff force and reduces the risk of derailment. In contrast, some older locomotives, yard switchers and locomotives in passenger service, such as the 4 isolated locomotives on CN 376, are not always equipped with alignment

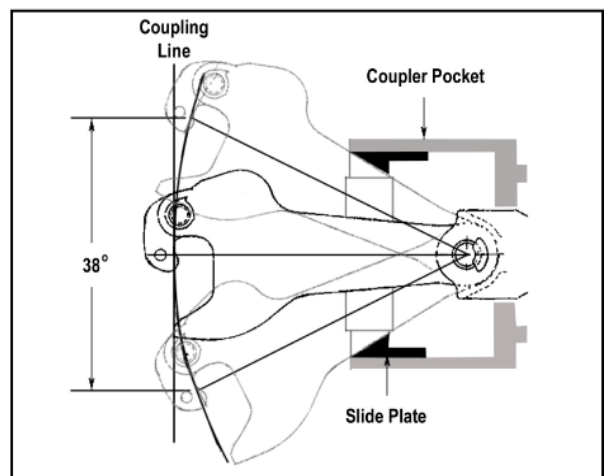
Figure 4 - Coupler without alignment control

control couplers. The absence of these features provides locomotives with a greater range of coupler movement (i.e. larger coupler angle) for negotiating tighter curves that are commonly found in train yards, passenger and/or transit service. In these operations, train weights and lengths are relatively low with similarly reduced buff and draft forces that act upon the train.

- The couplers on the isolated passenger locomotives with no alignment control had coupler angles up to 21° in jackknifed positions as measured on the derailed equipment.

The alignment control couplers on the operating locomotives limited the coupler angle to 8°, but the non-alignment control couplers on the isolated passenger locomotives had coupler angles of up to 21°. In the presence of high in-train buff forces exceeding 200 kips, the large coupler angle of the isolated locomotives with no coupler alignment control magnified the lateral drawbar force and produced a high L/V ratio that exceeded derailment criterion. Isolated locomotives not equipped with either alignment blocks or alignment control couplers present a higher risk of derailment.

Any non-CN locomotives without alignment control couplers must be retrofitted with coupler alignment blocks, and for GP trucks, the bolster stop must be used to permit movement.
